Route 1 Falmouth Commercial District

Stormwater Management Plan

Town of Falmouth, ME

January 2013

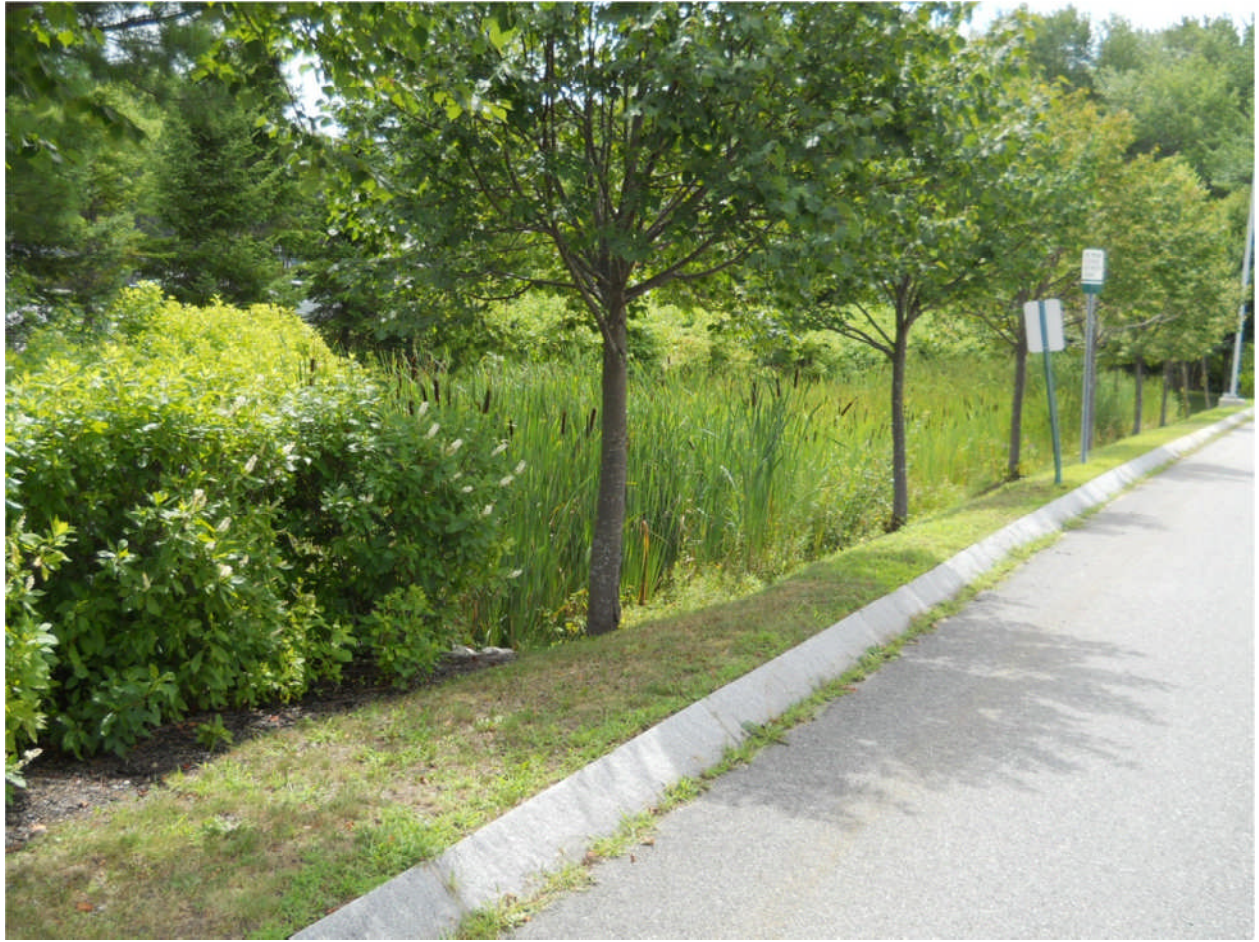
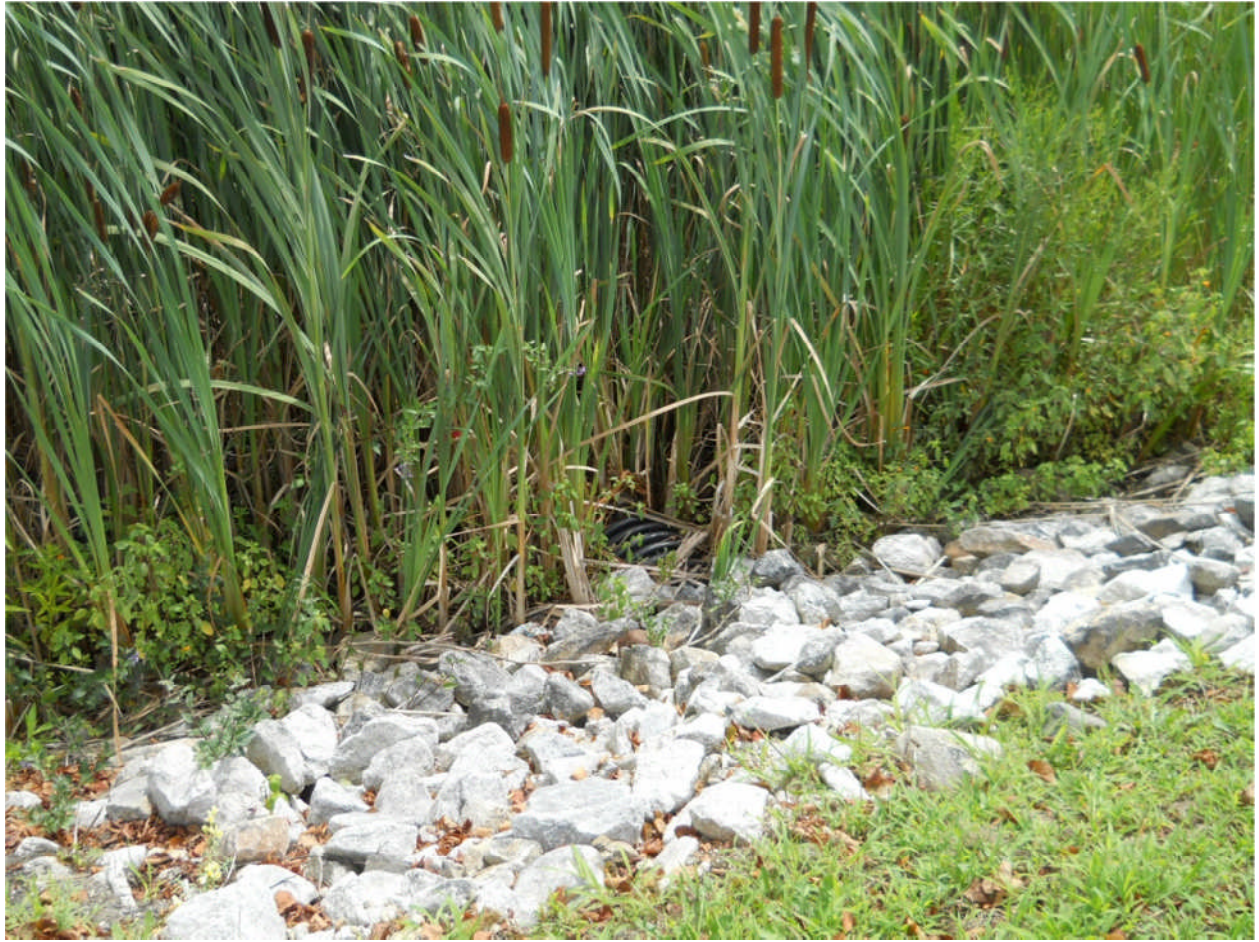
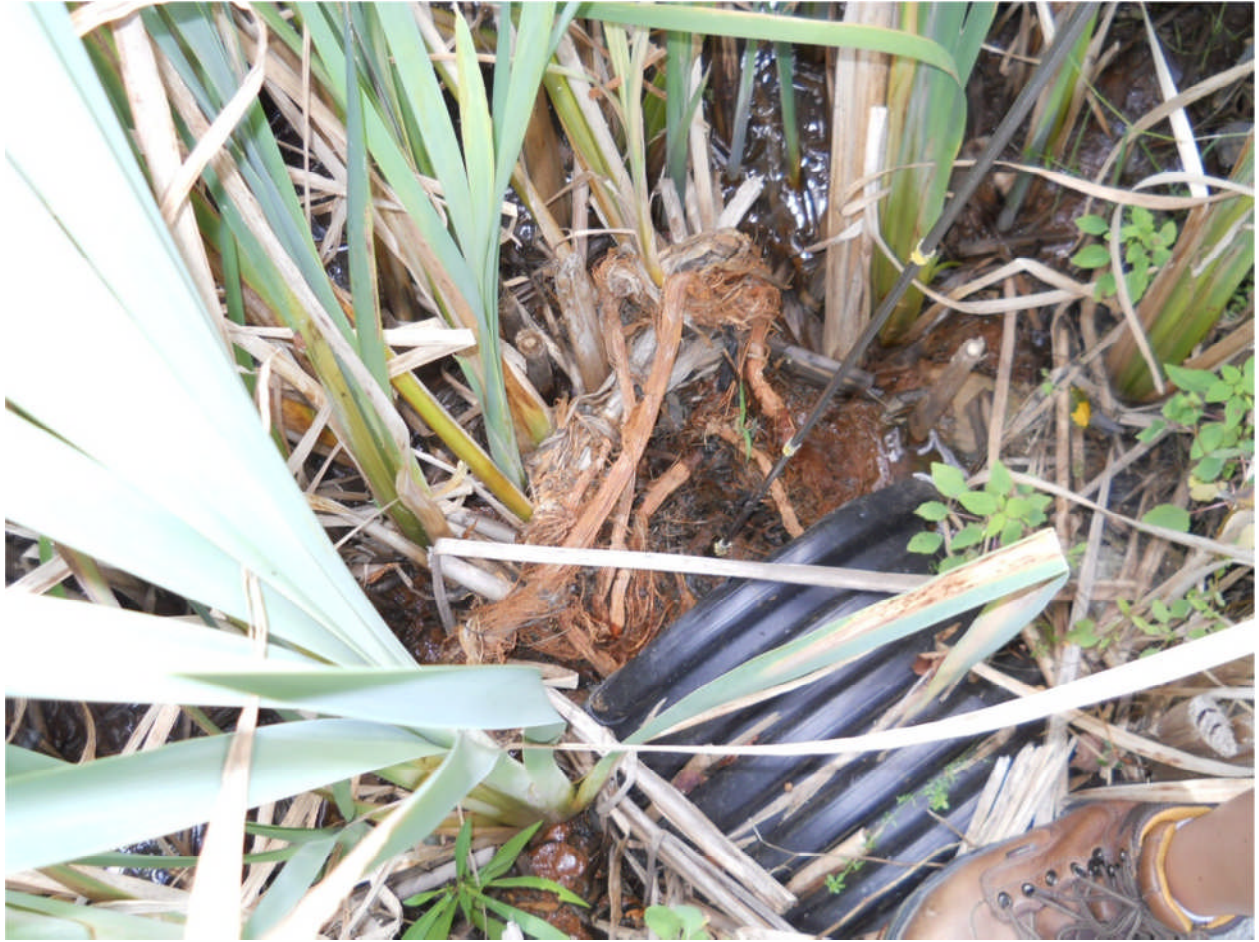
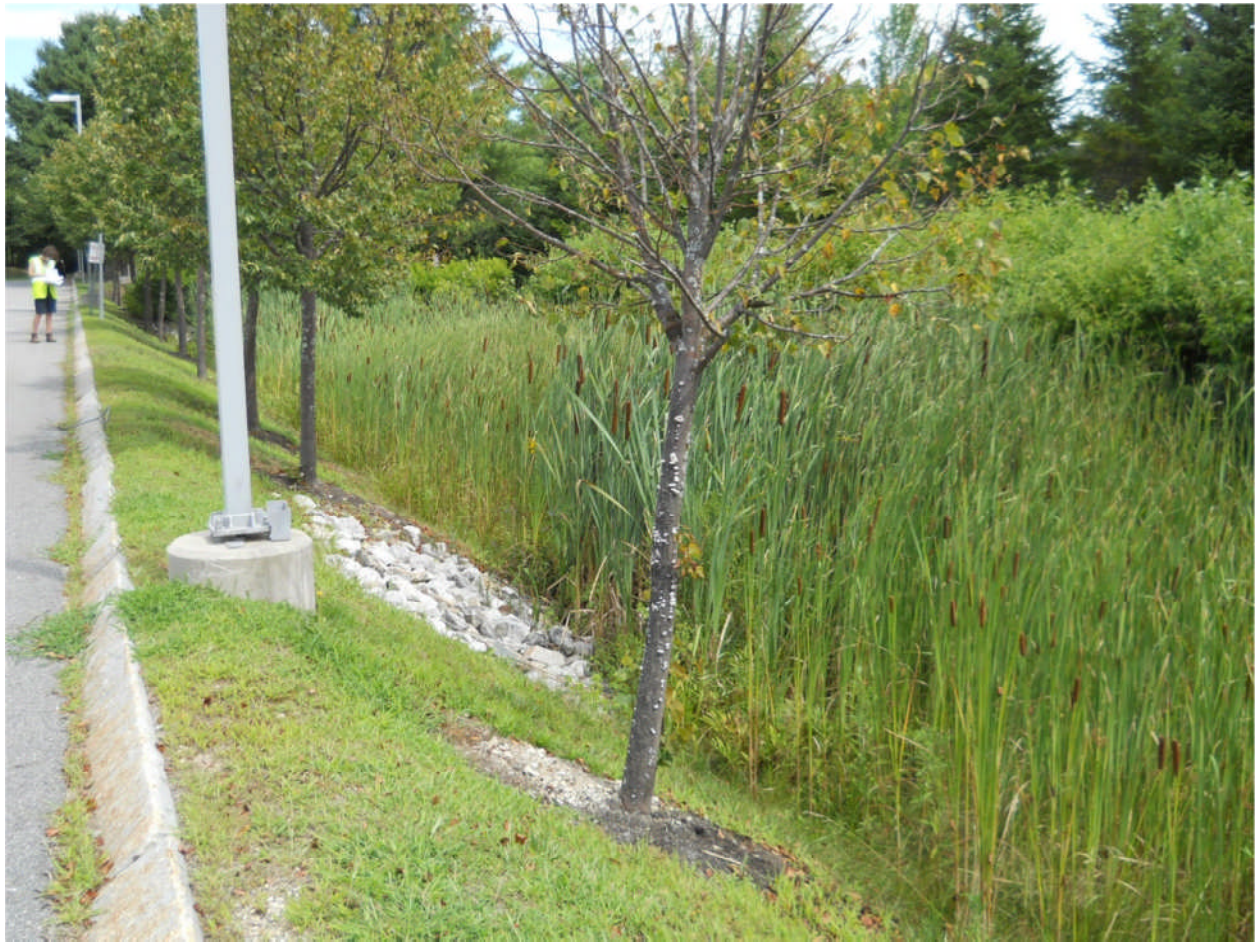
Fundy Circle (Dry Detention Basin 1) Parcel ID: U11-035C

The stormwater management facility at Fundy Circle consists of two Dry Detention Basins located on the eastern end of the Fundy Circle parking lot. Detention Basin 1 has one inlet, which discharges from a catch basin within the parking lot and which is almost completely clogged with sediment and vegetation. The standing water in both the catch basin and the pond (a.k.a. detention basin) was noted as having

visible surface sheen, which may be indicative of oil contamination from the adjacent parking lot. In addition to having sheen, the water in this pond had evidence of suspended solids and algal blooms. It should be noted that no sampling was conducted on the standing water, so the pollutants resulting in the sheen remain unknown.

Based on the condition of the pond's water, its historic issue with sediment, and the excessive vegetation and standing water (which are not components of properly constructed Dry Detention Basin), this facility was evaluated as Poor.

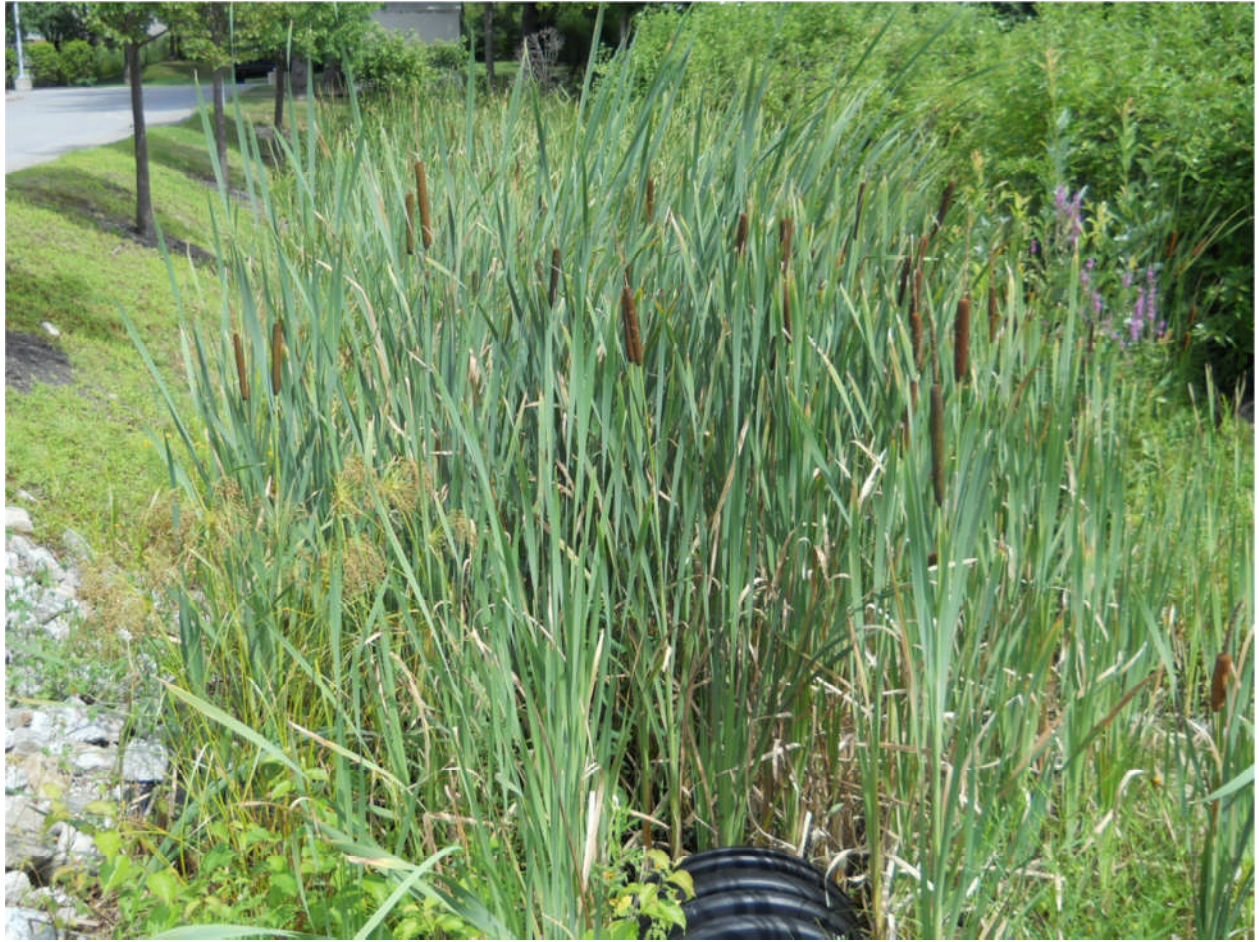
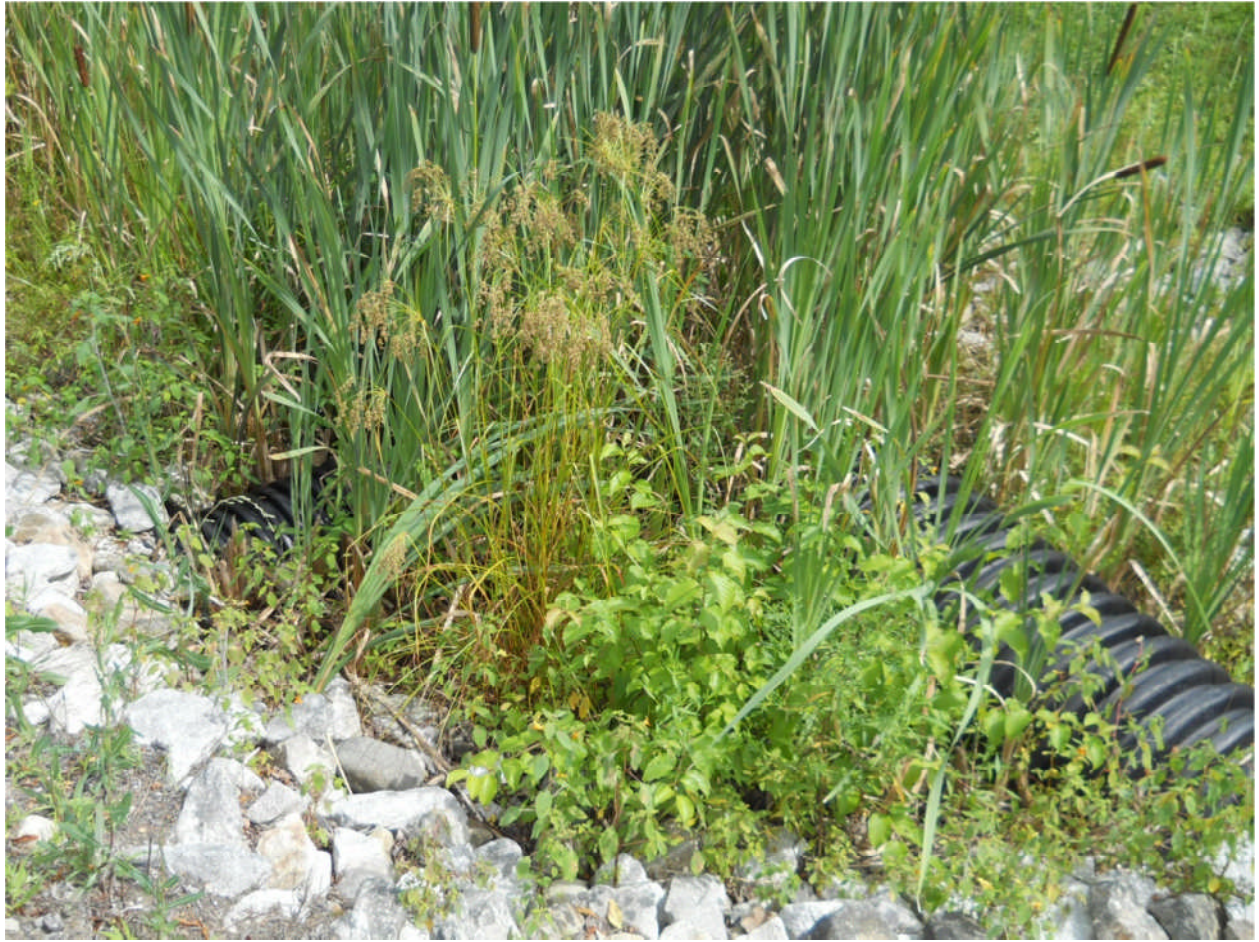
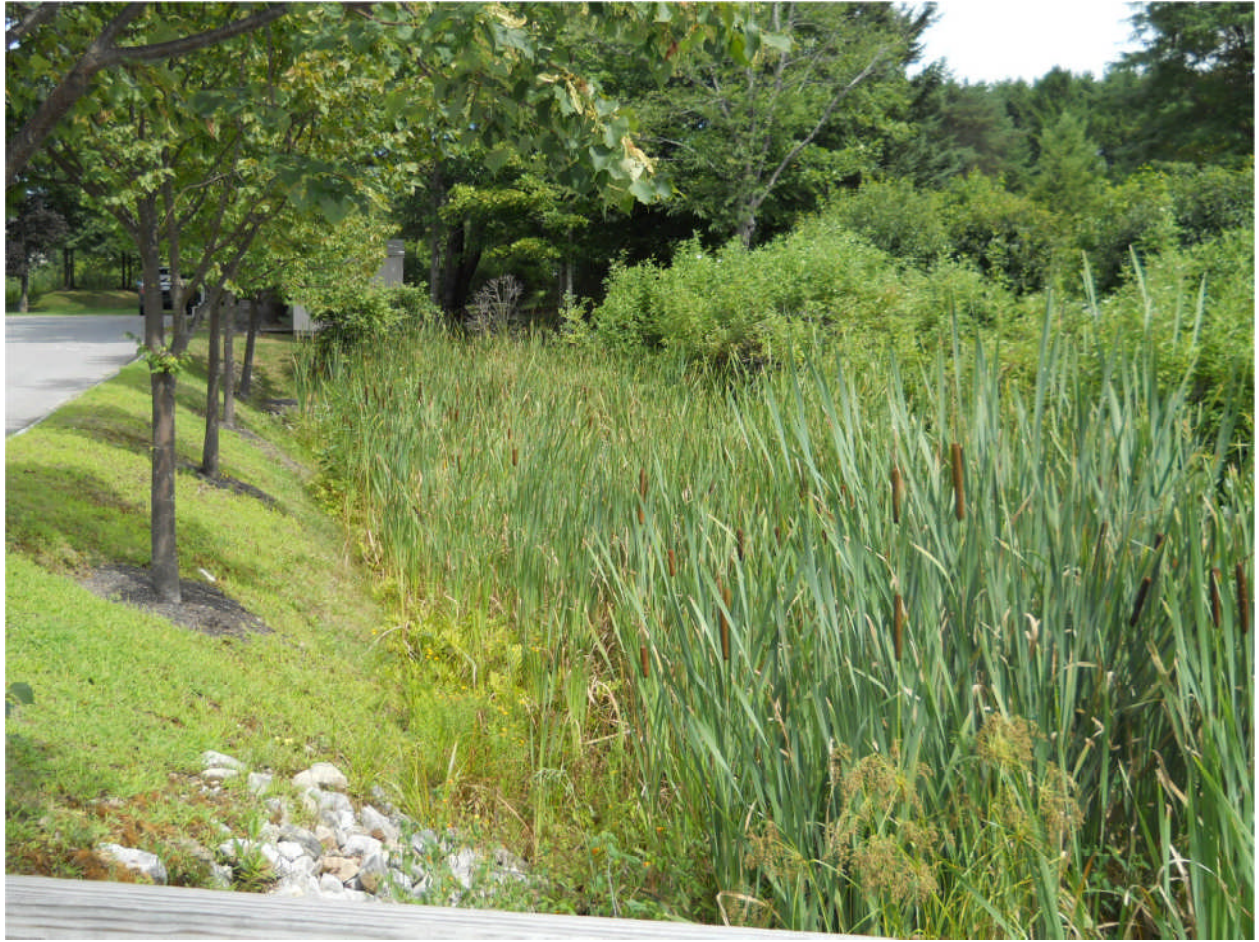
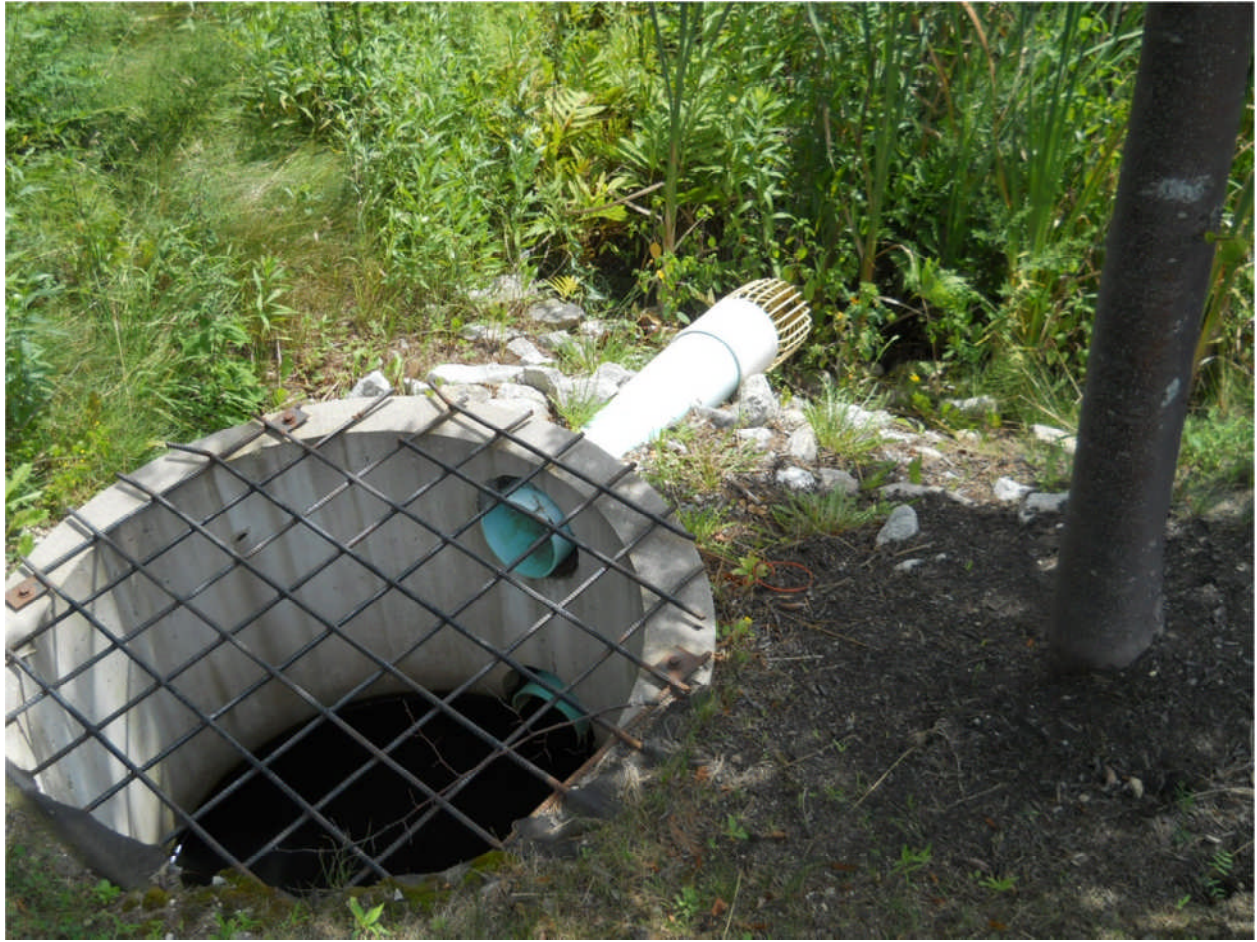
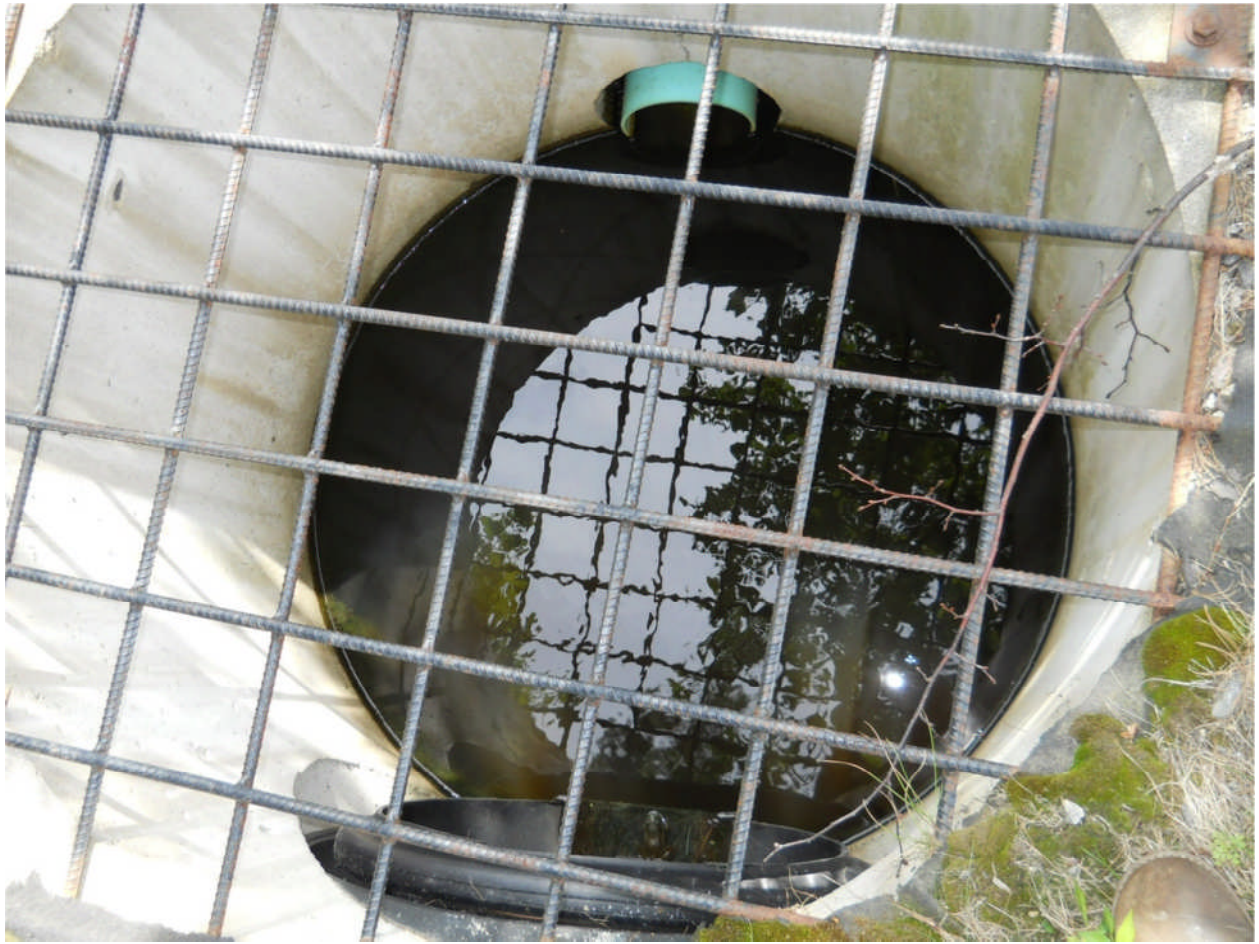
Fundy Circle (Dry Detention Basin 2) Parcel ID: U11-035C

The second of the two Dry Detention Basins located in series at Fundy Circle (as noted above) is located slightly north of the walking path between the two ponds. It accepts discharge from two outlets, one from Pond 1 and the other from a catch basin in a more northern part of the lot. The pond has an outlet control structure. The outlet of the pond consists of a catch basin with overflow pipe, a trash rack, and an emergency spillway. The low-flow inlet from the pond to the outlet structure could not be located in the field; it may be submerged and potentially clogged. Both inlets into the pond have much less sedimentation than Detention Basin 1, but still have excessive vegetation growth in front of the culvert. Just as in Pond 1, there was approximately 1-foot of sediment deposit, about 1.5-feet of standing water, and approximately 90% vegetated cover consisting largely of cattails. In addition to having an oily sheen, the water in this pond had evidence of suspended solids and algal blooms.

Based on the condition of the pond's water (which appeared slightly better than Detention Basin 1), its historic issue with sediment, and the excessive vegetation and standing water (which are not components of properly constructed Dry Detention Basin), this pond was evaluated as Fair.

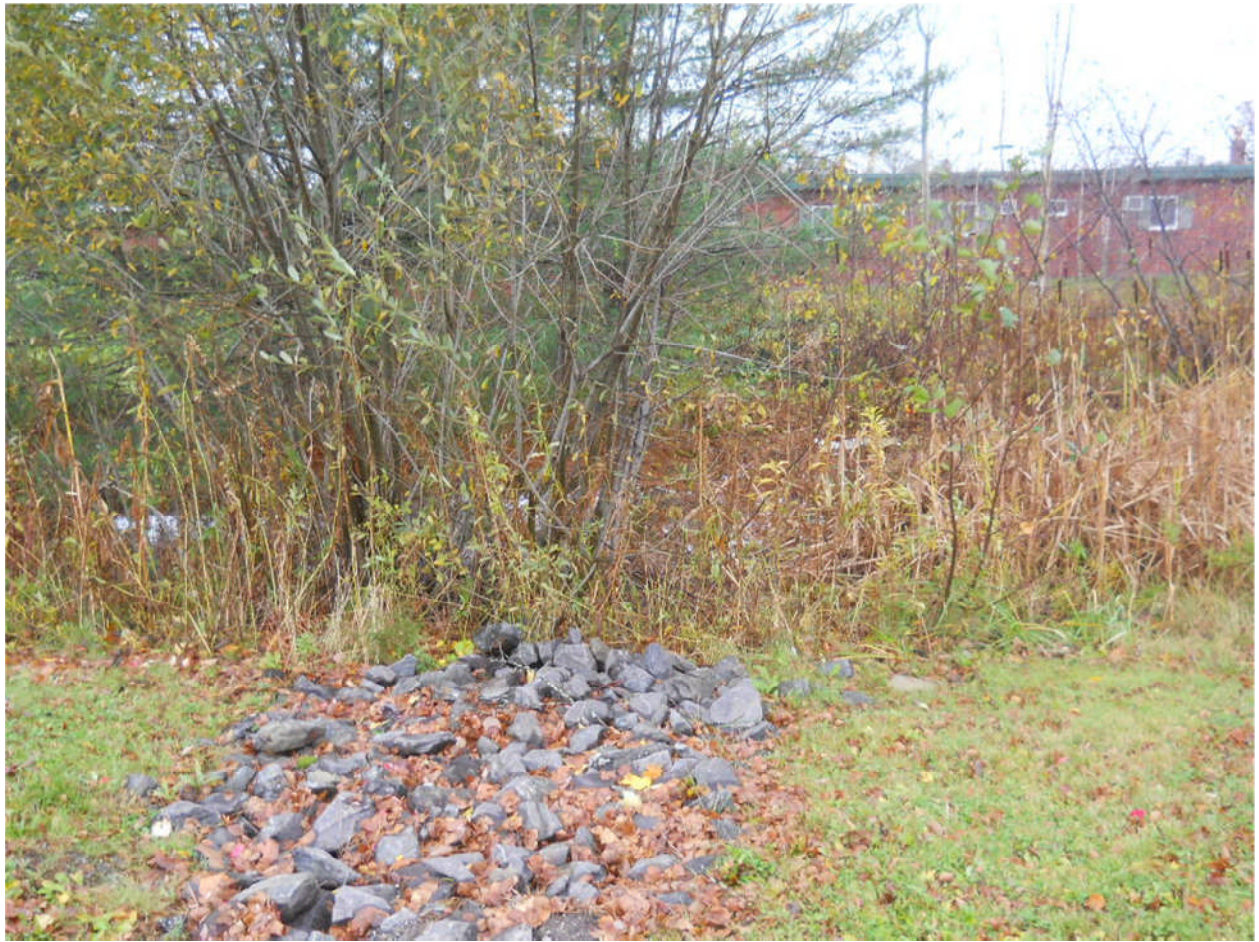
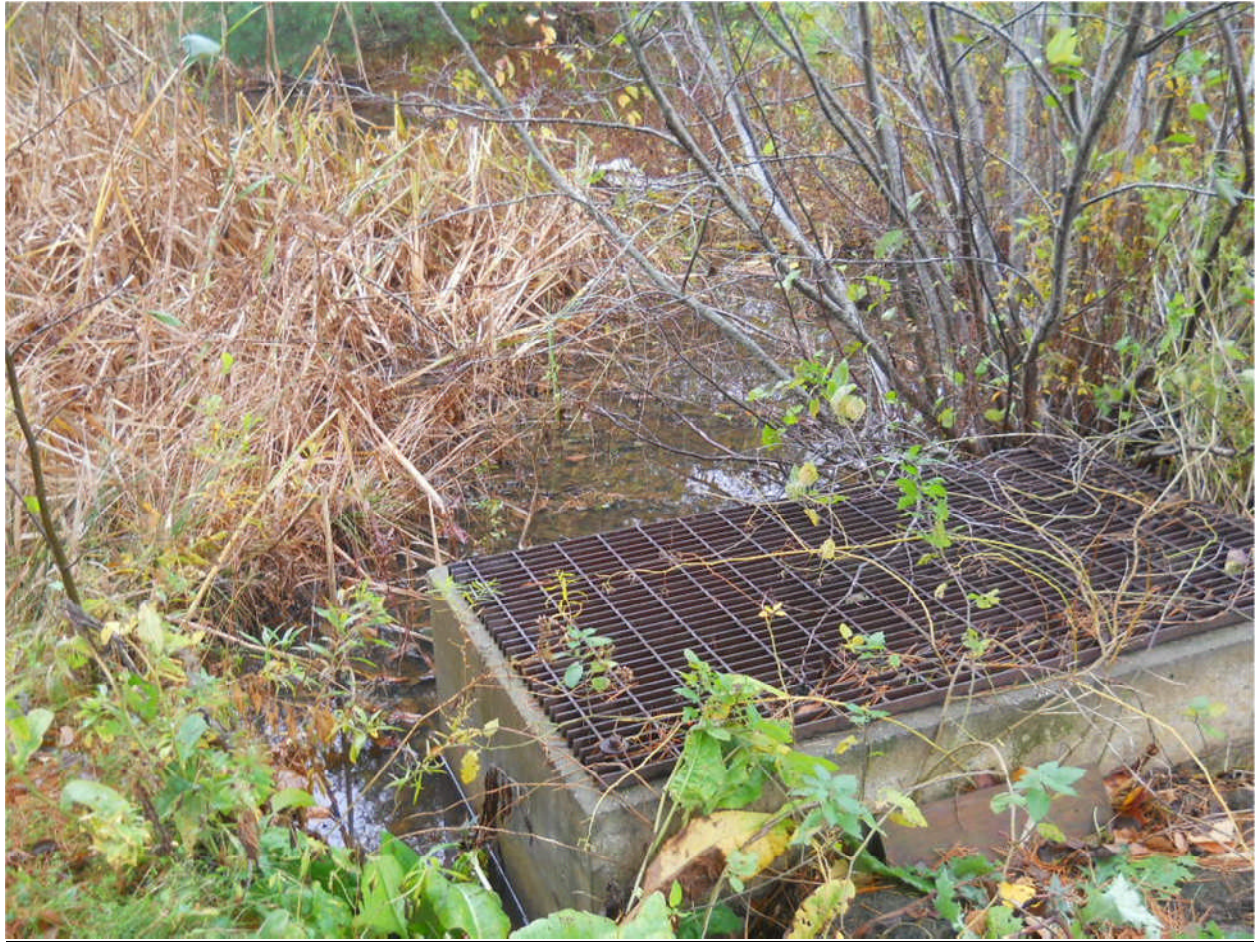
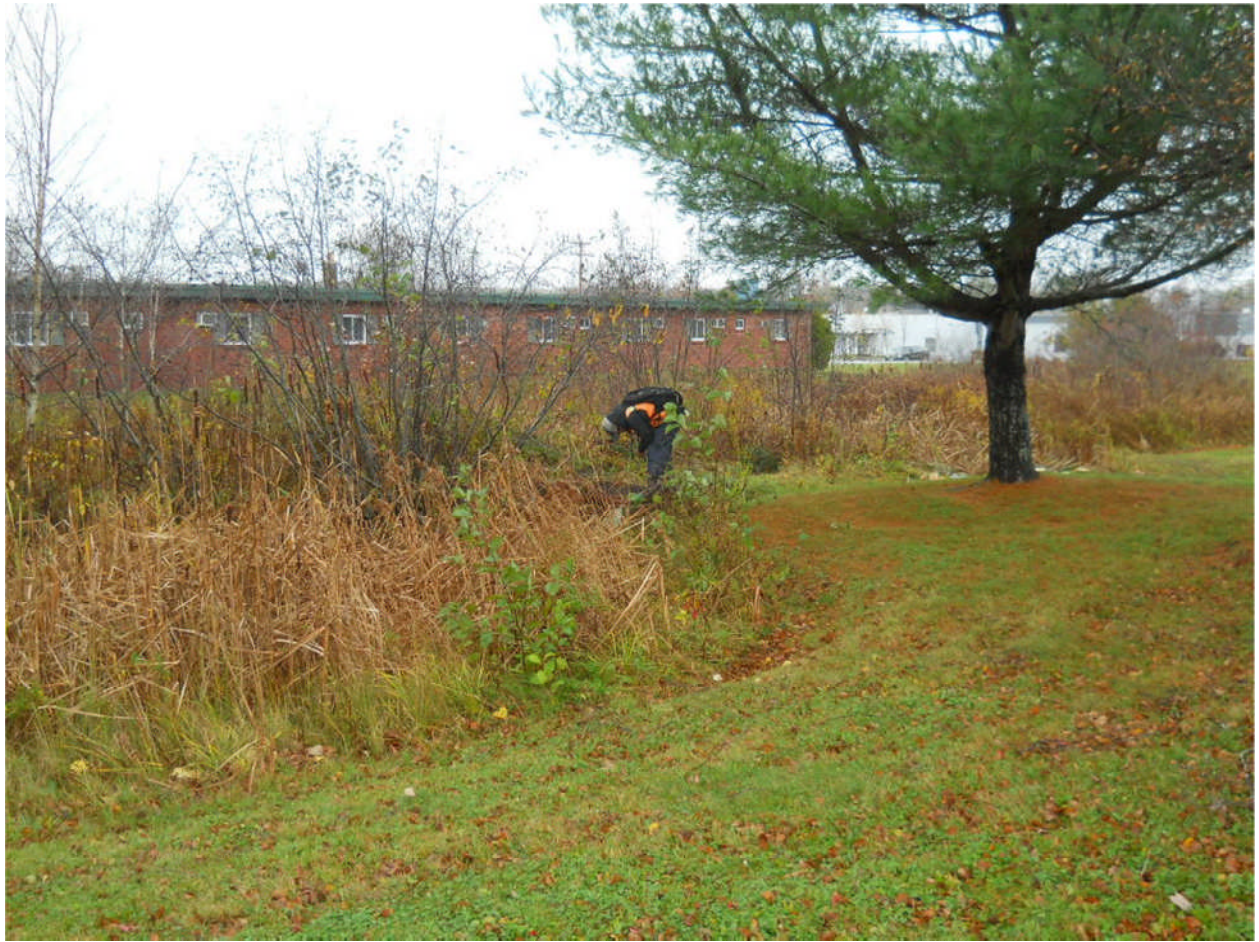
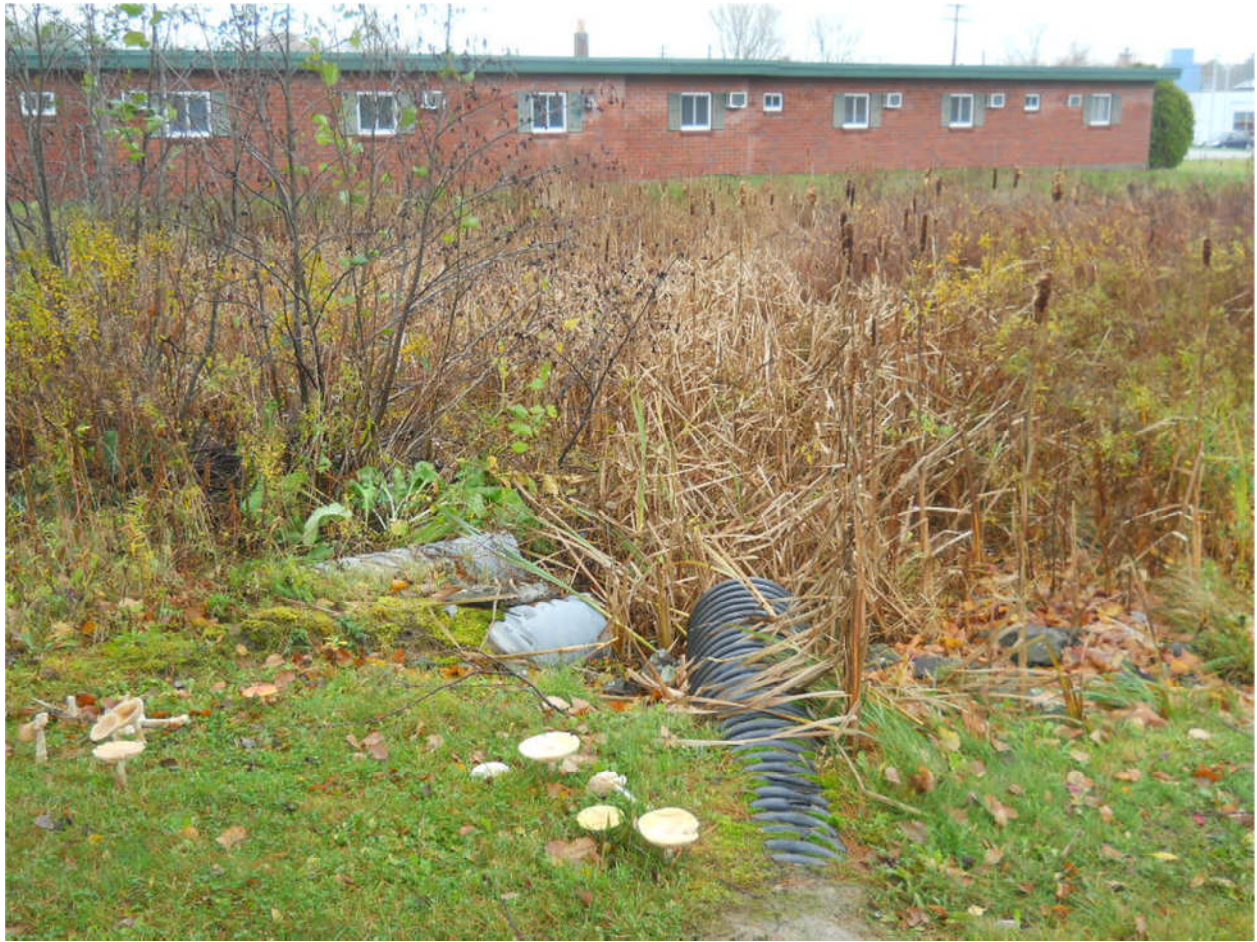
Fundy Road (Dry Detention Basin 3) Parcel ID: U11-035D

Based on the condition of the pond's water and embankments, and the presence of vegetation and standing water (which are not components of properly constructed Dry Detention Basin), this pond was evaluated as Good.

The outlet control structure should be cleaned
