Route 1 Falmouth Commercial District

Stormwater Management Plan

Town of Falmouth, ME

January 2013

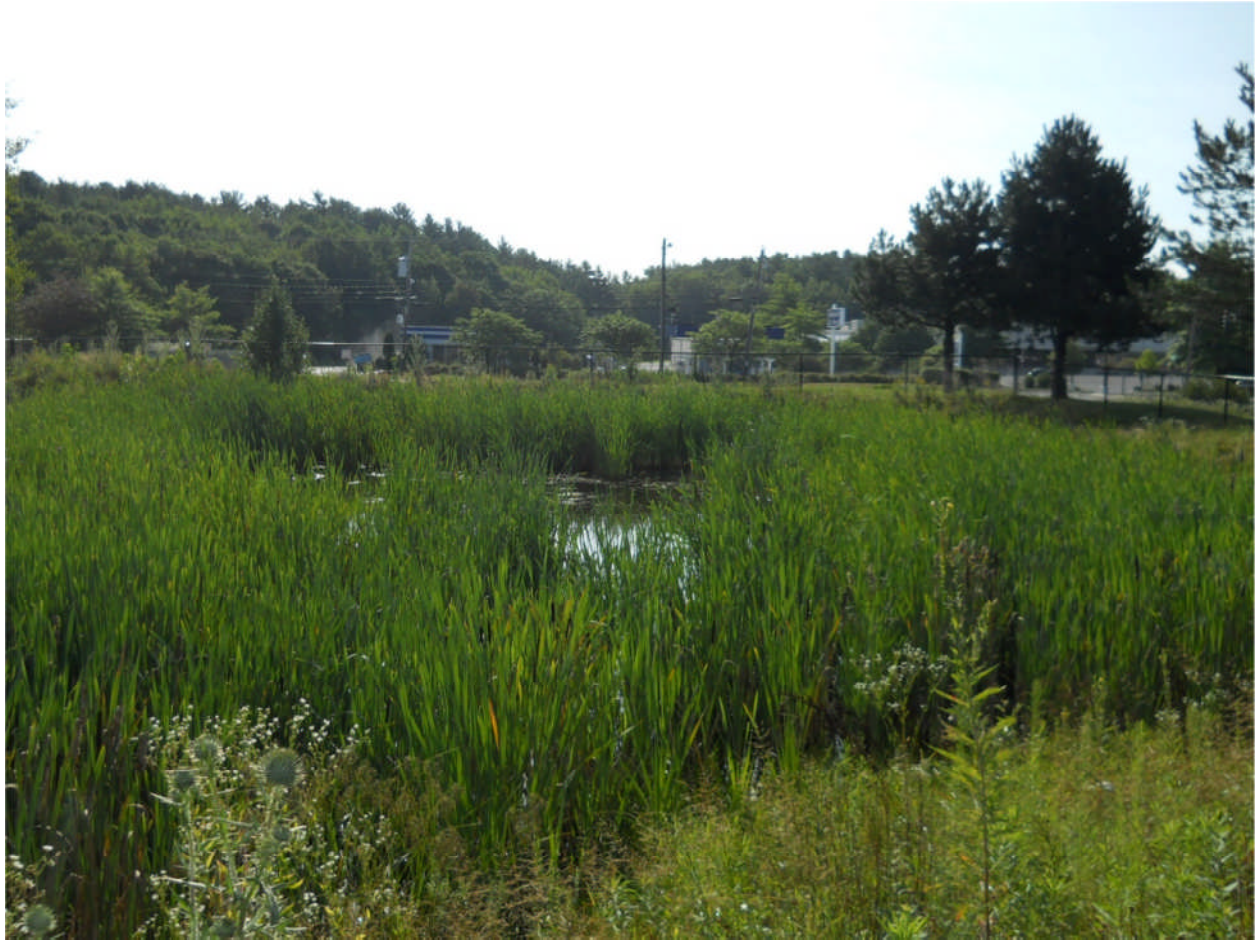
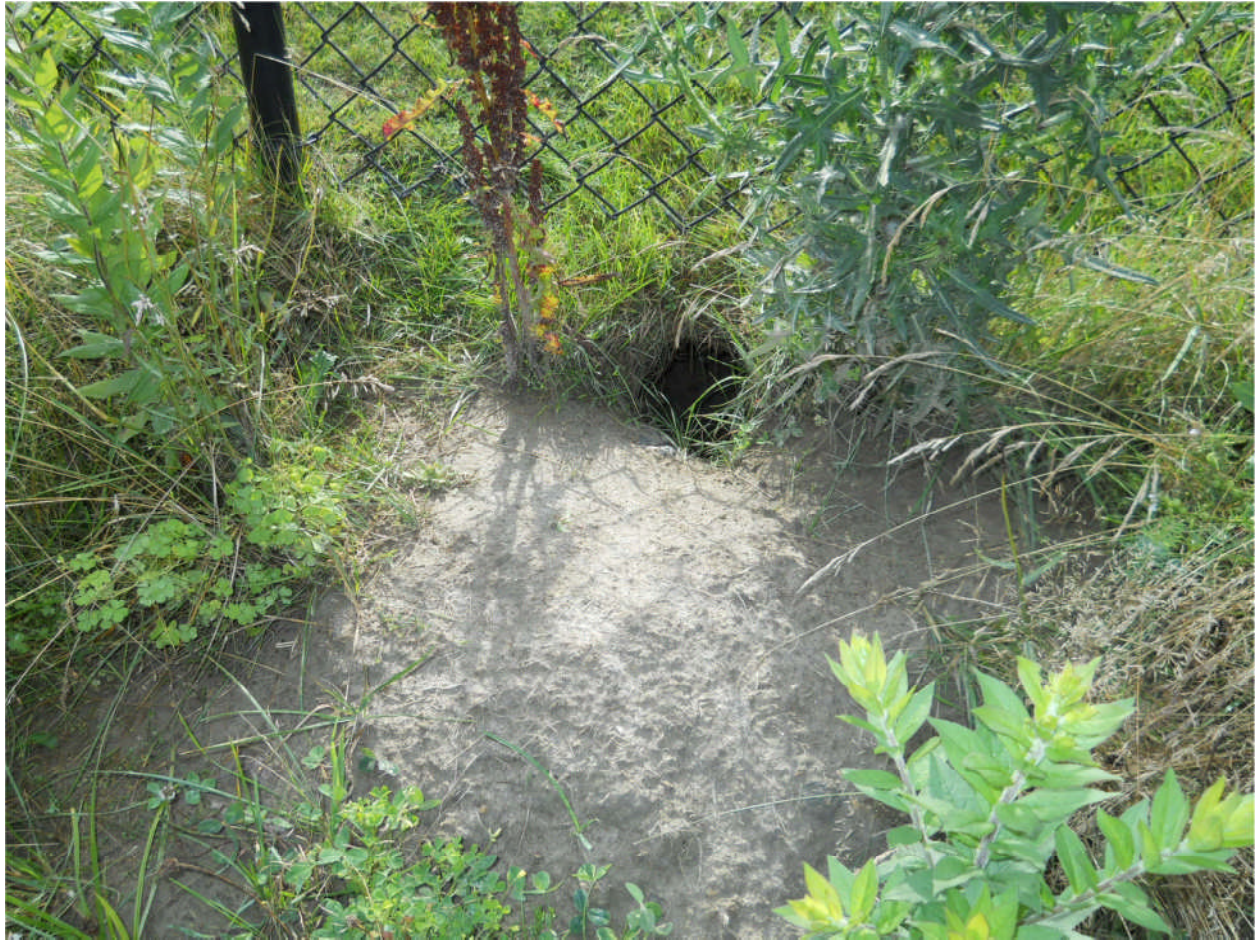
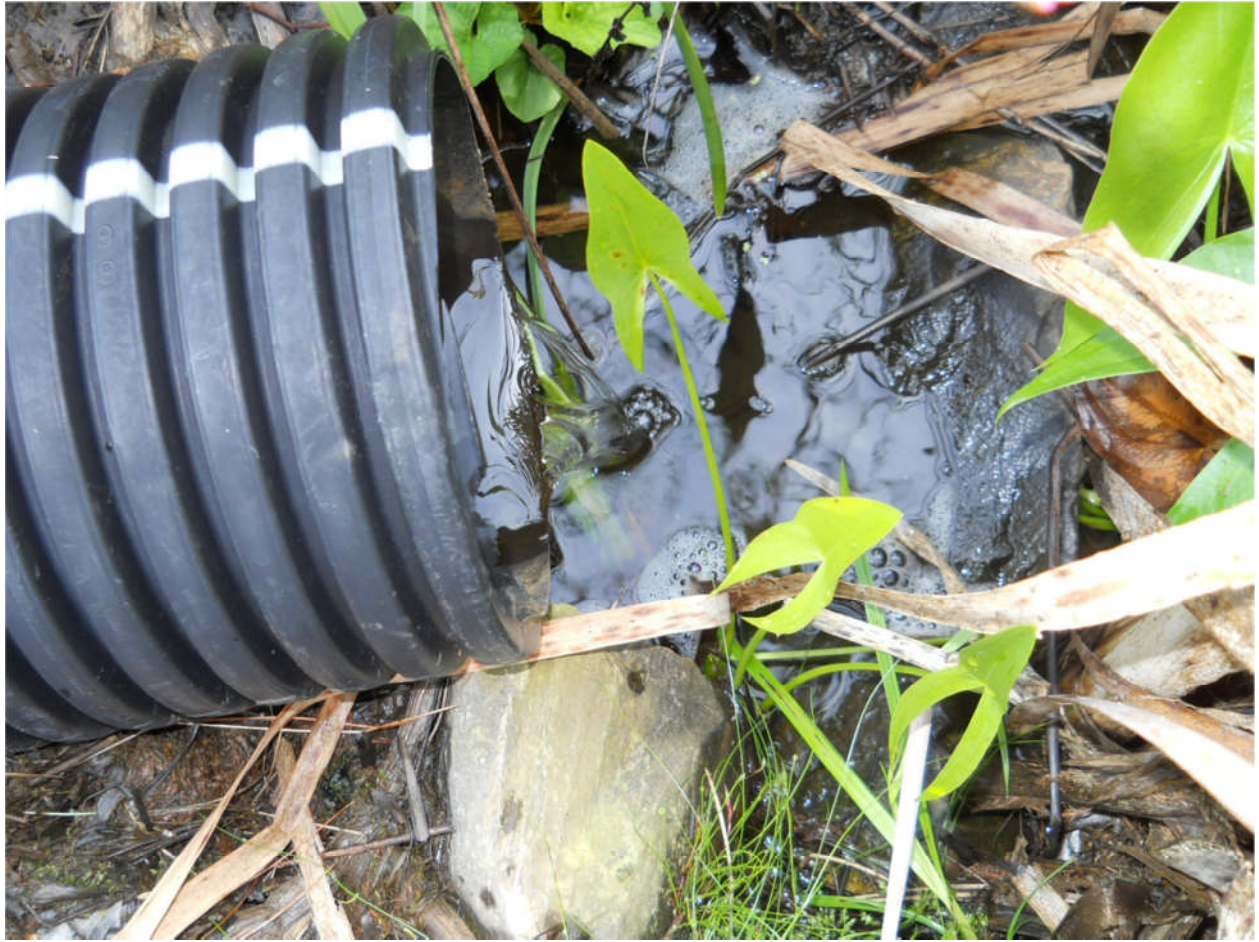
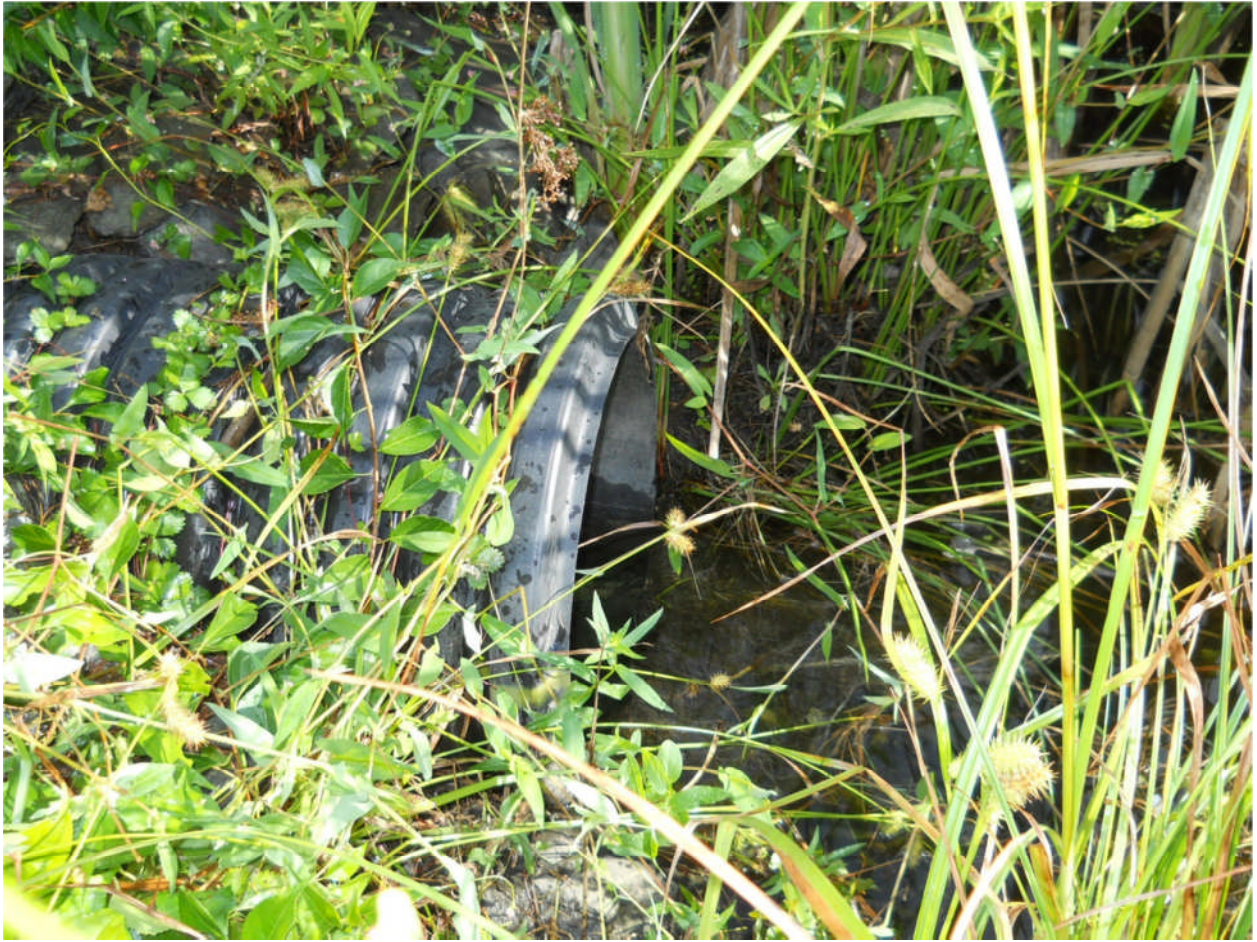
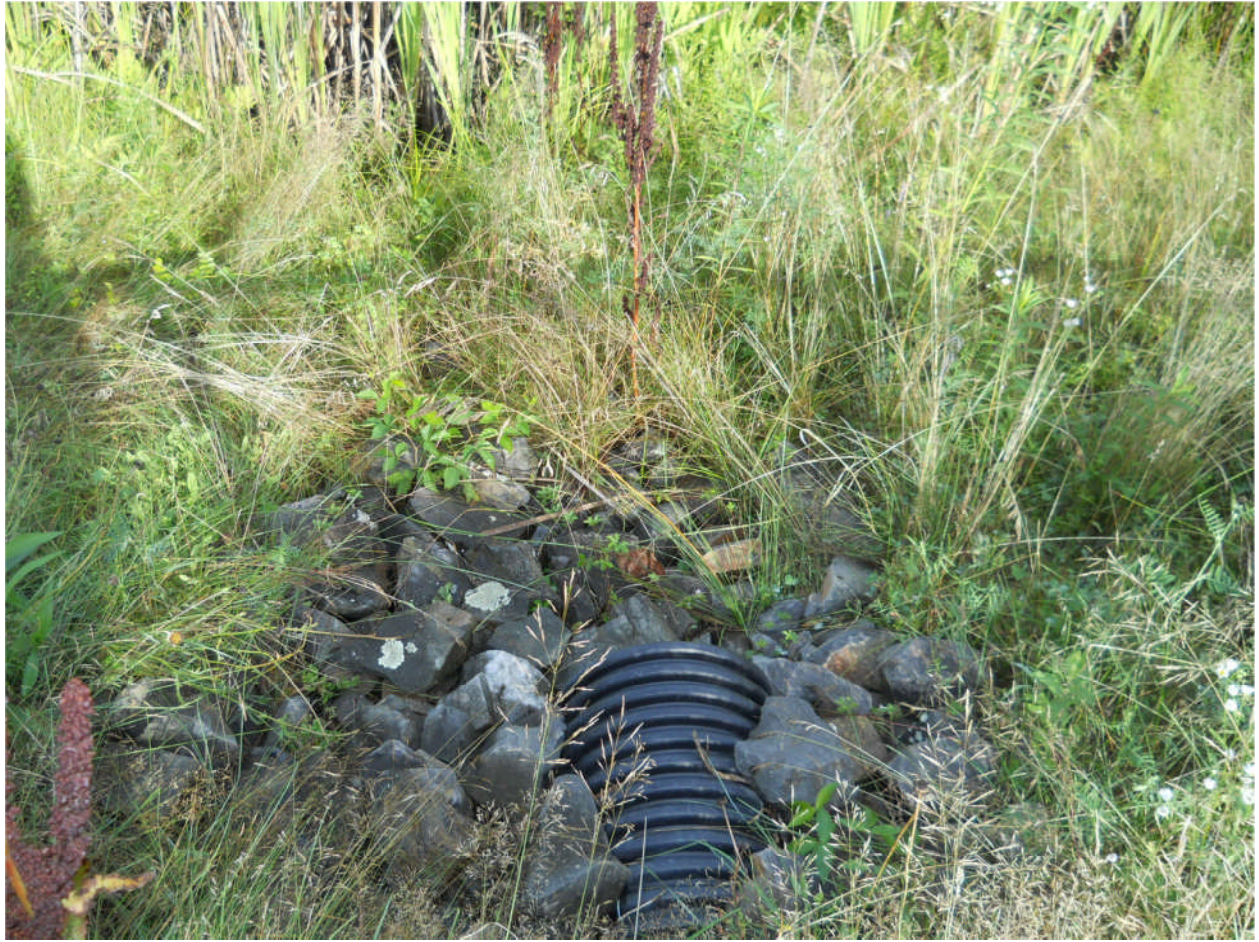
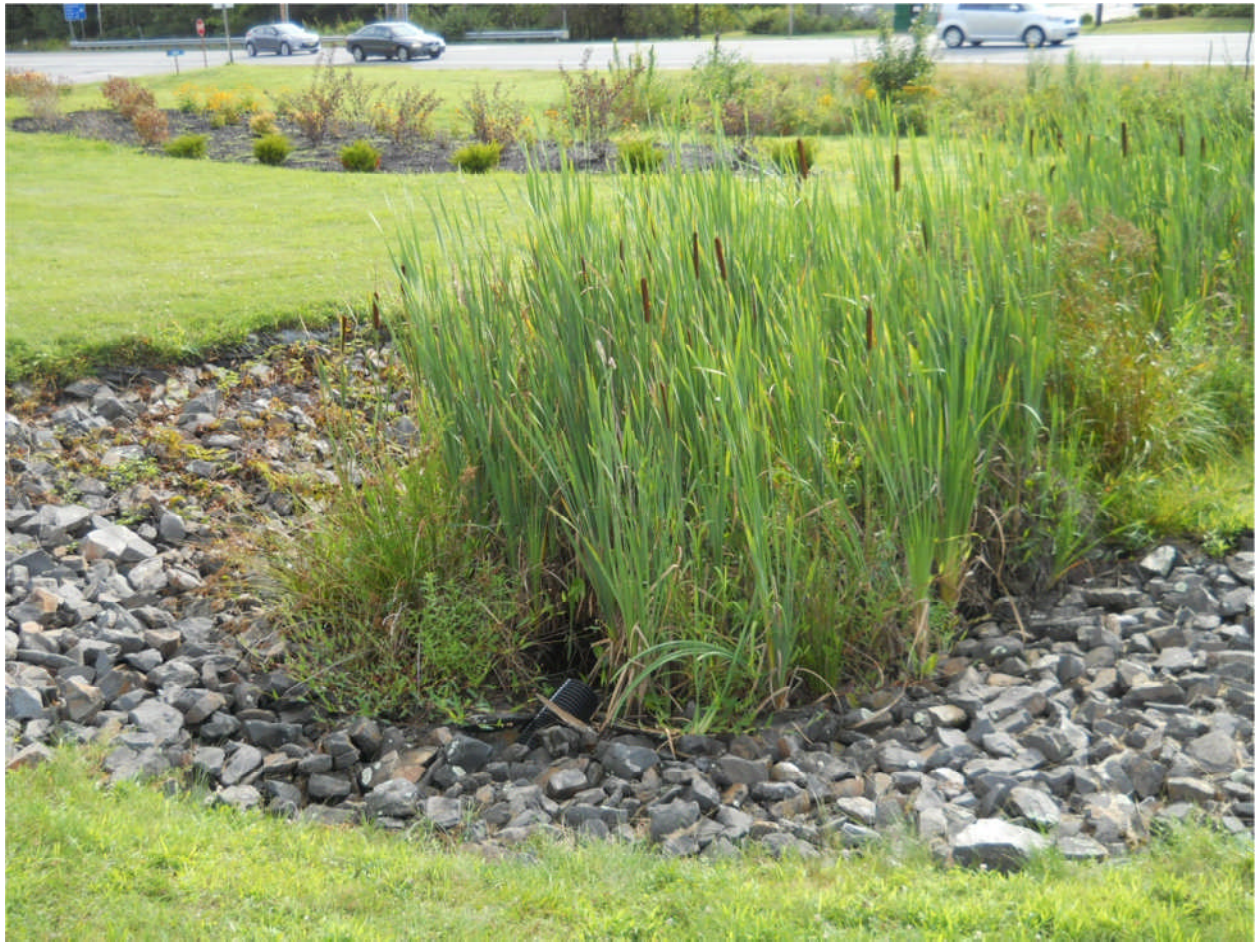
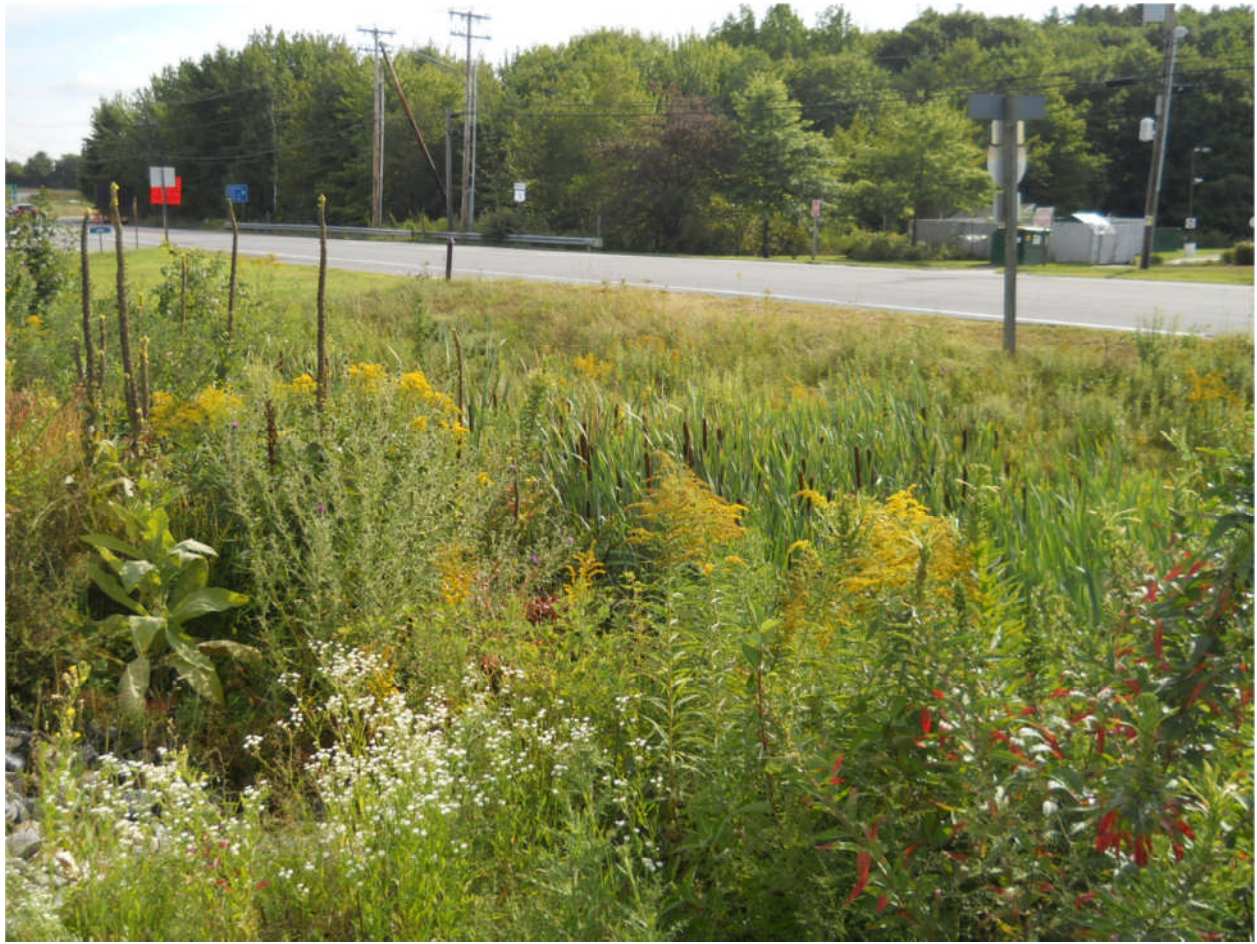
Maine Med (Dry Detention Basin) Parcel ID: U58-010

Based on the condition of the pond's water, and the shape of the pond, the presence of vegetation and standing water (which are not components of properly constructed Dry Detention Basin), this pond was evaluated as Good.

Numerous animal burrows throughout pond berm

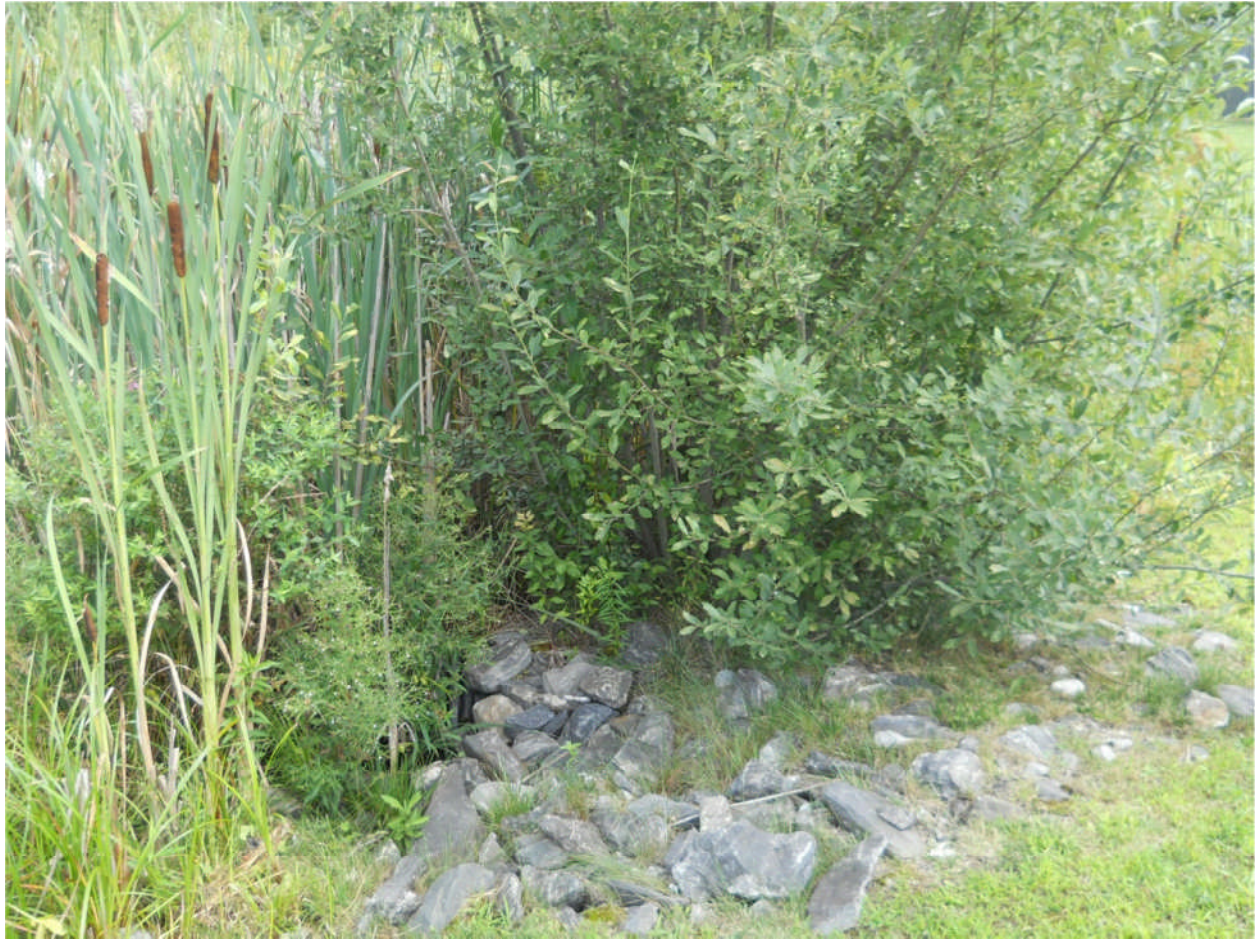
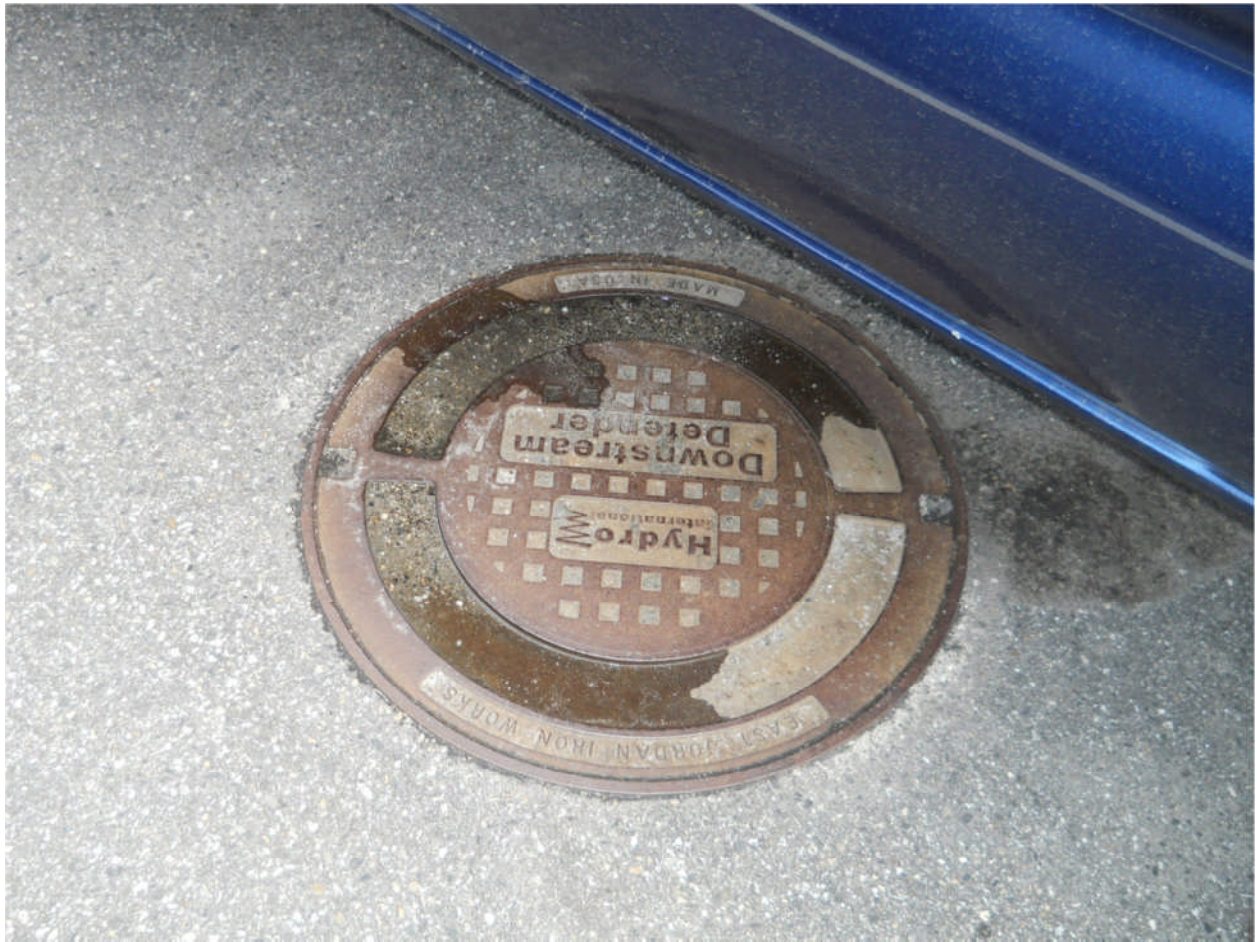
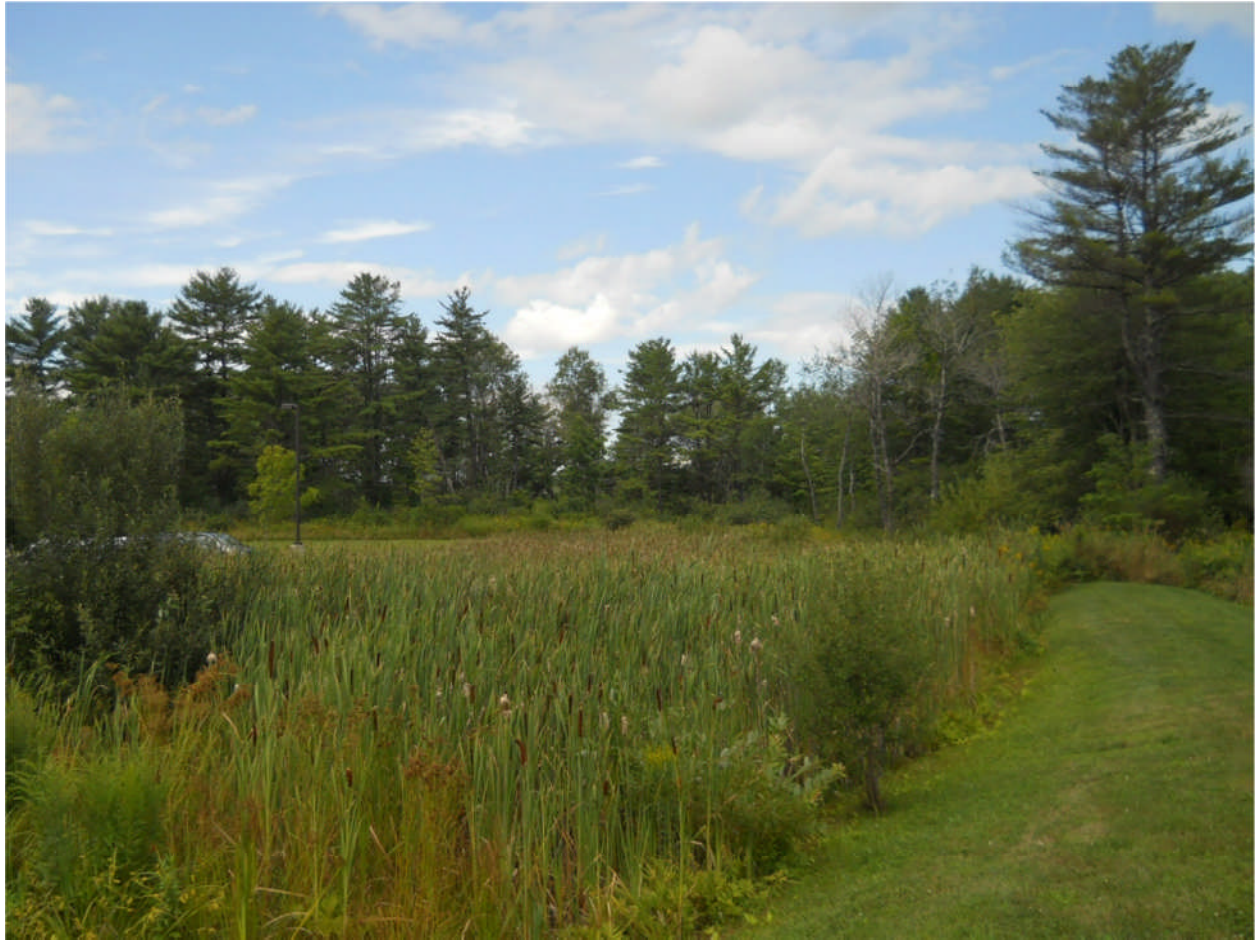
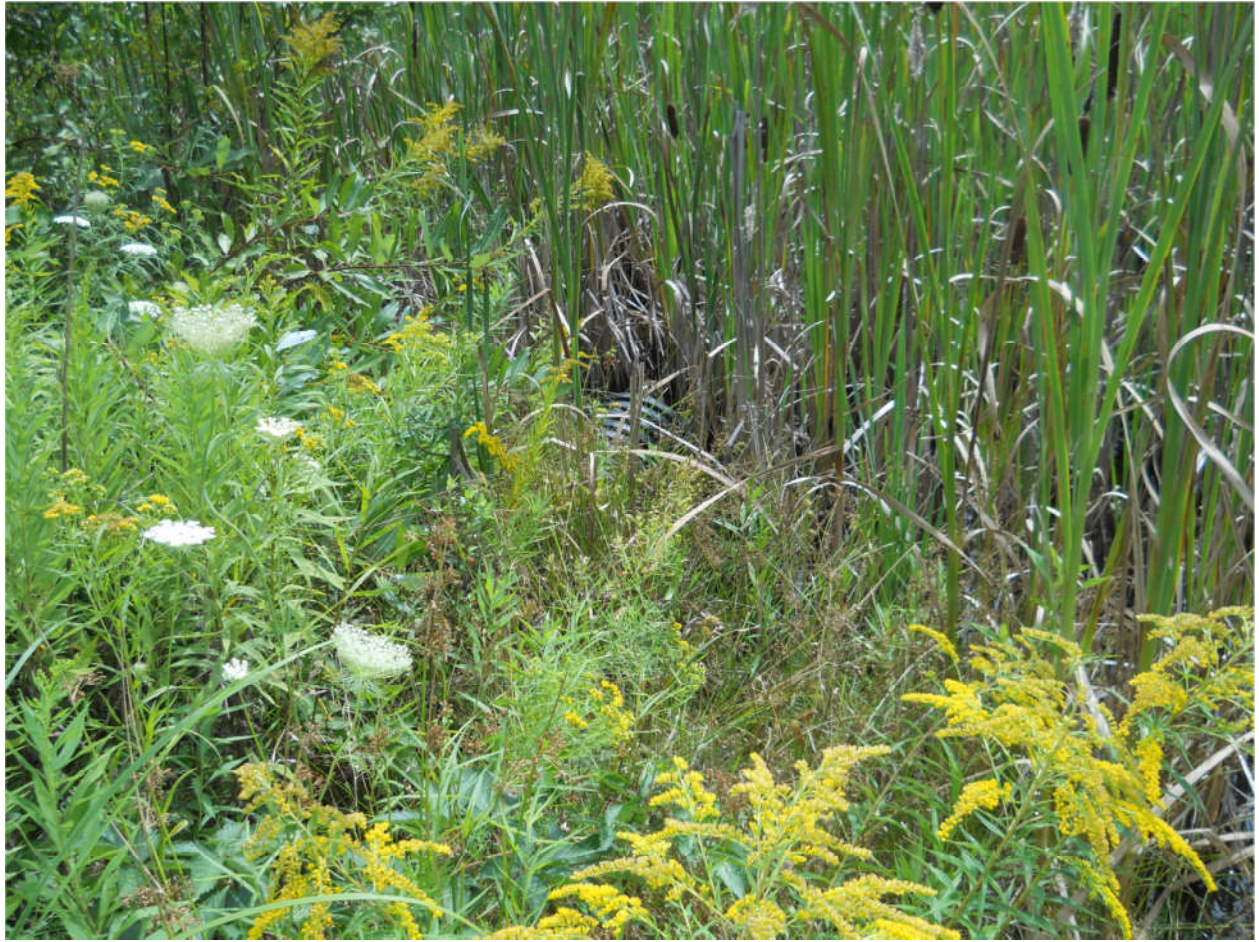
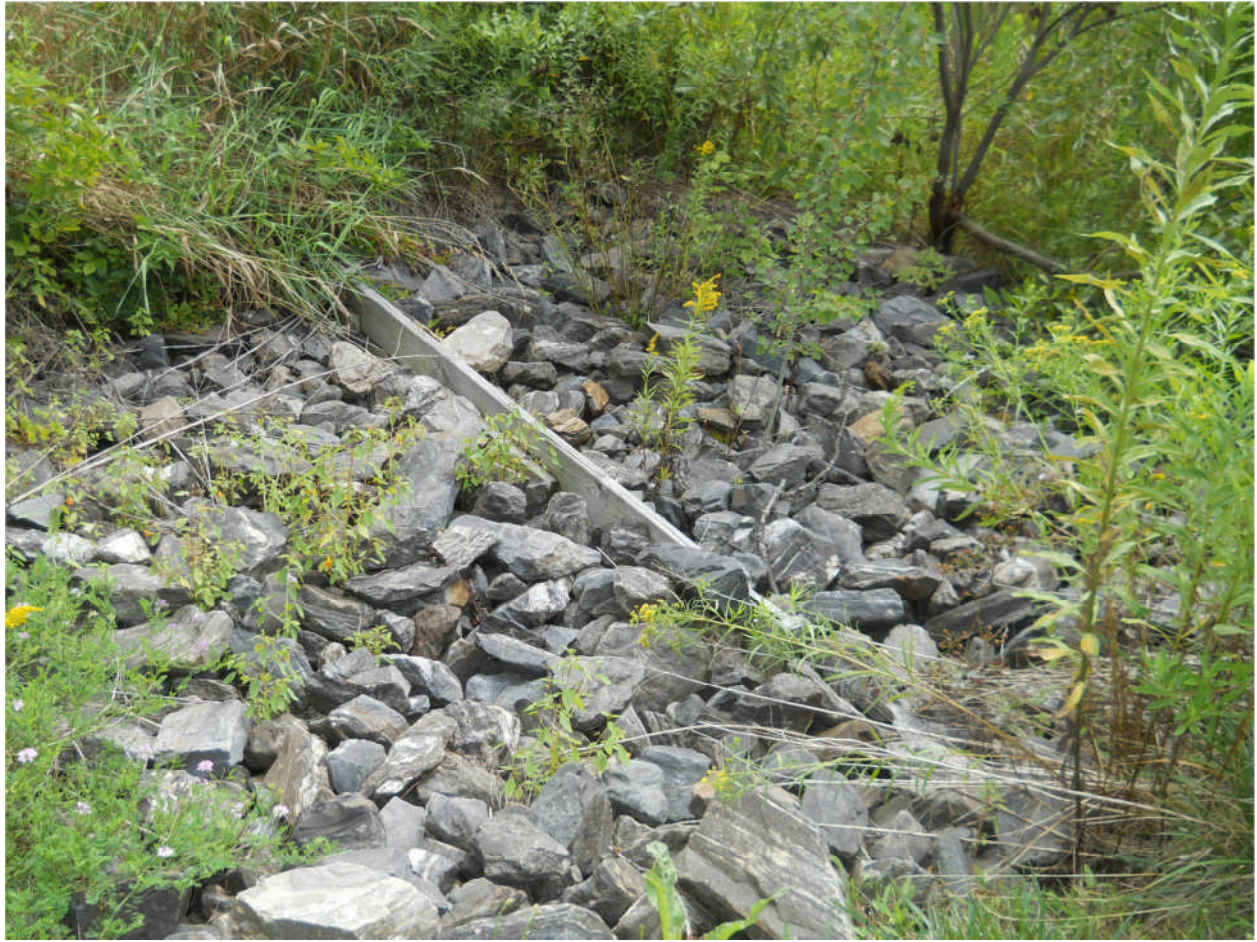
Morong Service Center (Dry Detention Basin) Parcel ID: U52-001B

The Morong Service Center, as discussed in Section 3 of this Report, currently has a large dry detention basin, which was evaluated as being in relatively good condition. Furthermore, it is located in a catchment that has sensitive storm drain capacity. Existing infrastructure consists of two inlets, an 8-inch PCV and an 18-inch HDPE pipe, discharging into a dry detention basin approximately 16,500 SF in size, with a single outlet control structure, which discharges to a large, densely vegetated, undeveloped area.

1 Emergency Spillway with wooden berm/weir.

An appropriate stormwater quality retrofit for this facility would be a Temperature Control Structure, or a more extensive gravel wetland retrofit, which would provide enhanced quality treatment, but would be more costly to implement. For the purposes of this Report, a simple modification of the outlet control system to provide temperature control is recommended for this location.

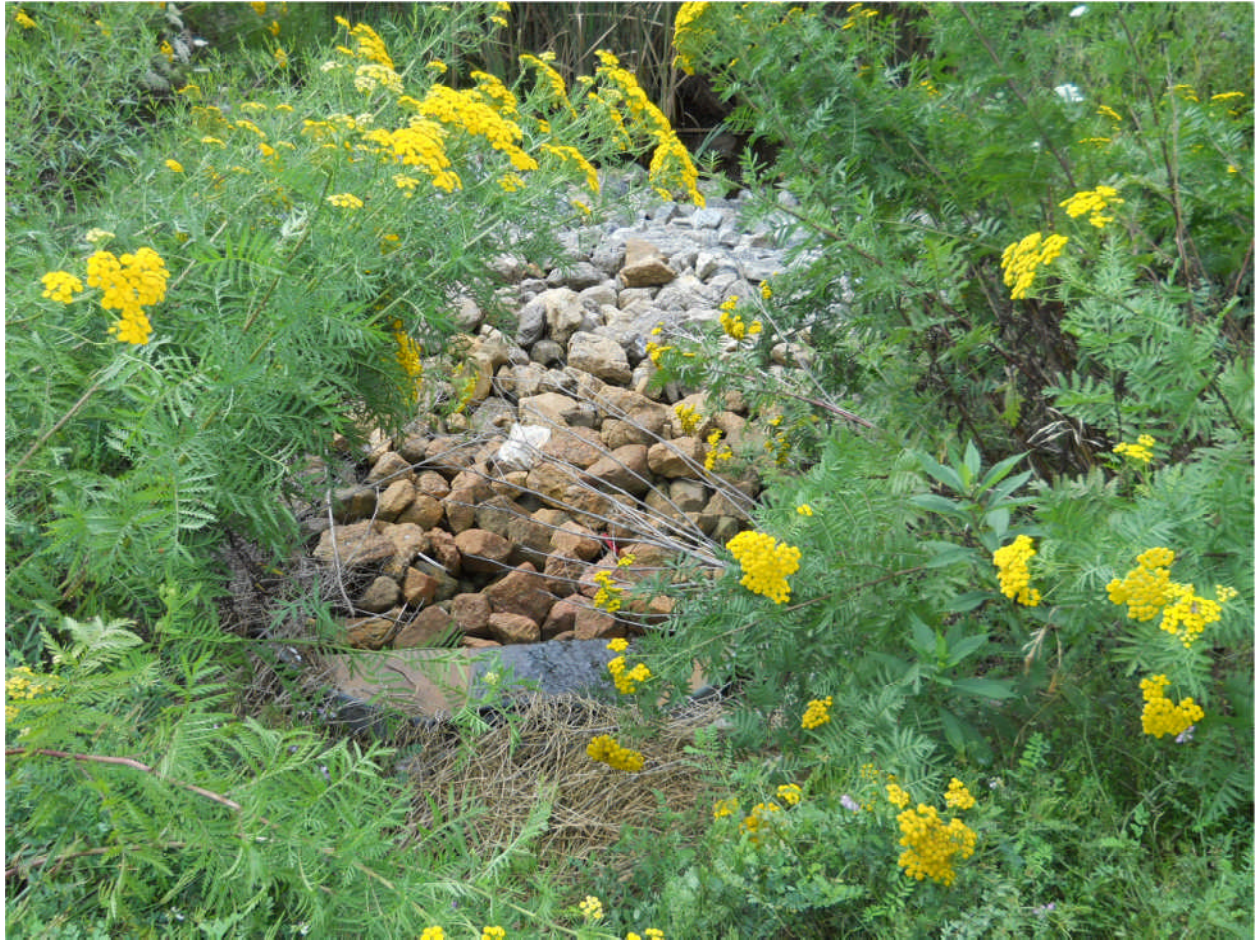
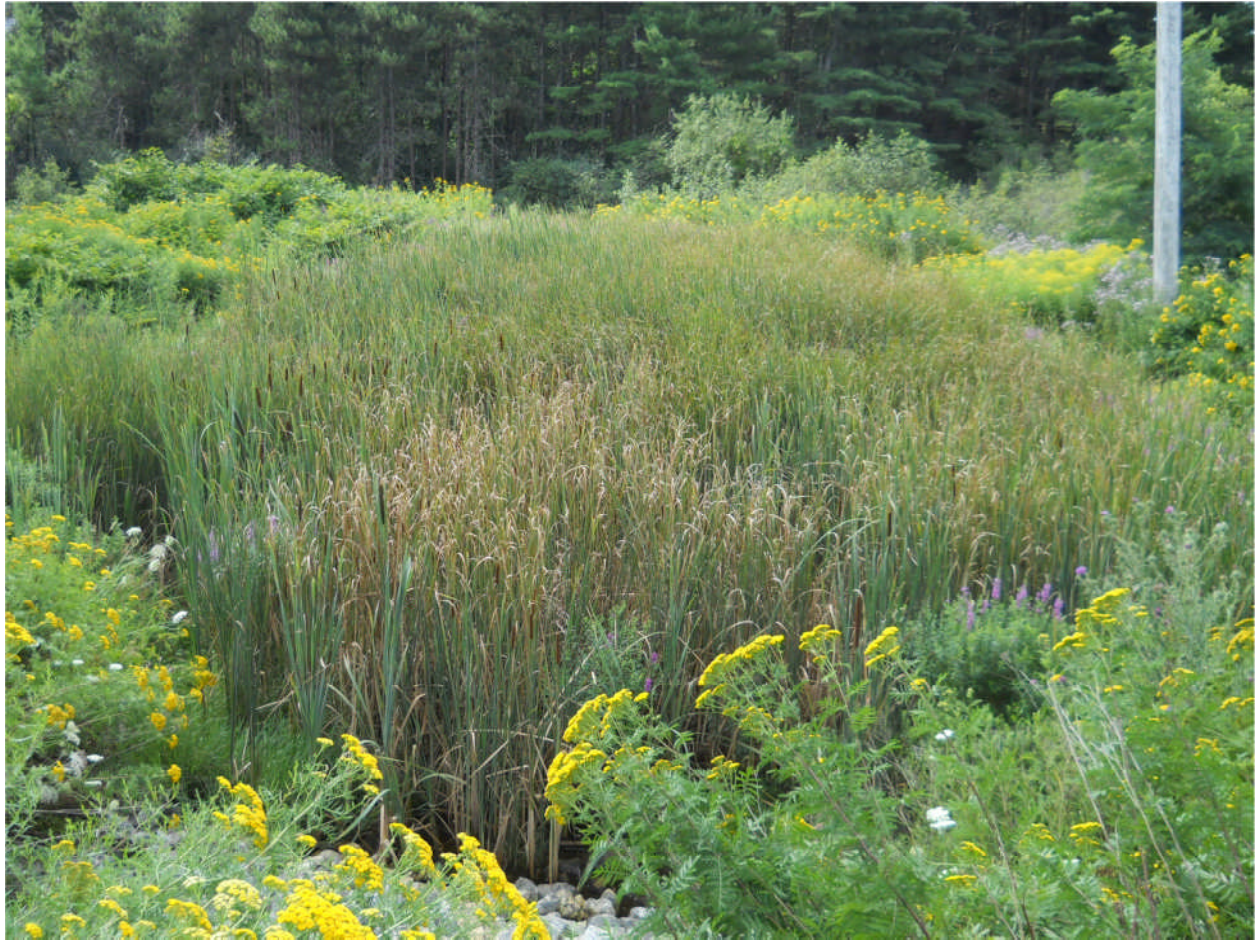
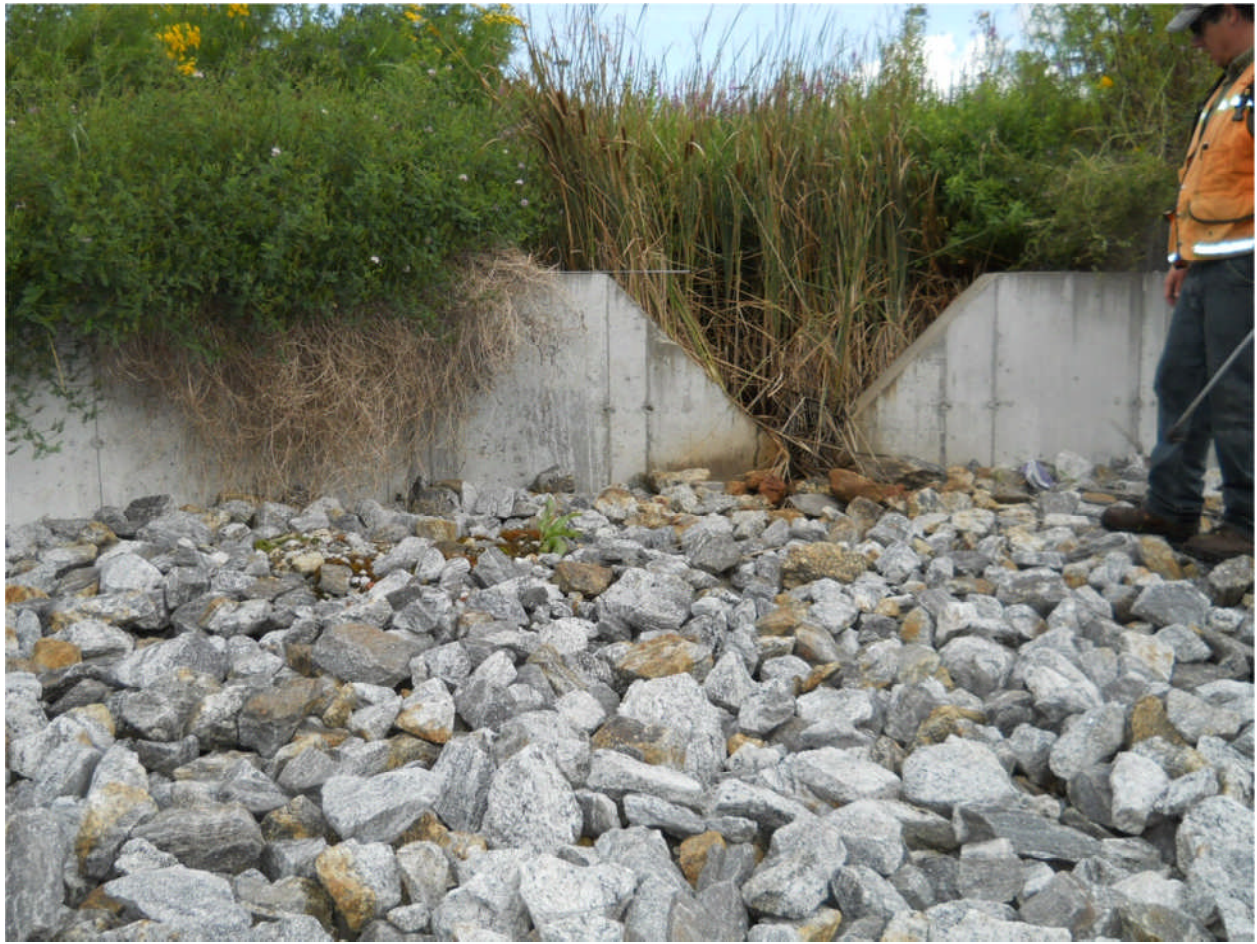
Falmouth Shopping Center (Dry Detention Basin) Parcel ID: U12-002

1 Outlet Control Structure (V-notch weir). Good flow out, unobstructed

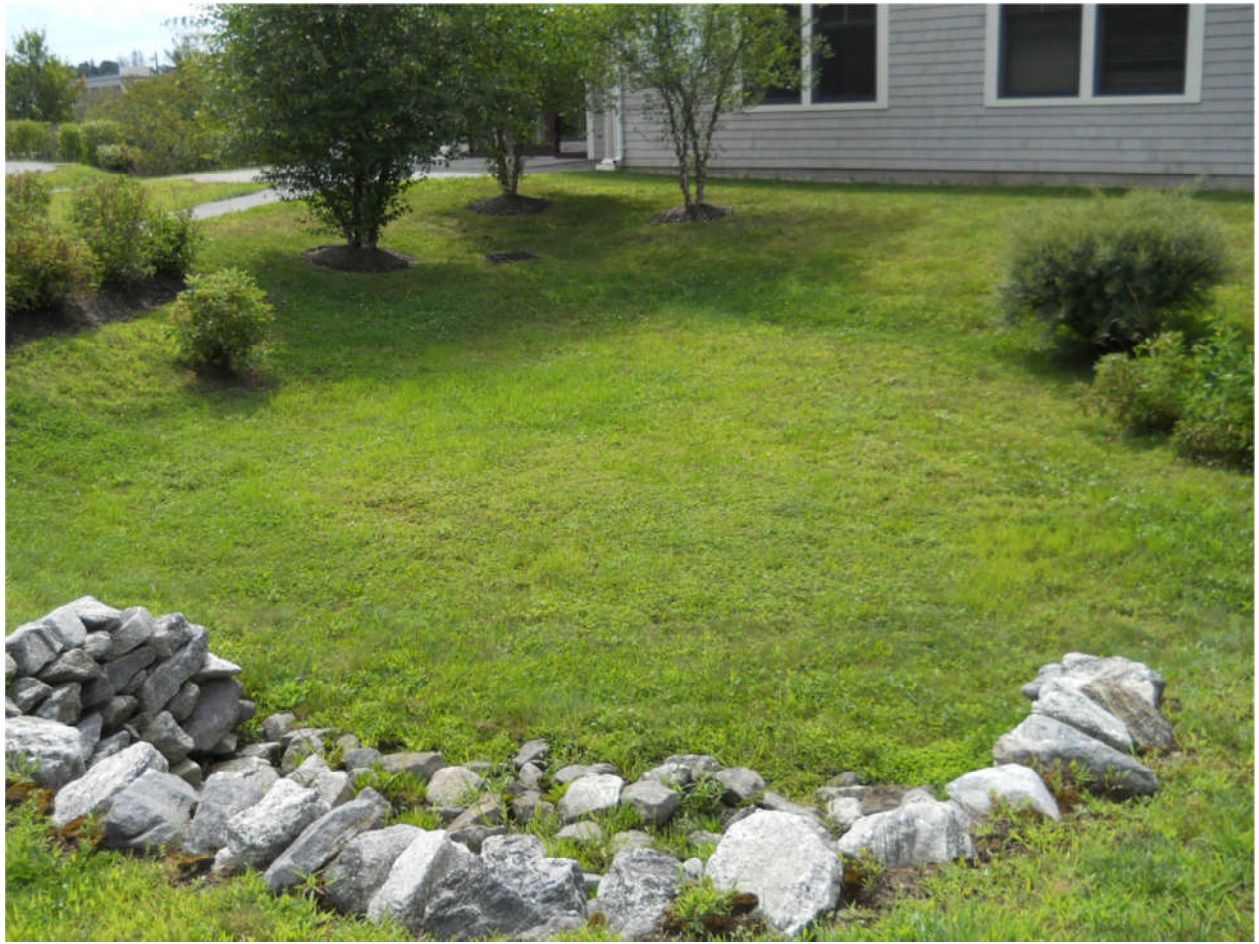
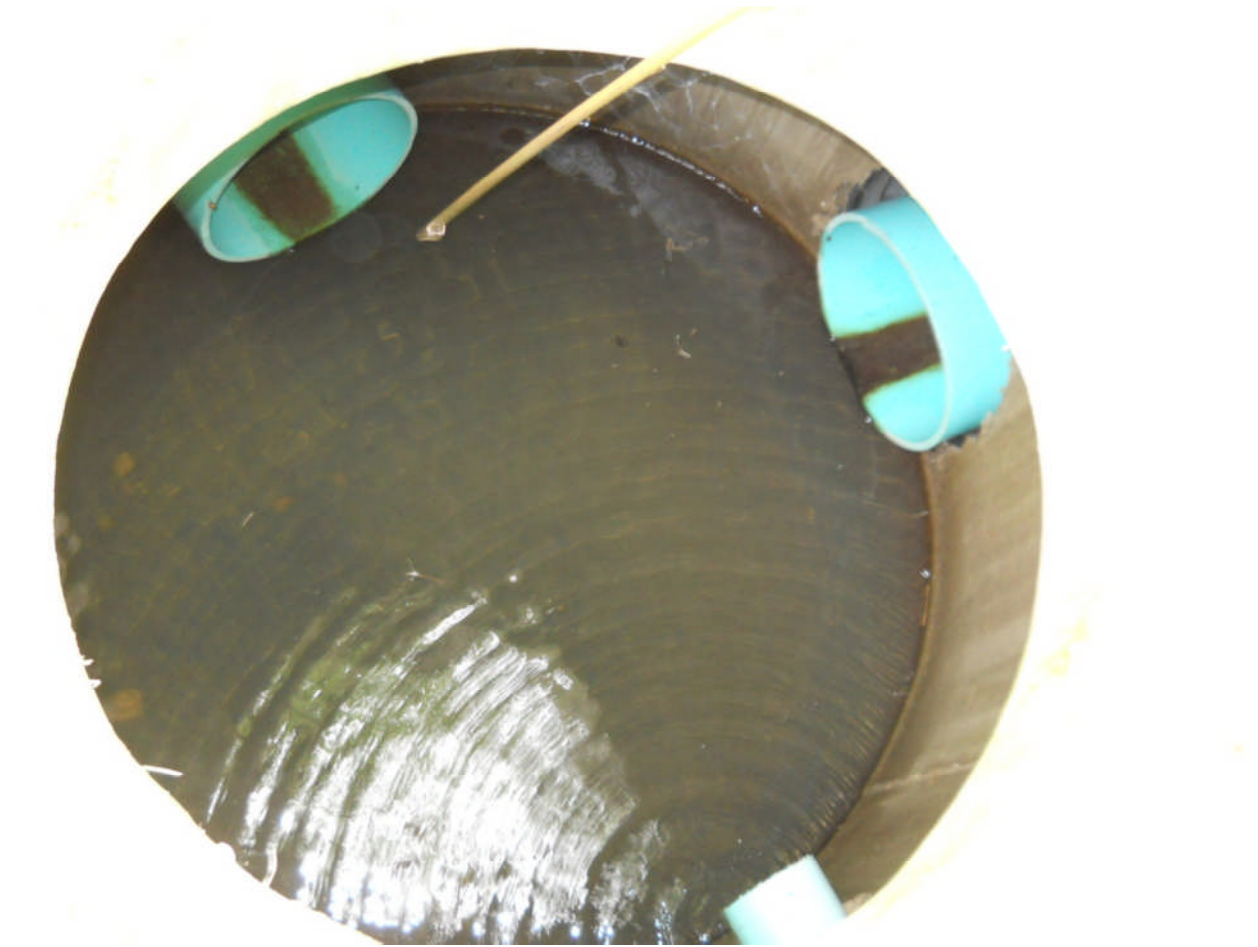
Key Bank (Soil Filter 1) Parcel ID: U58-006

The stormwater management facility at Key Bank is comprised of two Underdrained Soil Filters (USF). USF 1 is the smaller of the two and has one inlet and one outlet with an outlet control structure located in the southern end of the basin. There is very minor sedimentation at the inlet pipe. The outlet control structure which this soil filter discharges to was found to have two unknown connections; these connections could not be identified on the plans and should be investigated, as it is unclear as to whether the site plans are out-of-date, or if the systems have adequate capacity to accept these additional flows. There was also evidence of minor sediment deposition at the discharge point of the outlet structure.

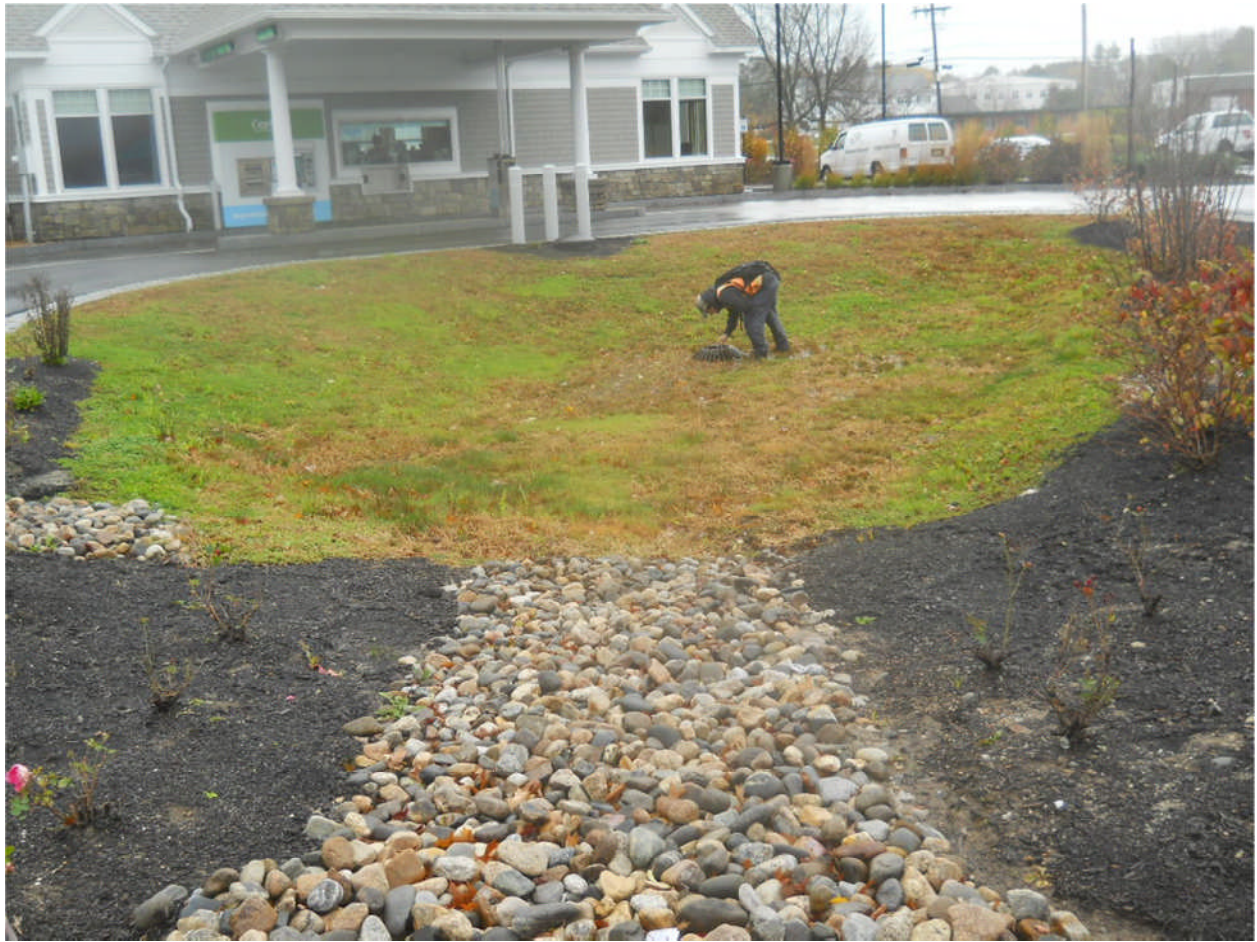
Gorham Savings Bank (Soil Filter) Parcel ID: U52-004-ON

The stormwater management facility for Gorham Savings Bank is located in the center of the parking lot. Review of the site plans proved inconclusive in determining what type of system this was intended to be, given a lack of details, unknown subsurface conditions, and the at-grade overflow control structure, so this system was assumed to be a soil filter for evaluation purposes. The outlet control consists of a catch basin, which according to the site plan, includes a "bio-skirt" and snout oil and debris separator, and sits approximately at-grade within the soil filter, and ties into the Route 1 drainage system. The outlet control structure accepts stormwater runoff via surface flow from the surrounding parking lot, and from nearby catch basins. There is very good vegetation growth throughout the system.

It should be noted that there was evidence of standing water in the system, and it is unclear as to whether this is due to the recent storm event, clogging of the filter media, or if the design intent was for the system to provide detention prior to discharging to the outlet control structure.
