Route 1 Falmouth Commercial District

Stormwater Management Plan

Town of Falmouth, ME

January 2013

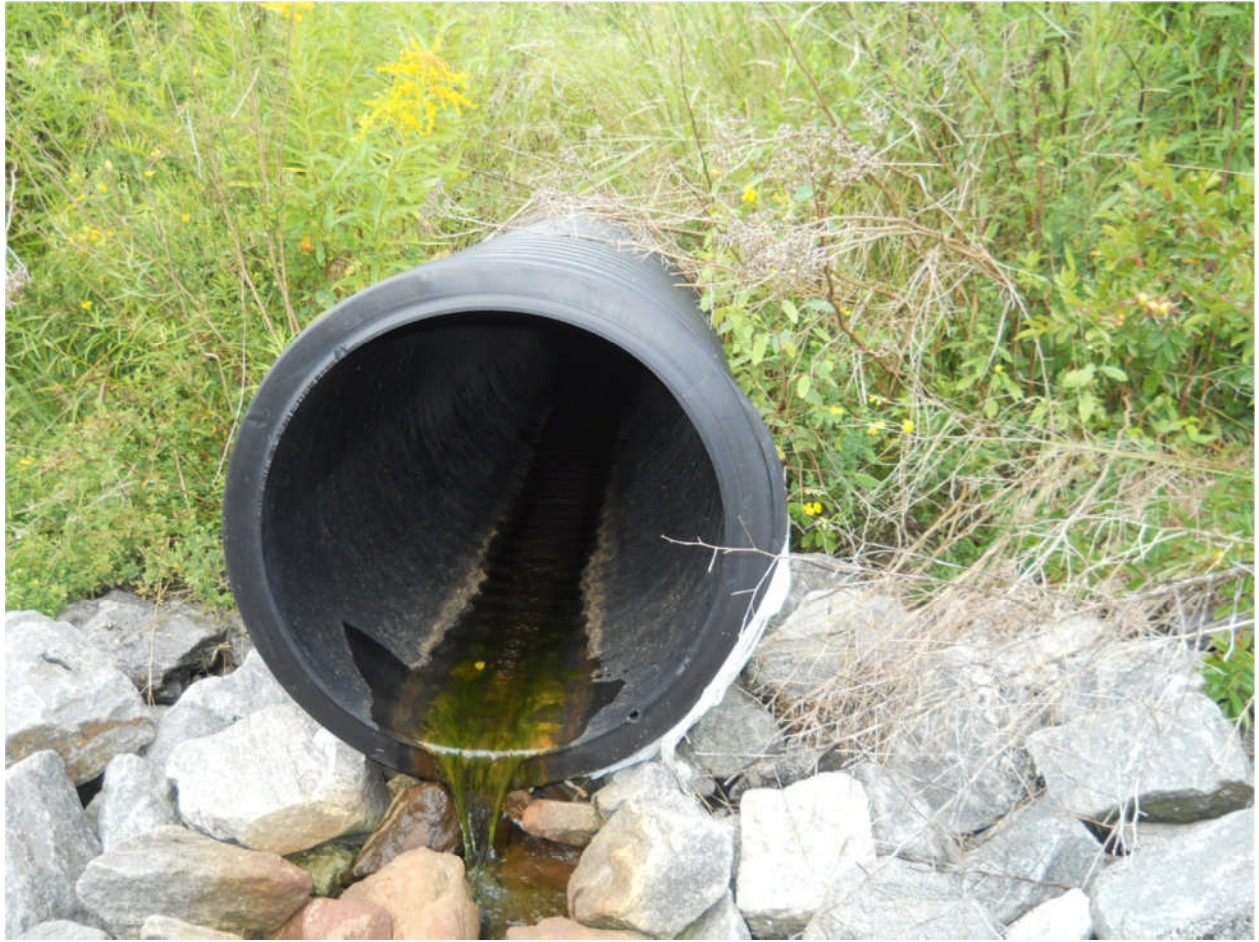
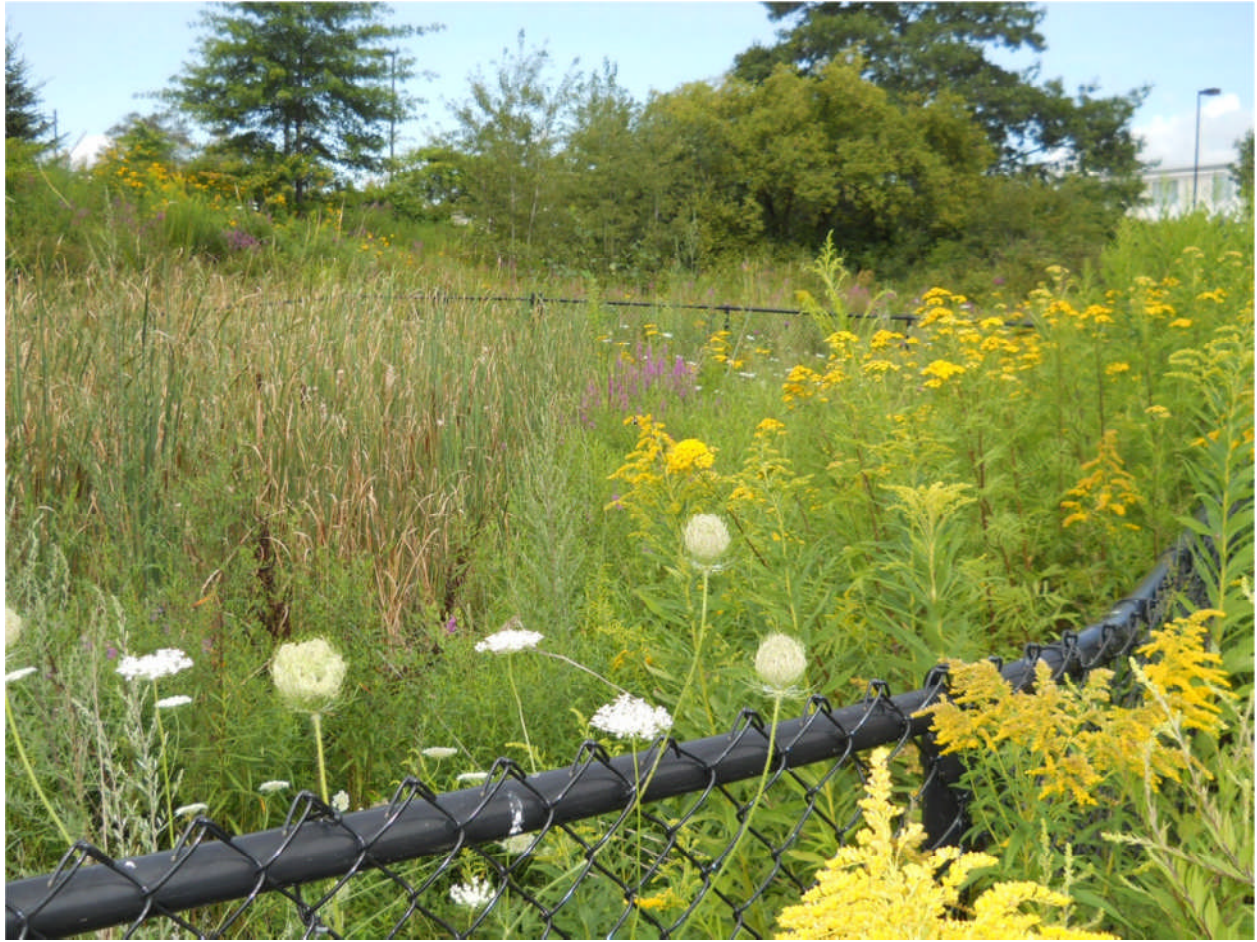
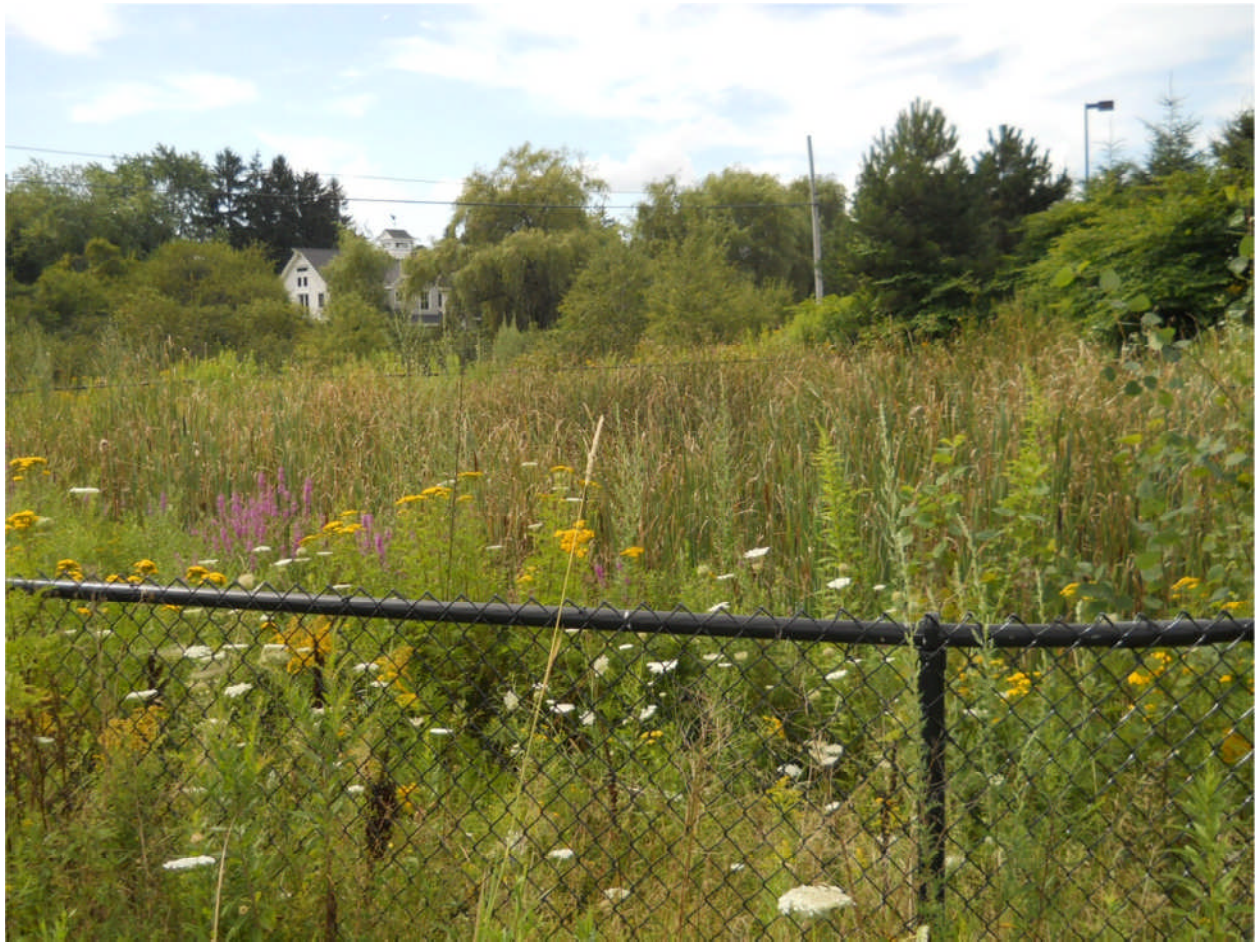
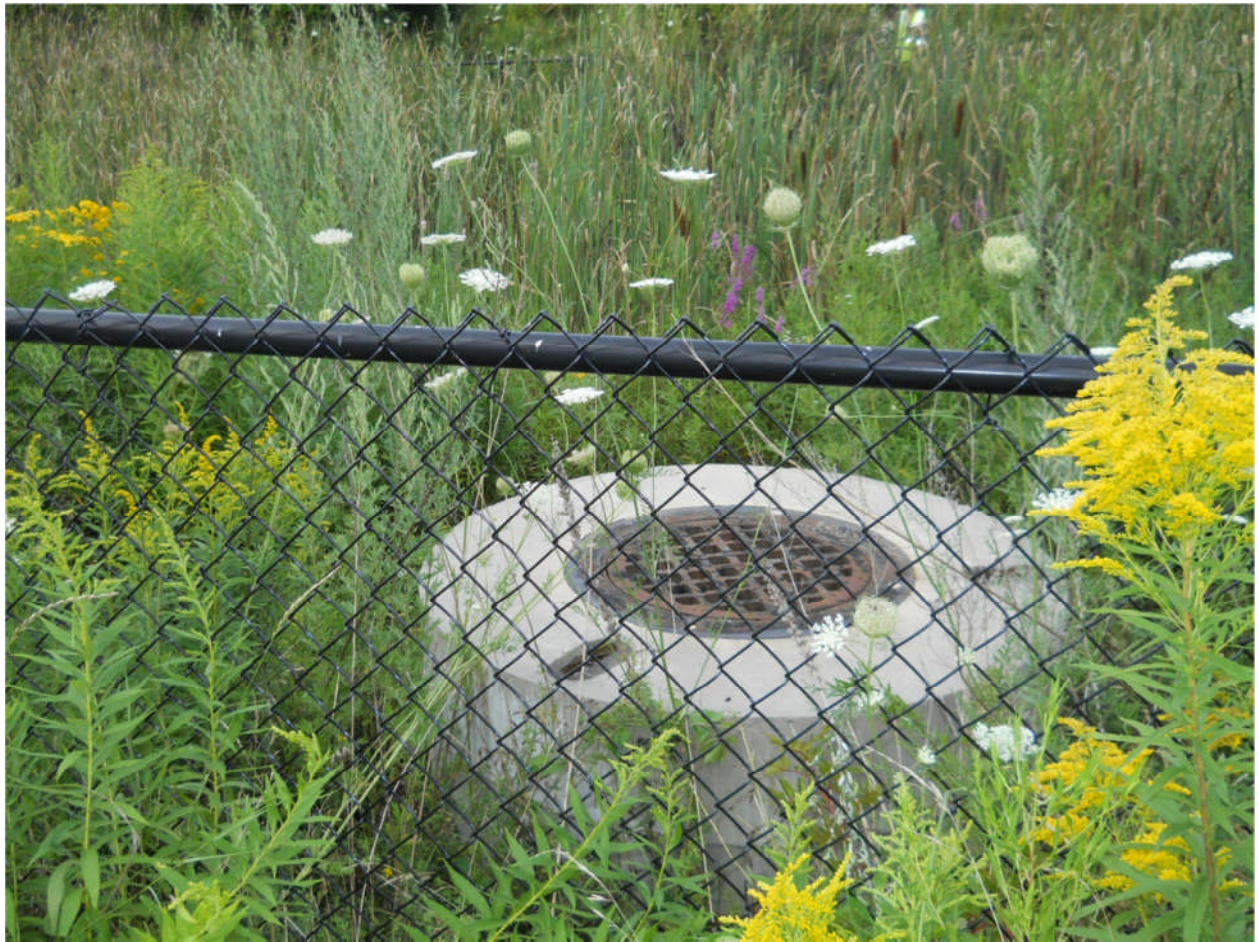
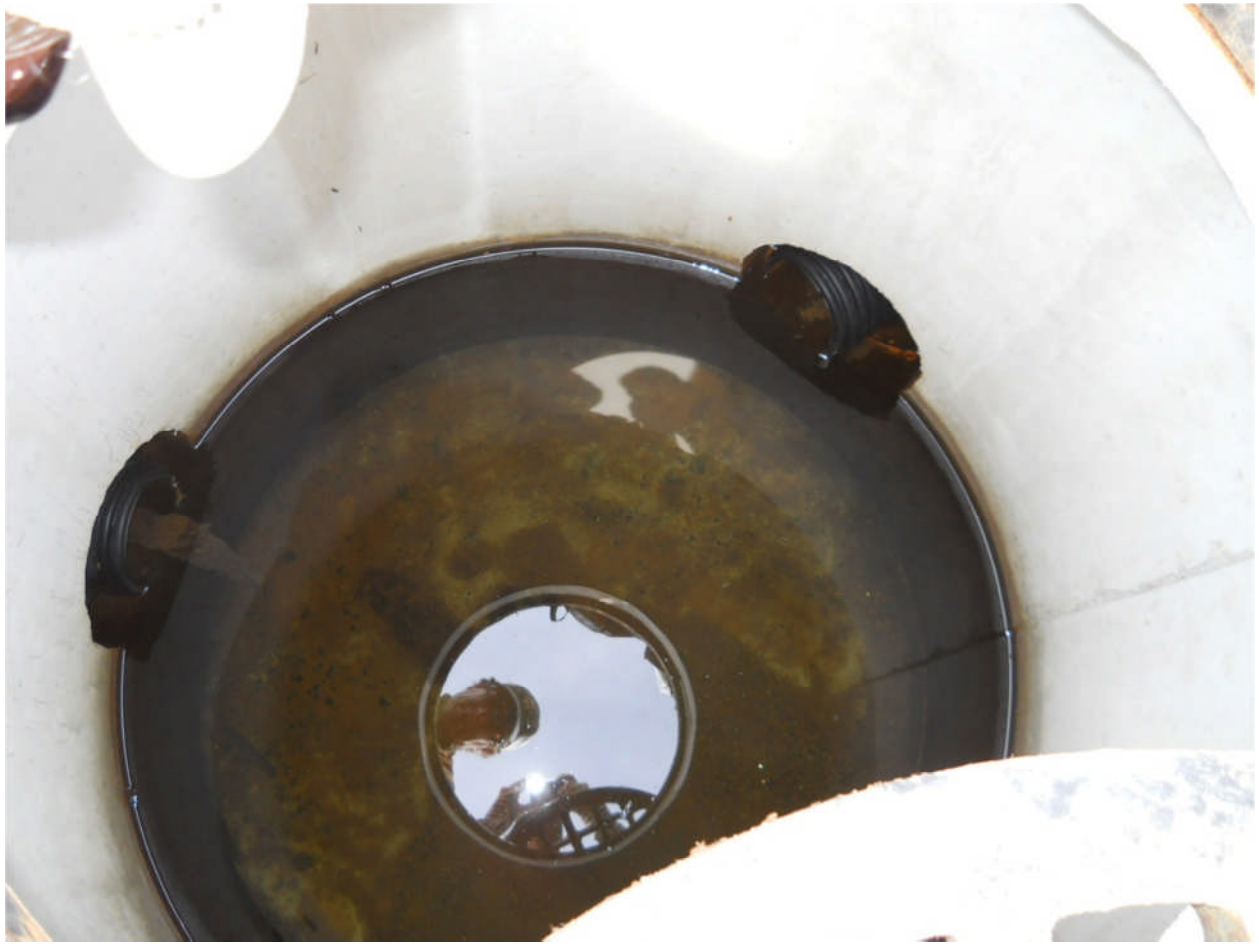
Rite Aid (Wet Pond) Parcel ID: U12-011

It should be noted that this facility is adjacent to an open area with a downstream buffer before discharging to Webes Creek.

System has underdrained gravel trench, but no flow control orifice
