APPENDIX B: PRIVATE STORMWATER MANAGEMENT FACILITY INSPECTION FORMS & PHOTOGRAPHS

Stormwater Treatment: Assessment and Maintenance

Field Data Sheet for Level 1 Assessment: Visual Inspection Dry Ponds

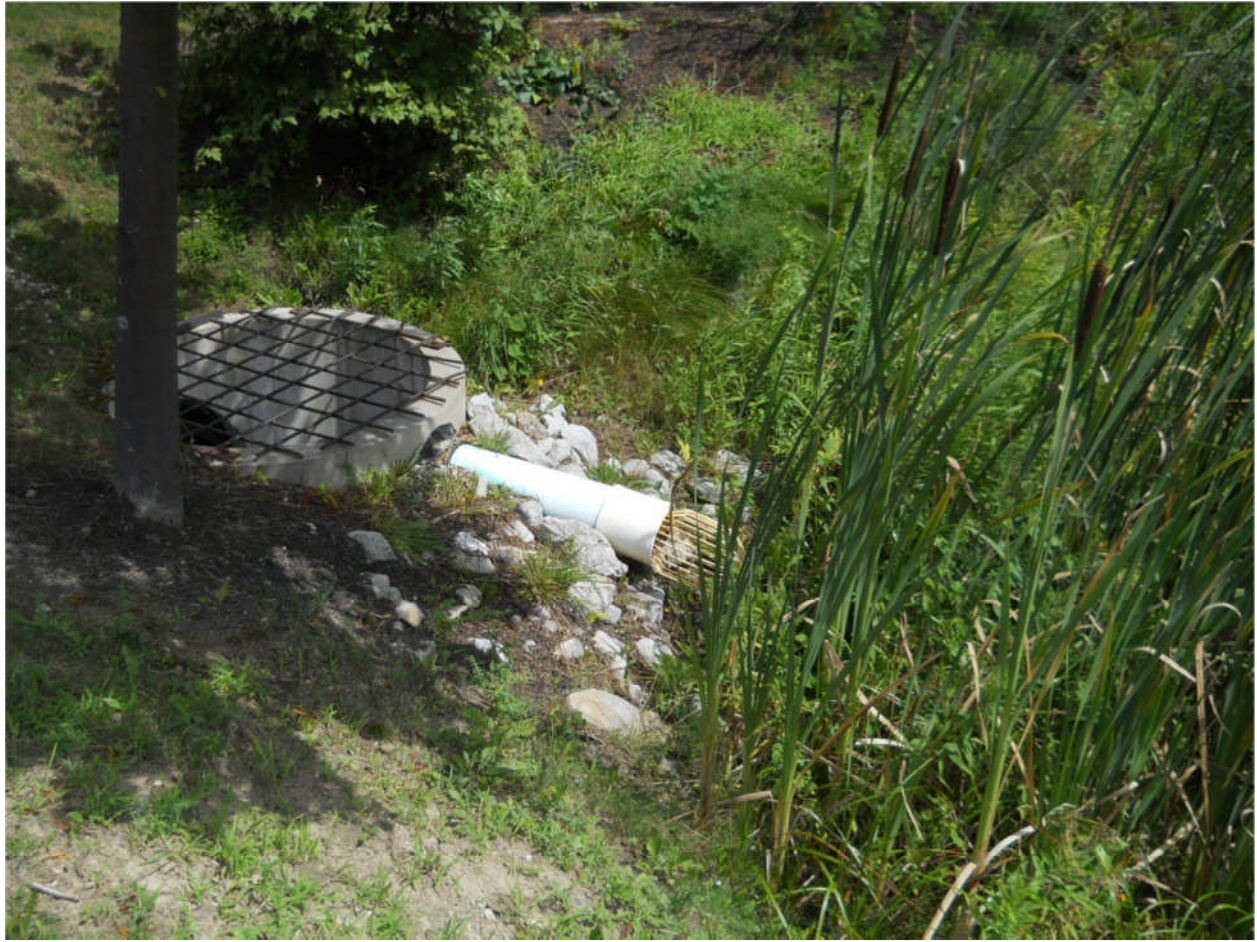
Fundy Circle (Dry Detention Basin 2) Parcel ID: U11-035C

Both inlets are mostly open for flow, partial sedimentation

Major cattail growth within pond

About 1' of deposited sediment in pond

Outlet overflow trash rack free of debris

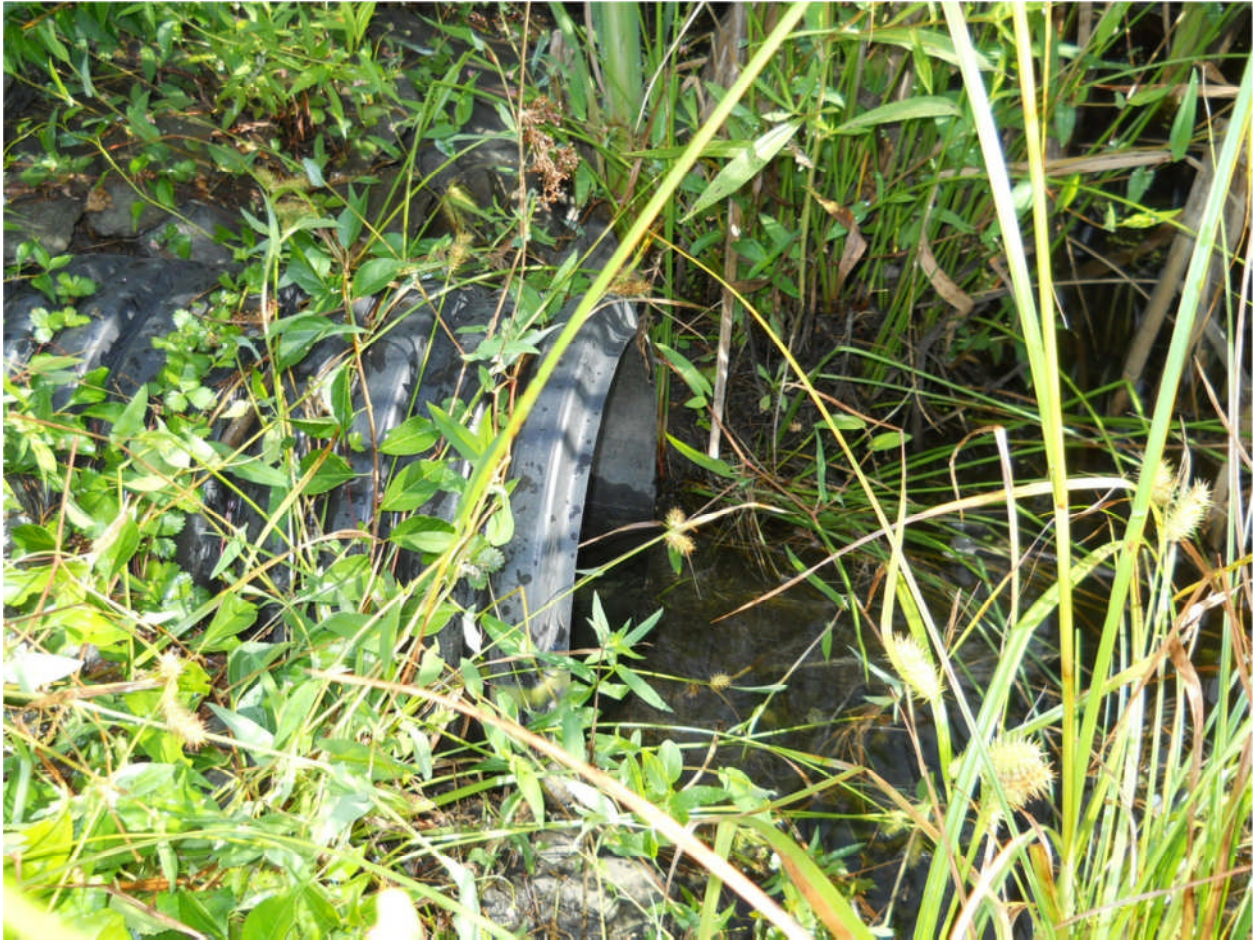
Maine Med (Dry Detention Basin) Parcel ID: U58-010

Numerous animal burrows throughout pond berm

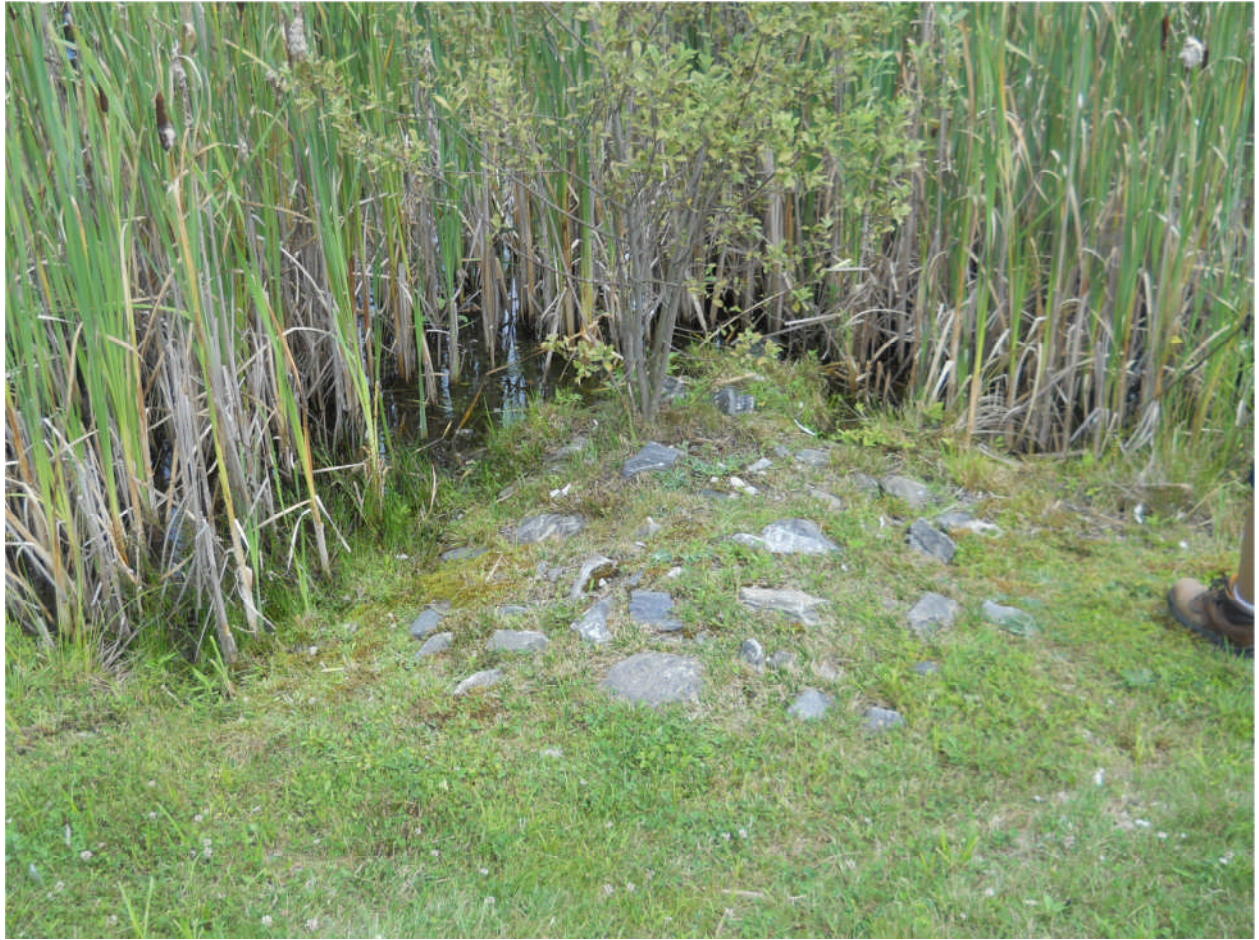
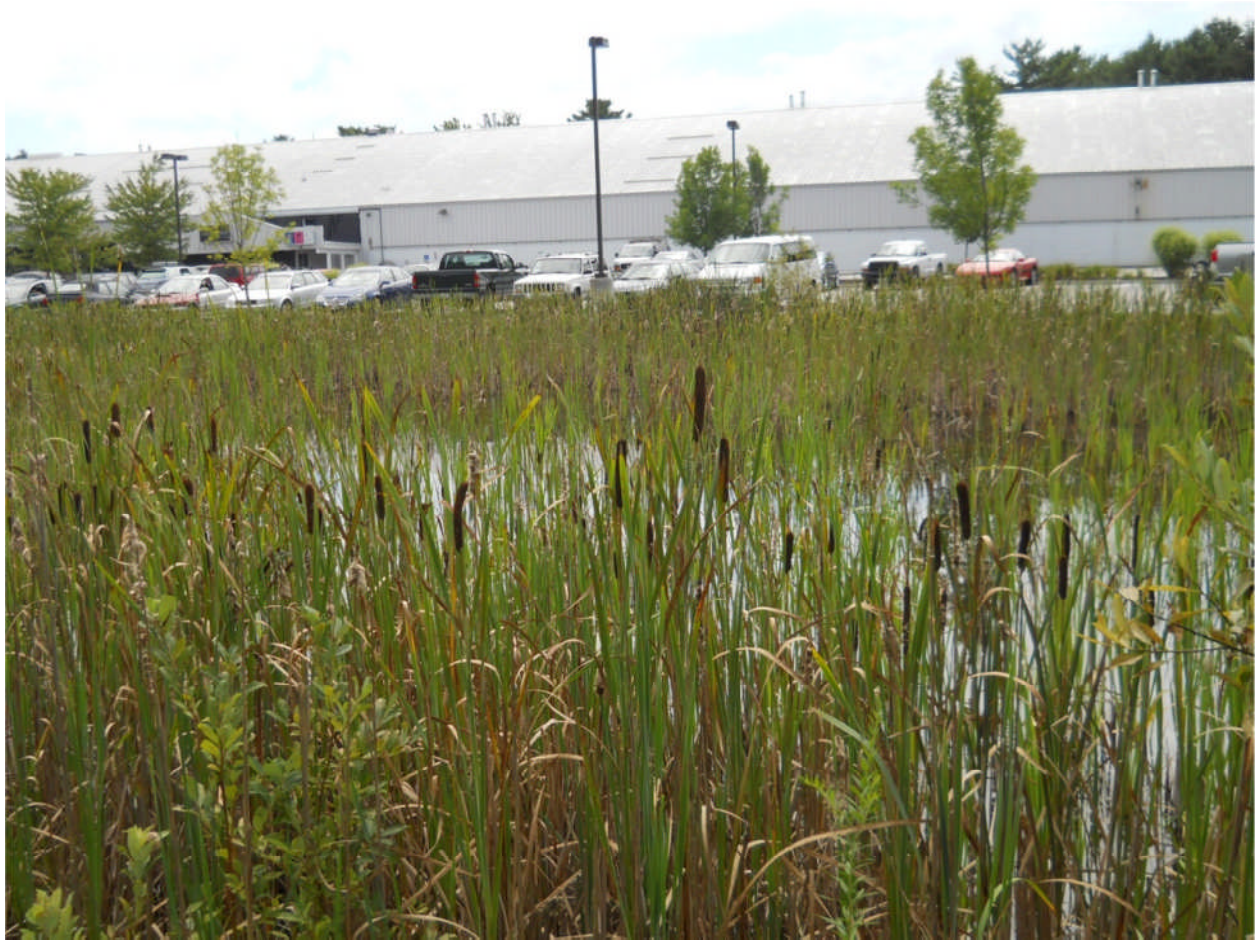
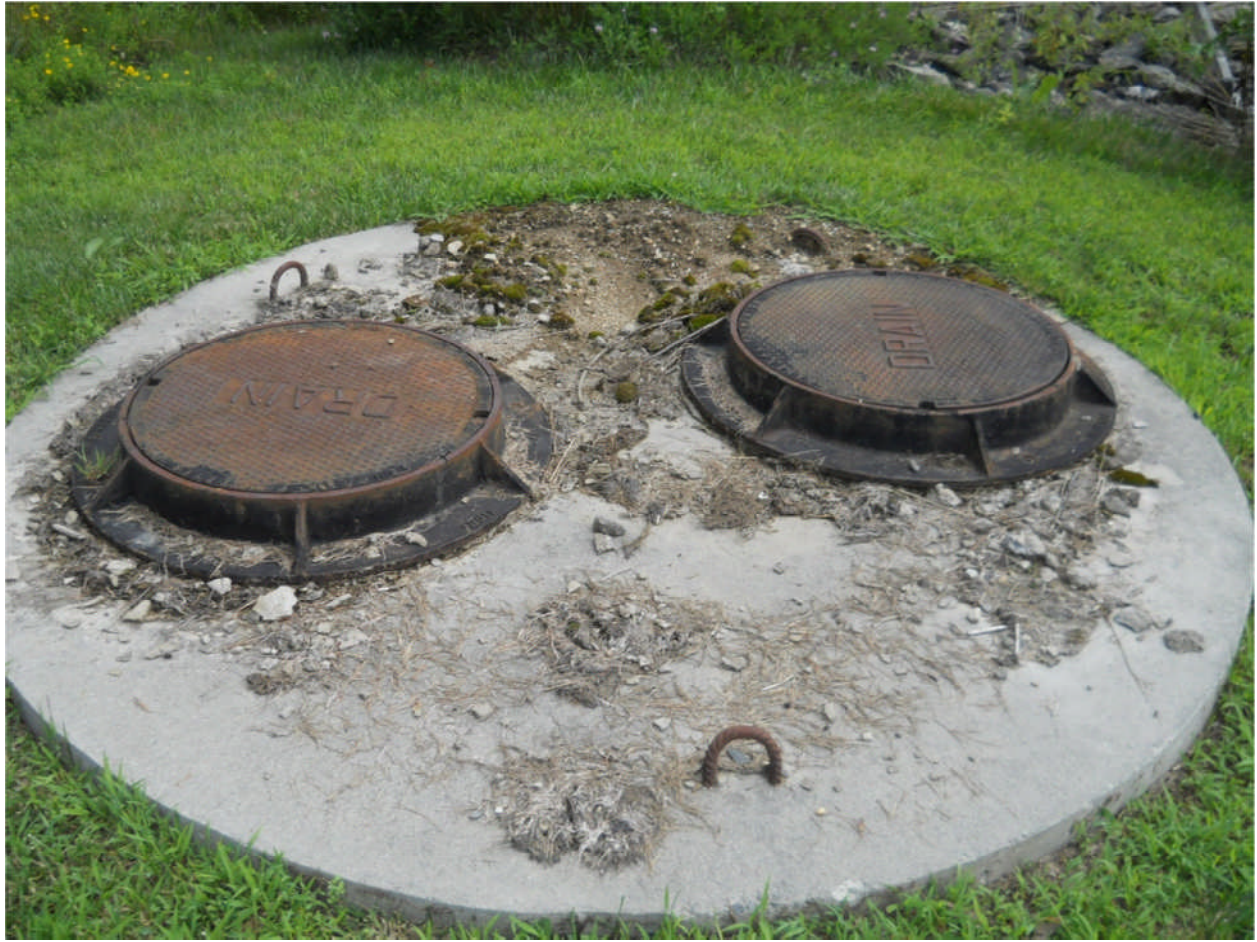
Morong Service Center (Dry Detention Basin) Parcel ID: U52-001B

1 Emergency Spillway with wooden berm/weir.

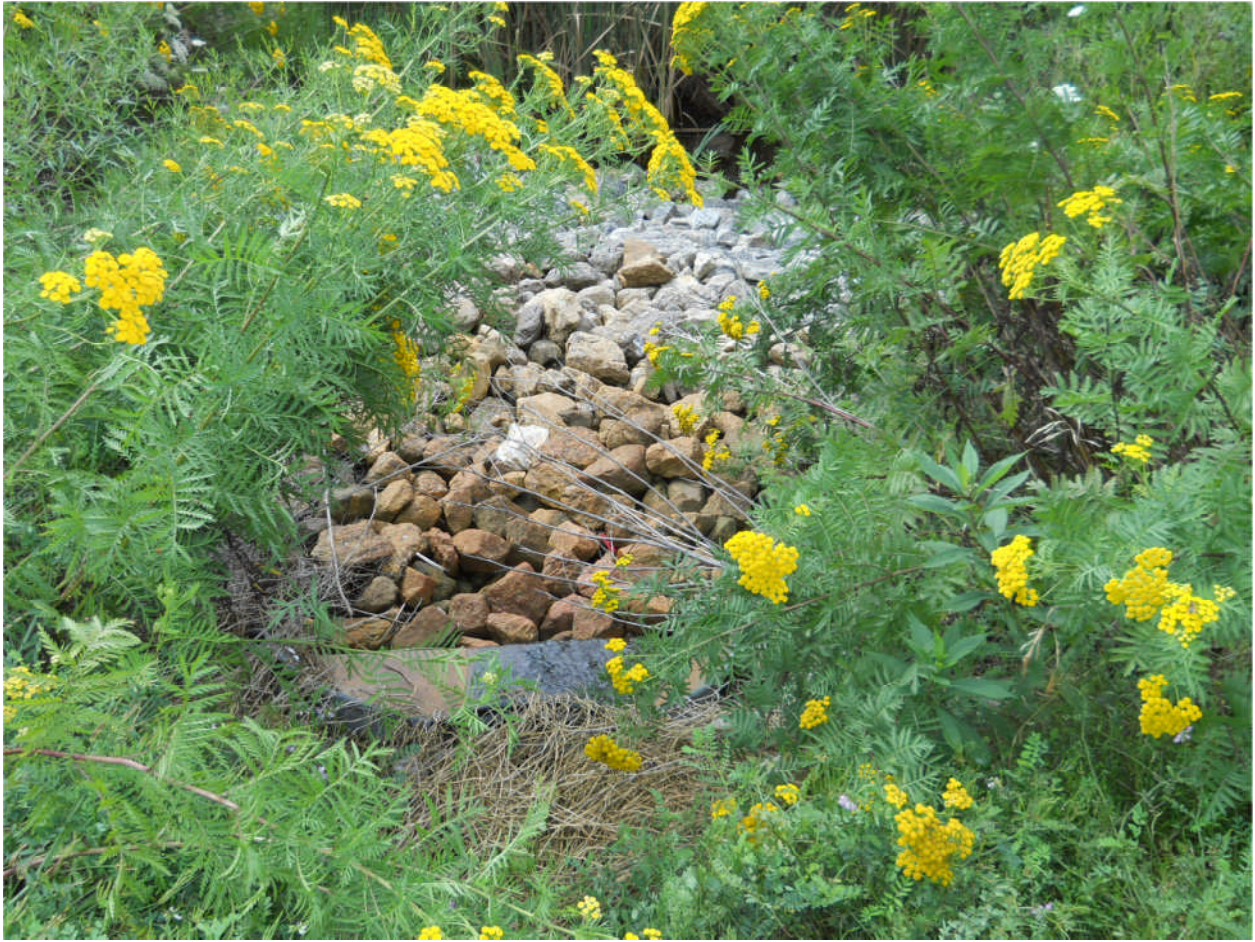
Falmouth Shopping Center (Dry Detention Basin) Parcel ID: U12-002

1 Outlet Control Structure (V-notch weir). Good flow out, unobstructed

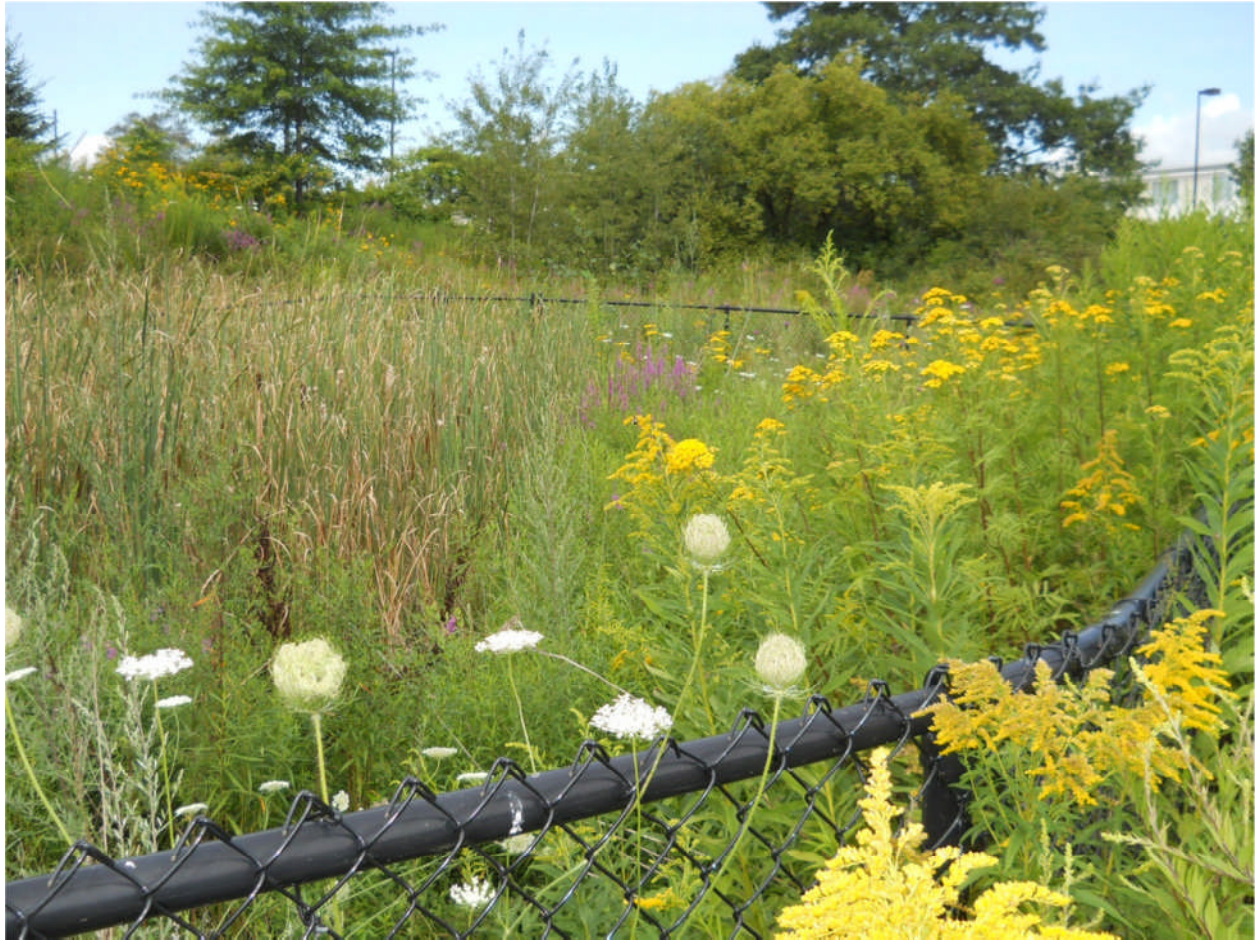
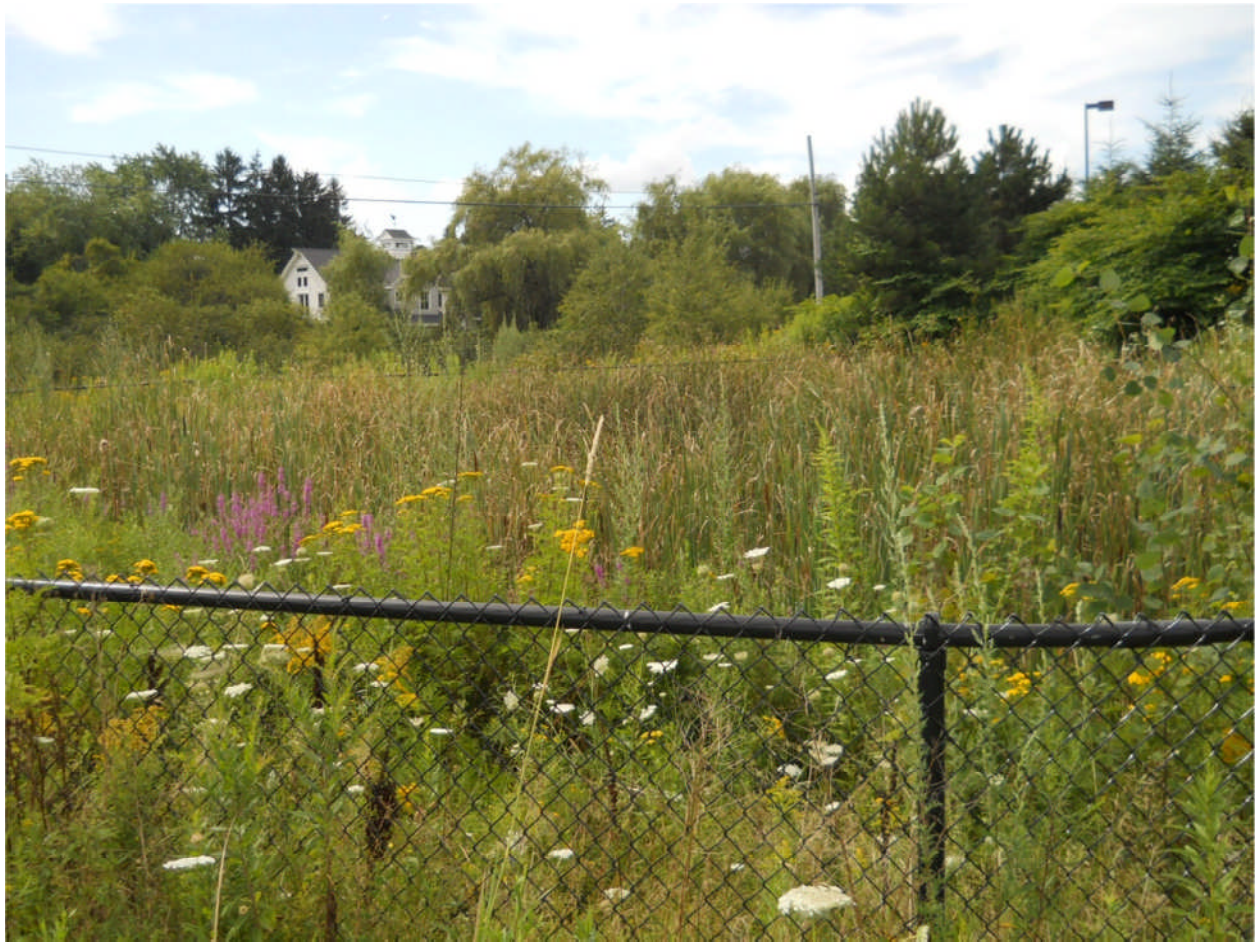
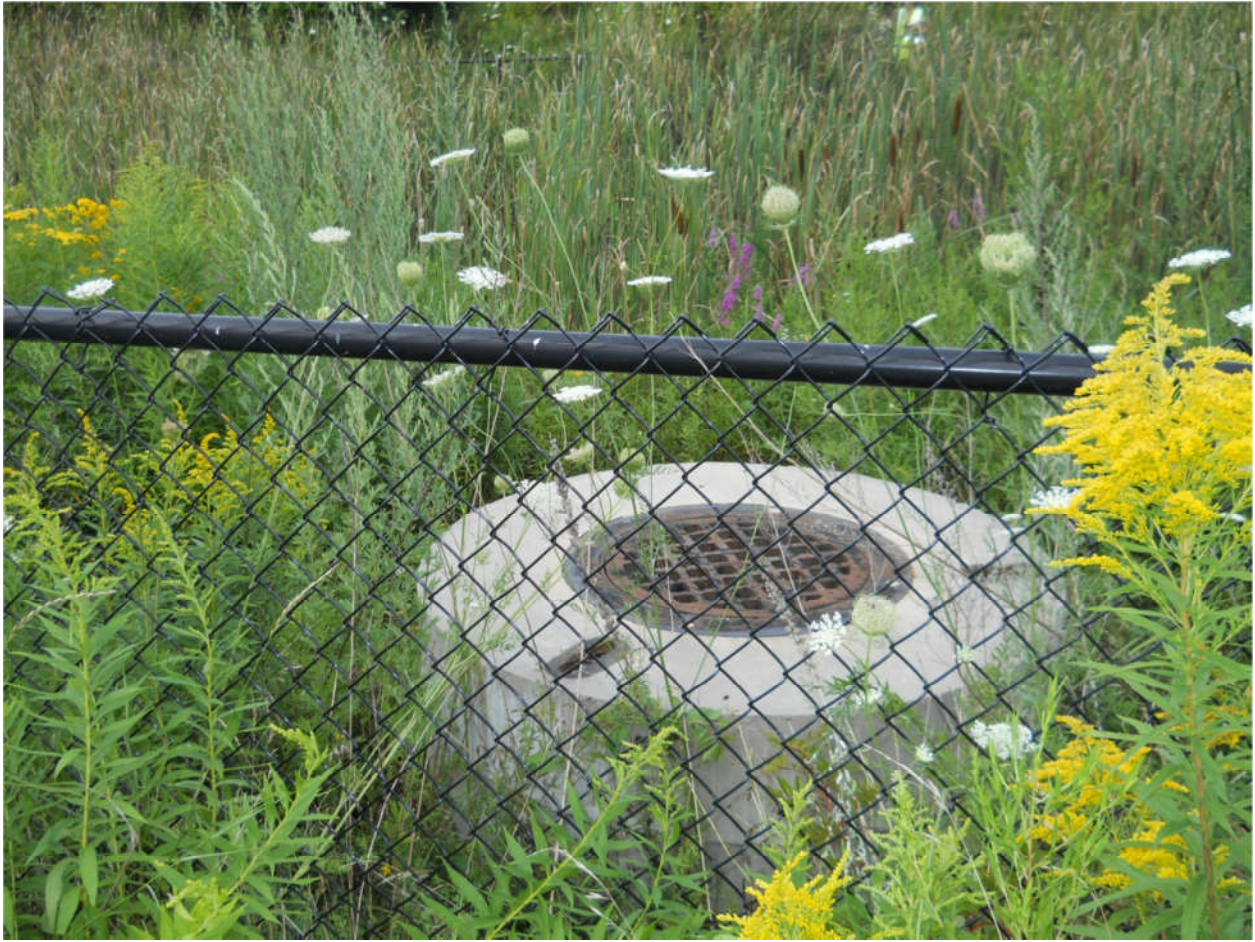
Rite Aid (Wet Pond) Parcel ID: U12-011

System has underdrained gravel trench, but no flow control orifice
