TO:	Pete Clark	DATE:	September 1, 2015
FROM:	Jonathan Edgerton	PROJECT NO.:	13147A
SUBJECT:	Slope Failures – South of Town Landing

Subject: Site Reconnaissance and Preliminary Geotechnical Services
Coastal Shoreline Stability
Falmouth Town Landing
Burgess, Mason and Studley Streets
Falmouth, Maine

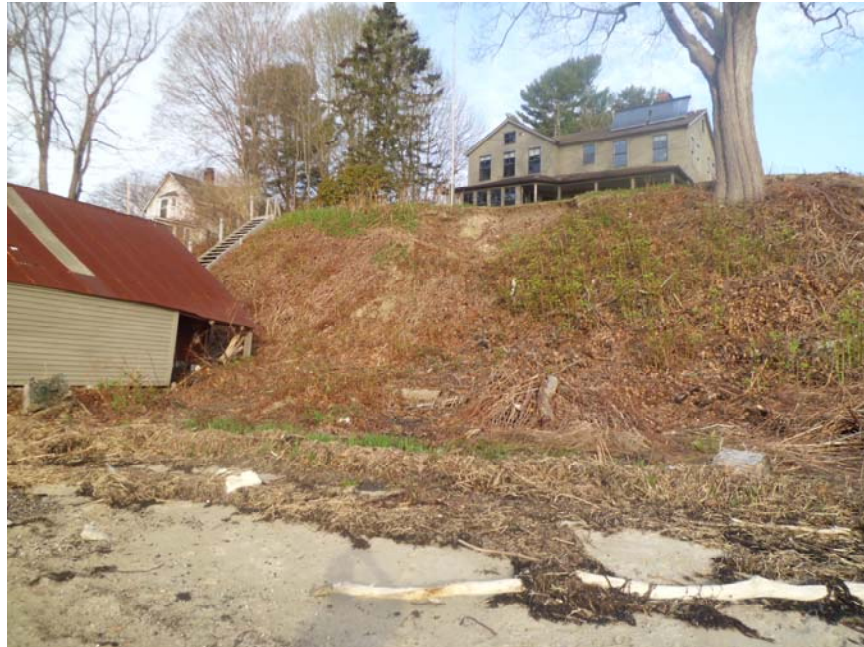
PHOTO 1

- Studley Street: A slumped area near the head of the slope off the end of Studley Street about 15 to 20 feet wide and extended about 10 to 15 feet down the face of the slope. This area is about 30 feet from a residential structure on Lot 57.
- Mason Street: In addition to observations on March 11, 2015, we observed material slumped off the slope was deposited at the toe of the slope.
- Burgess Street: In addition to the observations on March 11, 2015, we observed the relic failed area was covered with established vegetation. The head of slope is about 25 feet from the residential structure on Lot 44.

- Studley Street: The eroded area appears to be the result of surface erosion. We recommend stabilizing and re-vegetating the bare, exposed soil. This area should be periodically monitored following repair to assess the need for reconstruction.

Slope erosion with Lot 57 at head of slope.

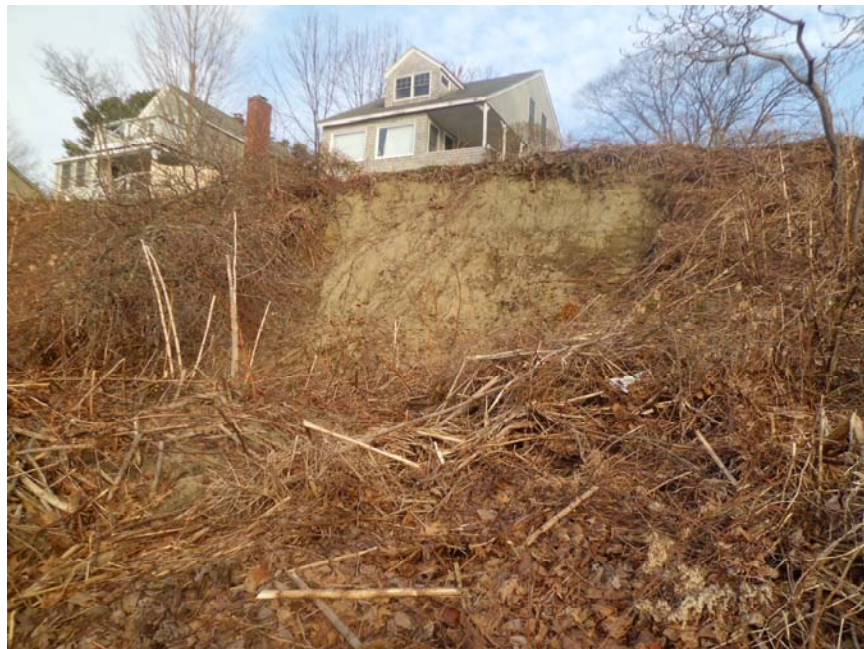
PHOTO 2

- Mason Street: A recently slumped area with an approximate 4-foot vertical, headscarp and moderate groundwater seepage was observed off the end of Mason Street. The exposed soils in the headscarp consisted of saturated fine sands and silts. The head of slope was observed to be about 15 feet from a residential structure on Lot 49 and close proximity to several other residential structures.
- Burgess Street: A relic failed area was observed off the end of Burgess Street. This relic failed area was obscured by vegetation. A stormwater outfall was observed near the head of slope and a large deciduous tree on the slope below the outfall.

- Mason Street: The slumped area appears to be the result of toe erosion. We recommend reconstructing the slope according to the conceptual repair option provided by Wright-Pierce with additional recommendations from S.W. COLE as shown on the attached sketch. Additionally, we recommend the gravity sewer pipe bedding be drained and outlet to the toe of the repaired slope area by means of an underdrain and pipe.

Slumped area with Lot 49 at head of slope

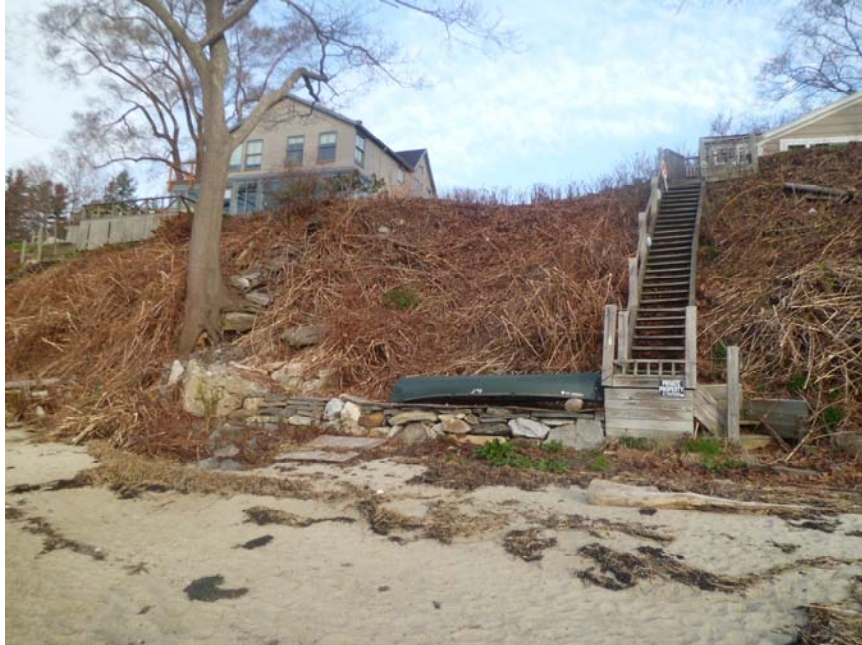
PHOTO 3

- Burgess Street: The slope face is covered with established vegetation and therefore, we currently do not recommend additional stabilization measures in this area. This area should be periodically monitored to assess the need for reconstruction.

Relic slumped and bulging area with Lots 45 and 44 at head of slope.

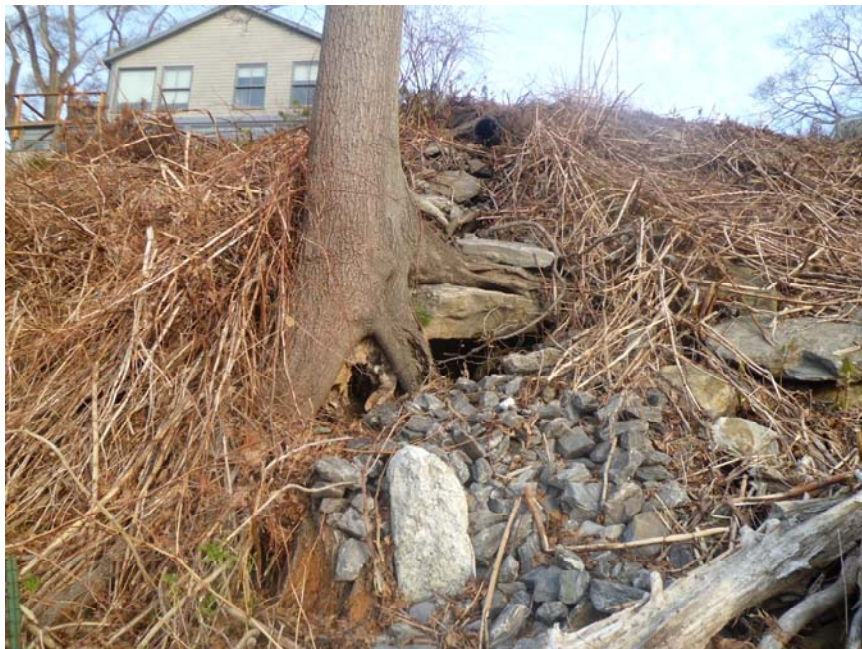
PHOTO 4

Close up of tree within bulging area.
