# Mackworth Island

Conceptual Utilization  
Master Plan

Final Report

January 27, 2023

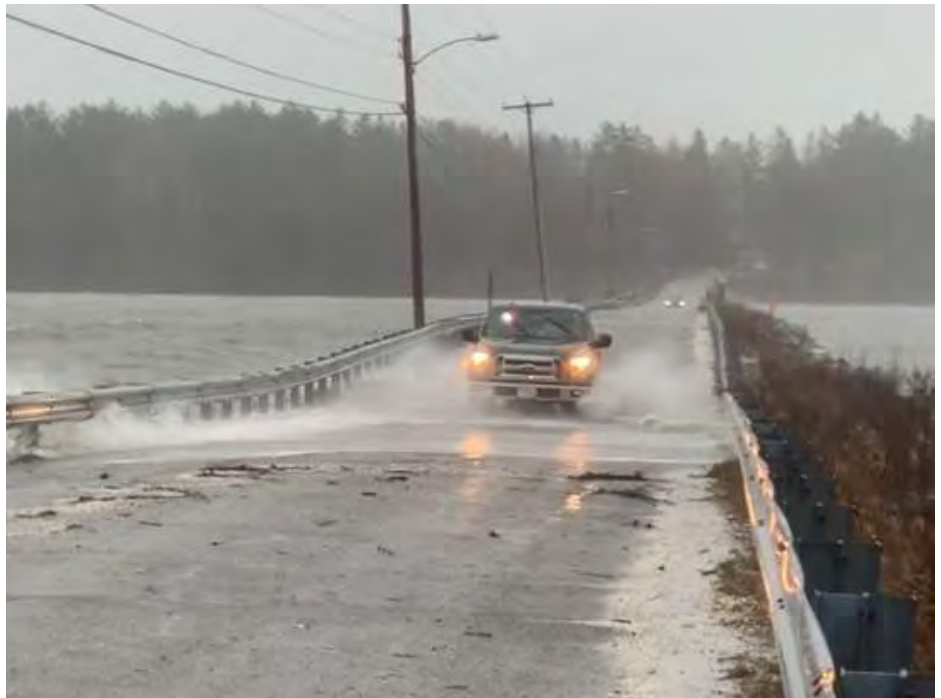
CAUSEWAY OVERTOPPING DURING DECEMBER 23, 2022 STORM

The causeway, a stone armored filled construction, has immediate, short-term and long-term improvement needs. It is low and overtopped by wave action during significant storm events. It is reported that the low portions of the causeway are overtopped by seawater more than once per year. Each overtopping event undermines the integrity of the causeway by pulling fine material from the composition and leaving gaps which accelerates settling. Immediate concerns include utility pole damage, and transverse steel beam play at one of the bridge support locations. Short-term needs include repair and stabilization of the two locations where the marine mattresses have failed, and settlement of the causeway has occurred. Long-term needs include reducing vulnerability from sea level rise and storm surge. This may be achieved by rebuilding the causeway at a higher elevation, partial replacement of the causeway, or complete replacement with a bridge. Recommended modifications include raising the causeway between 6 feet and 10 feet above its current road height to meet the Maine Climate Council's (MCC) 'Commit to Manage' (C2M) and/or the more conservative 'Prepare to Manage' (P2M) design criteria. Depending on the forecast, the causeway and bridge will be underwater throughout the year within 27 or 47 years.

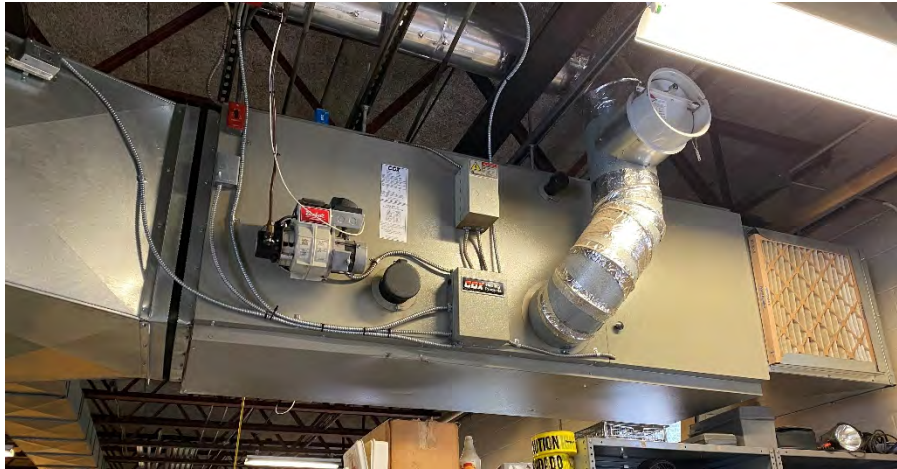
The main garage is served by a single, oil-fired furnace which is connected to a simple ducted air distribution system. The furnace was installed approximately 6 years ago and appears to be in excellent condition.

*Figure 3 - Oil-fired Furnace*

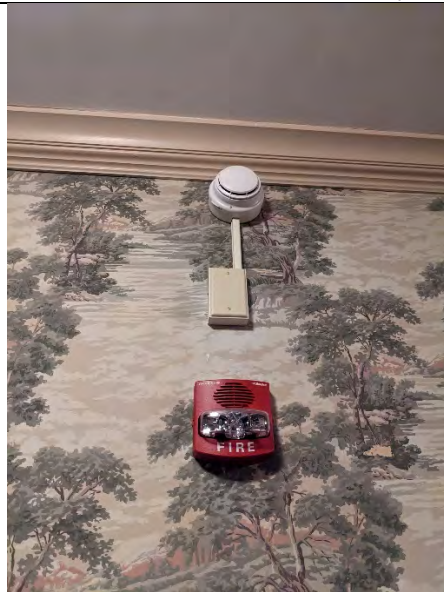
Fire alarm – the panel and devices appear to have been replaced within the last few years to a Simplex panel. Existing devices appeared to be in good condition, though only Smoke Detectors and Speaker Strobes were witnessed. Carbon monoxide detection was not observed and is recommended to be added to code required areas based on building occupancy type.

*Fire Alarm Devices*

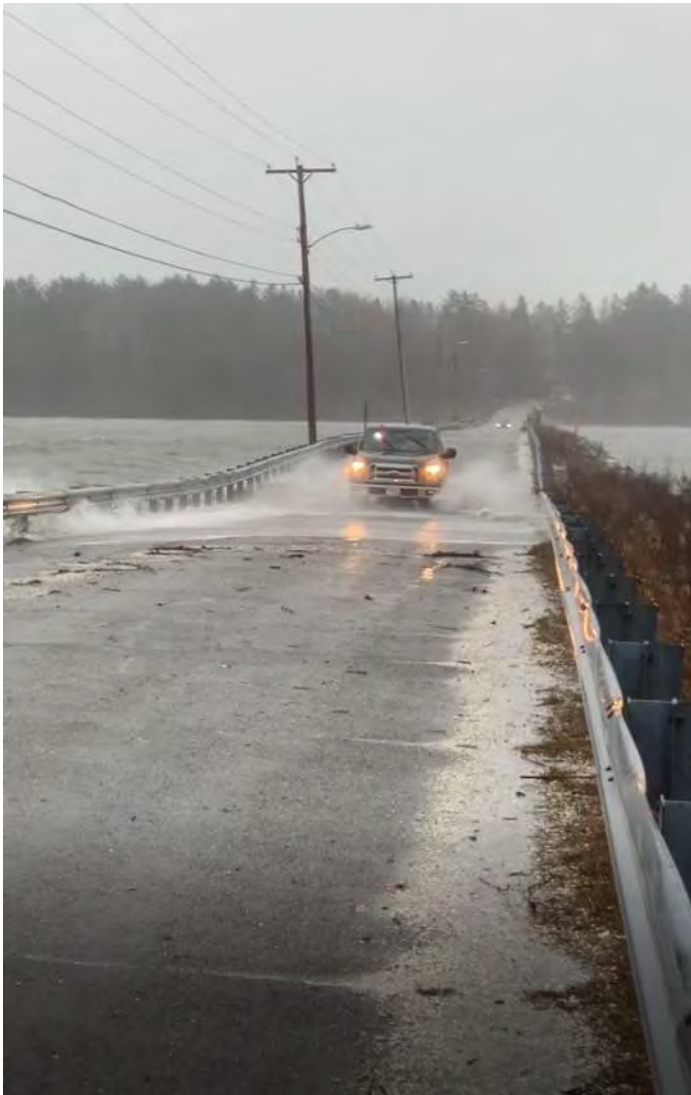
**Fig. 1. Causeway Overtopping During December 23, 2022 Storm Event**

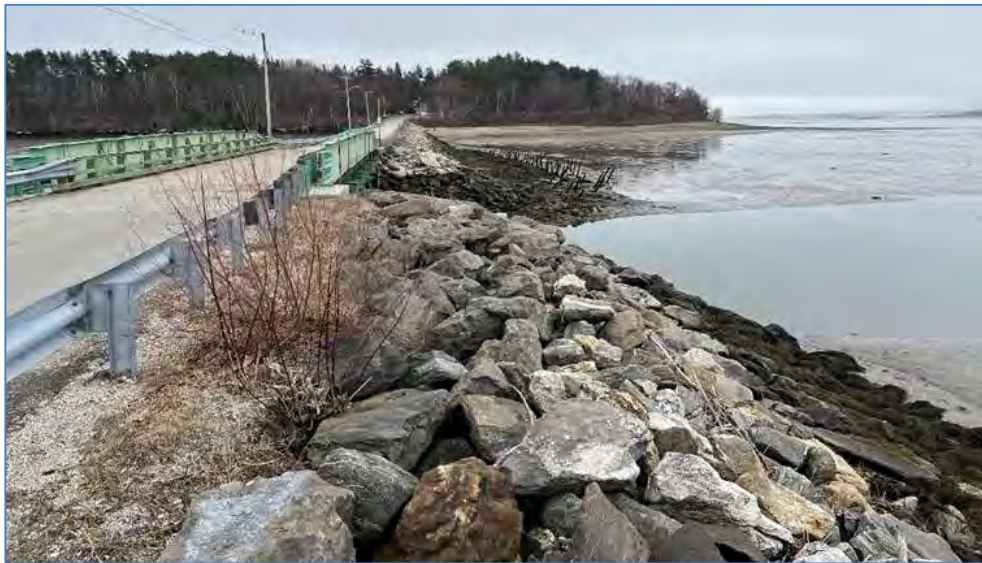
overtopped by wave action, making it vulnerable to washout and migration of fines that create voids below the pavement.

**Fig. 10. Mackworth Island Bridge Looking East from Mainland**

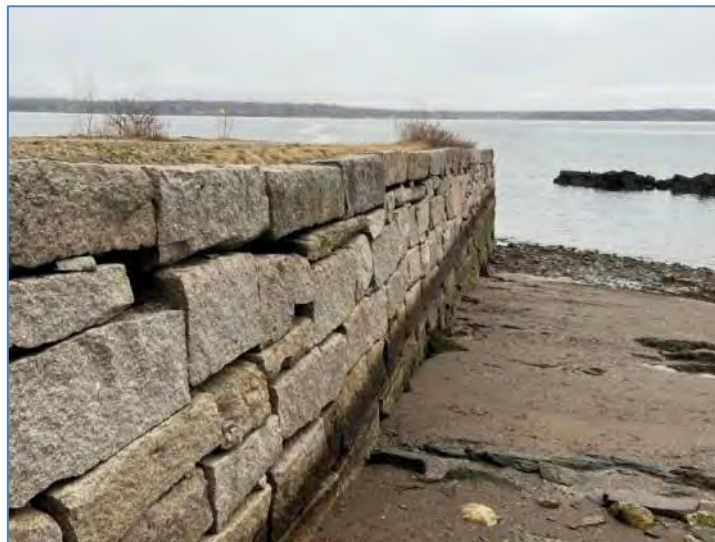
The seaward end of the pier was overtopped during the December 23, 2022 coastal storm causing minor washout in the fill at the end of the pier. The fill material and salt-tolerant grass/ plantings should be replaced in the spring for an estimated \$2,000 to \$3,000.

**Fig. 12. Granite Pier at Low Tide**  
(Remnants offshore suggest the original pier extended into deep-water)

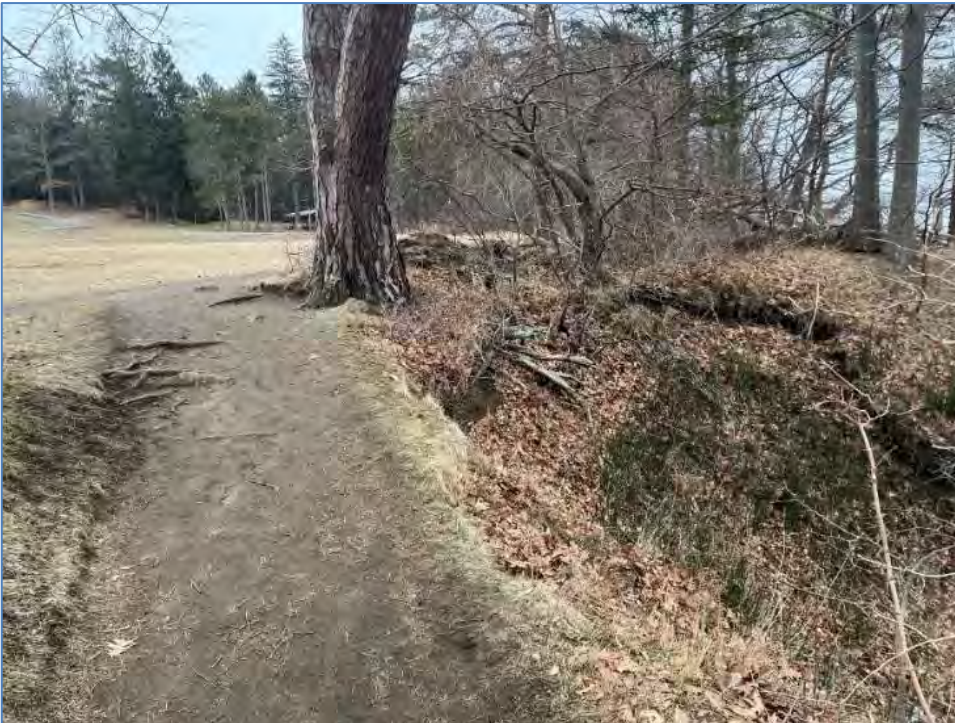
**Fig. 14. Section of Trail Located at The Top of a Steep Coastal Slope**

(Note evidence of surficial slide and subsequent repair.)

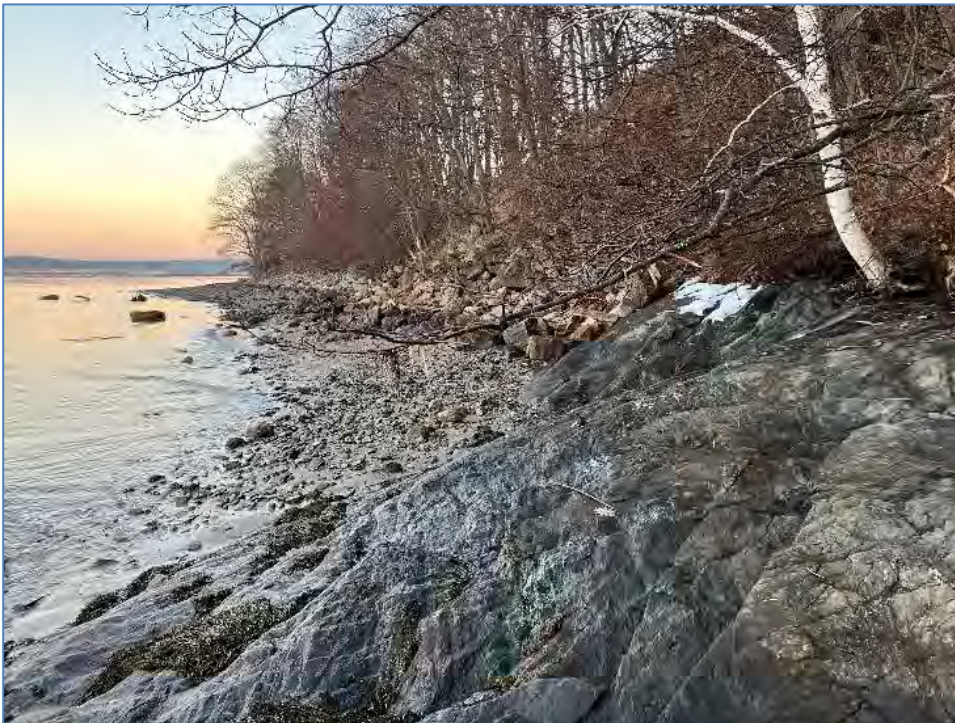
**Fig. 15. Natural Ledge and Imported Riprap Protect the Coastal Embankment**
