Geomorphic Assessment and Restoration Recommendations for Five Streams in Falmouth, Maine

Prepared for
Town of Falmouth (Maine)

Prepared by
Dr. John Field
Field Geology Services
Portland, ME

June 2023

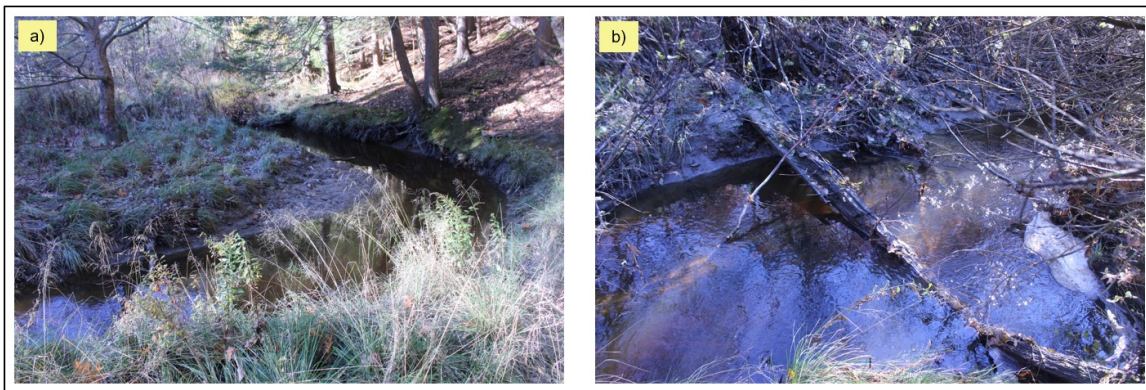
that characterize the low-gradient reach. Bank erosion and undermined trees are present where the meander apices impinge on the higher slopes of clay along the valley's edge with narrow sandy point bars observed on the inside bends of the tight meanders (Figure 3a). Numerous small logs in the channel create flow complexity where present (Figure 3b). More and larger wood would likely be in the channel if the riparian vegetation consisted of larger trees rather than the shrubs and grasses present under the power line under which the stream flows for most of the reach.

Figure 3. Reach C1 exhibits a) bank erosion where meander apices impinge on higher banks and b) flow complexity where wood is present in the channel.

Given the limited access to the reach, “chop and drop” wood additions (i.e., directionally felling standing trees into the stream) could increase wood loading and flow complexity in those areas where the stream moves away from the power line and tall mature trees are present.

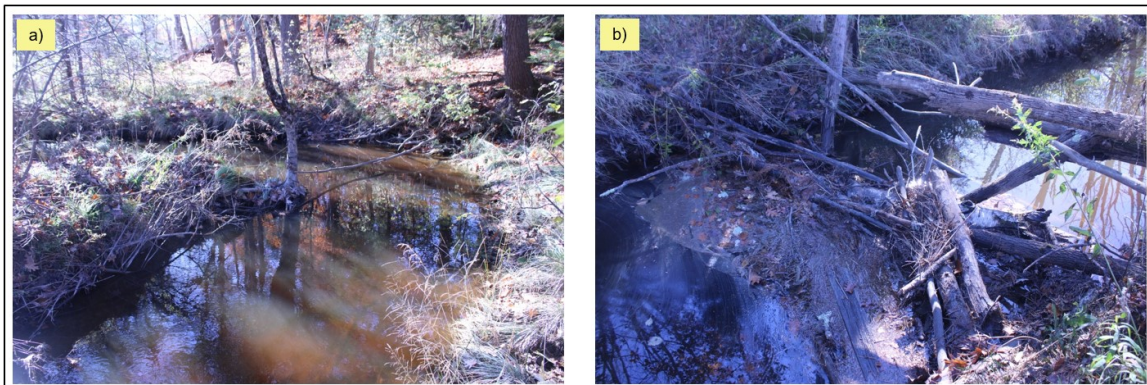
As the channel moves away from the I-295 road grade and the straightened portion of the channel ends, a more sinuous channel emerges with the meanders sometimes impinging on natural higher ground along the left bank (Figure 5a). Numerous tall standing dead trees are present on the floodplain, many of which have fallen into the channel to form log jams and good flow complexity (Figure 5b). Beaver activity was observed in the reach and is partially responsible for the abundance of wood in the channel. The dead standing trees suggest the area was previously impounded, but such ponding likely ended approximately five years ago based on the size of new saplings now growing on the floodplain. A small dam and upstream pond is present just upstream of Johnson Road near a residential property, although another unknown reason (perhaps beaver activity) is considered responsible for impounding the entire reach. The Johnson Road culvert is nearly as wide as the channel and no deposition is present upstream that would suggest backwatering is occurring upstream of the culvert.

Figure 5. Reach C3 is a) more sinuous than Reach C2 and b) loaded with large fallen wood that forms log jams and good flow complexity.

Stream conditions are good through most of the reach, but removal of the dam and associated rock work is recommended, assuming permission is granted by the landowners who do not seem to currently occupy or use the property.

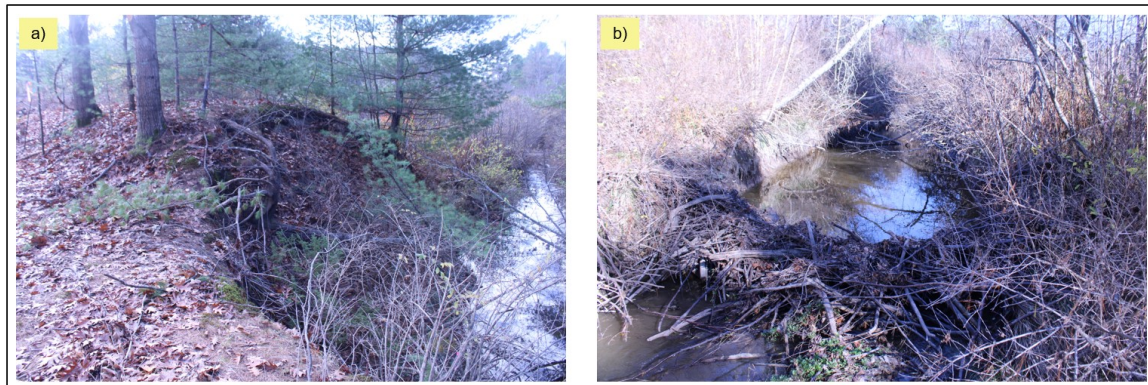
An 8-inch diameter gas line crosses the stream just downstream of the Johnson Road, but no significant scour is present at the culvert outlet that would threaten the pipeline. The high left bank just downstream of the gas pipeline is unstable (Figure 6a). A gravel substrate is present near the gas pipeline, perhaps associated with the pipeline or erosion from the high bank. The stream quickly transitions to a sinuous channel downstream with a low width:depth ratio and clay banks. Abundant small wood has created multiple log jams and beaver dams (Figure 6b), creating good flow complexity; a side channel has been carved into the wide floodplain where impounded flow behind one log jam overtopped the bank. The presence of two adjacent sharp right angle bends in the channel may indicate the reach was channelized in the past. The floodplain is well vegetated with shrubs dense enough to provide a good canopy over the narrow stream. The absence of tall mature trees suggest the floodplain is inundated for extended periods.

Figure 6. Just downstream of the gas pipeline a) the high bank is eroding, while further downstream b) numerous log jams and beaver dams are present in the channel.

Given the good condition of the stream, poor access, and lack of tall mature trees for chop and drop, restoration is not critical nor practical for much of the reach. Outreach to the landowner is recommended to discuss conservation, so the reach can remain undisturbed. Bank stabilization of the high bank just downstream of the gas pipeline could be completed with log cribbing but is not considered essential as the pipeline is not considered threatened by the erosion (Figure 6a).

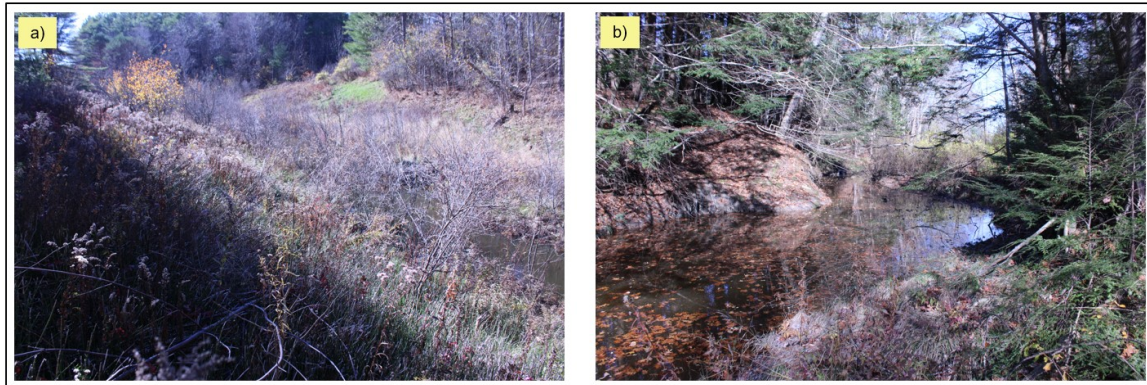
sized culvert. A large beaver dam is impounding much of the reach with abundant leaves floating on the stagnant water in the channel (Figure 7b) with a second smaller beaver dam just downstream. Additional logs and branches that have fallen into the channel also improve flow complexity. Tall trees are present on the high ground and provide some canopy over the channel (Figure 7b) with lower shrubs still dominating the floodplain vegetation (Figure 7a) as in Reach C4.

Figure 7. Reach C5 has a) a narrower floodplain as high ground on both sides converge and b) a lengthy impounded area upstream of a large beaver dam.

Given the good condition of the stream and poor access, restoration is not critical nor practical for much of the reach. Outreach to the landowner is recommended to discuss conservation, so the reach can remain undisturbed. With tall trees on the high ground in close proximity to the channel (Figure 7b), chop and drop could be performed along portions of the reach to further improve flow complexity.

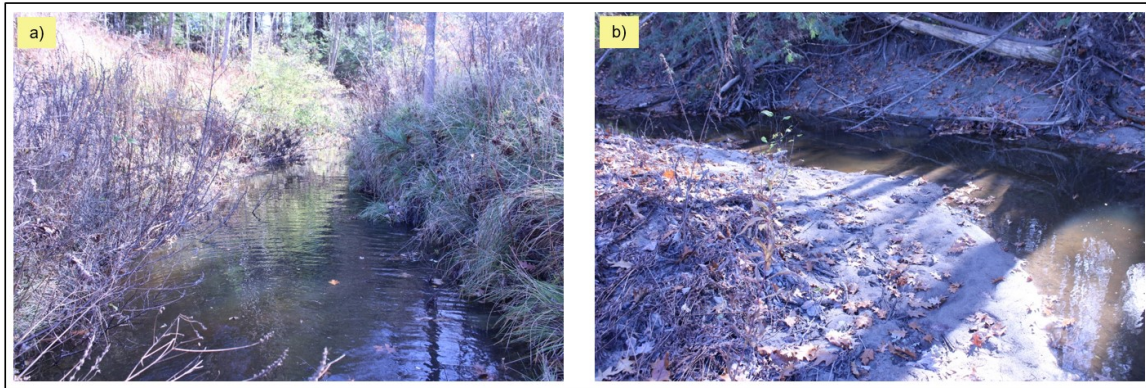
Immediately downstream of the I-295 culvert, Chenery Brook is narrowly confined by 8-foot high banks on both sides of the channel (Figure 8a). Ledge extends high up the left bank near the culvert, but is found only at the base of the bank further downstream with clay of the Presumpscot Formation above. The high right bank is largely composed of the glaciomarine clay with some sloughing close to the culvert. However, severe scour is not observed, because the culvert is nearly as wide as the channel. The right bank remains confining throughout the reach but a floodplain emerges on the left bank near the downstream end of the reach with a vegetated overflow channel present. Within the channel, a cobble substrate is present through the confined reach and becomes finer downstream with sand bars along the channel margins, including on the inside of the sharp bend at the downstream end of the reach (Figure 8b). The sand bar formation coincides with the emergence of the left bank floodplain and backwatering upstream of the sharp bend. A beaver dam and other wood are present in the channel but the wood is not abundant. A few mature trees are growing on both banks and provide some canopy over the stream channel.

Figure 8. C6 is a) confined at the upstream end with b) sand bars present further downstream where at a sharp bend at the downstream end of the reach.

Chop and drop wood additions could increase flow complexity in this short reach, but is a low priority given the existing in-stream wood and beaver dam.

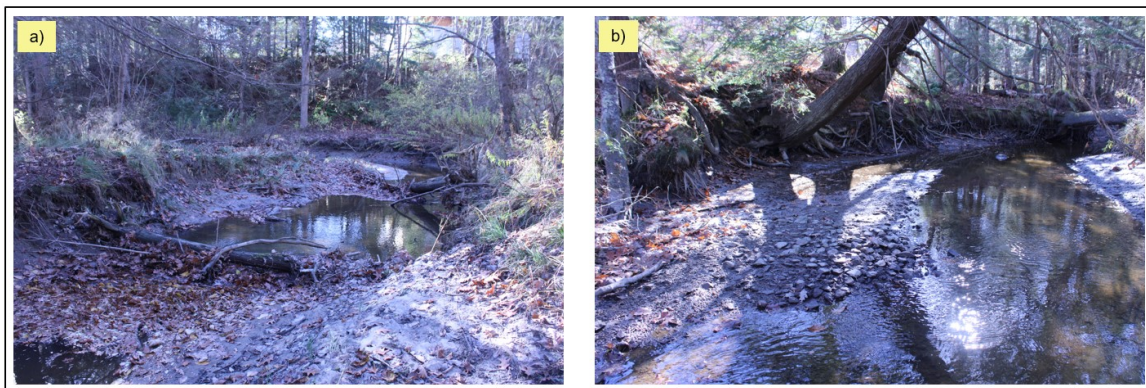
Reach C7 is highly sinuous with a sandy substrate and eroding banks on the outside bend of meanders (Figure 9a). A wide floodplain is present but the channel occasionally impinges on the high banks along the back edge of the floodplain. A former channel is present on the floodplain at the upstream end of the reach and along with two close by sharp right angle bends in the channel suggest the channel's position may have been altered in the past by humans. The presence of wide sand bars, leaning trees along undermined and eroding banks, and abundant wood in the channel indicate the channel is dynamic and the meanders actively migrating. While the channel has a low width:depth ratio in places as a result of the meander migration and bar deposition, flow complexity is good, pools are formed around logs in the stream, and a well developed canopy covers nearly the entire reach due to the mature forested floodplain. A cobble bar has formed at the mouth of a small tributary (Figure 9b) that is actively eroding from runoff concentrated along Route 1.

Figure 9. Reach C7 has a) a sinuous channel with abundant wood, bars, and undermined and eroding banks and b) a cobble bar formed at the mouth of an eroding gully off of Route 1.

Reach C7 is currently in good condition, so restoration in the channel is a low priority, although chop and drop and reactivating the abandoned channel could increase flow complexity and reduce sediment inputs from the high banks, respectively. A higher

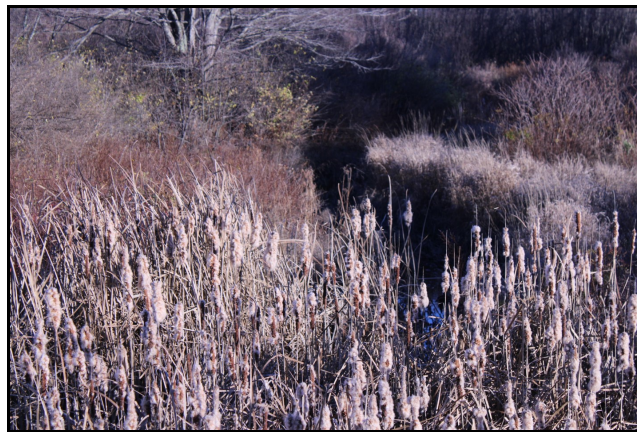
Reach H1 is characterized by a sinuous sand-bed channel with a low width:depth ratio flowing through an alder and cattail dominated wetland (Figure X). Flow in the channel was stagnant at the time of the assessment during low-flow conditions. Backwatering upstream of the Gray Road culvert may enhance the wetland conditions that would likely persist even in the absence of the culvert. A gas pipeline crosses the channel and wetland immediately upstream of the culvert. Few mature trees are growing along the channel nor was wood observed in the channel, although the channel was closely inspected only at its downstream end at Gray Road.

Figure 10. Reach H1 has a low width:depth ratio as it flows through a wetland.

Restoration is not recommended for Reach H1 given the persistent wetland conditions and no perceived threat to the gas pipeline, Gray Road, or other nearby infrastructure (e.g., adjacent residential homes).

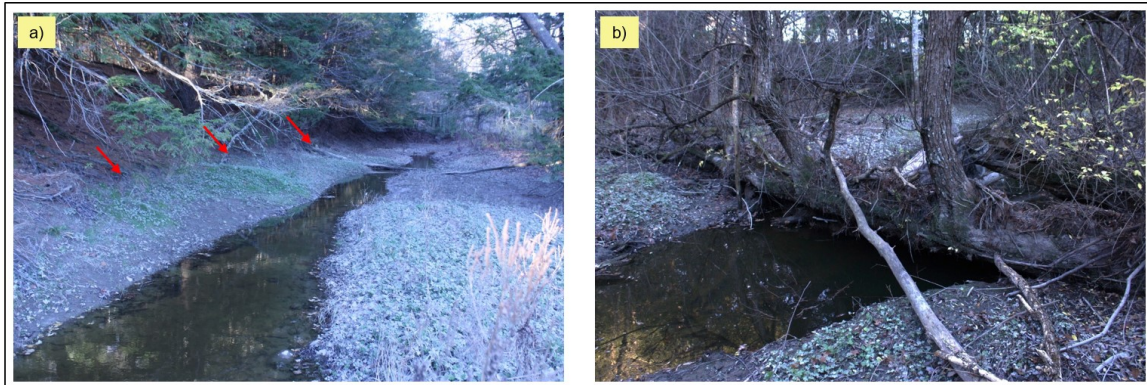
Reach H3 is a relatively straight channel that flows along a high surface on the left bank with only a narrow floodplain before encountering higher ground on the right bank as well (Figure 12a). The channel has a soft substrate and very low banks perhaps due to infilling by fine sediments associated with past ponding caused by a fallen large tree crossing the channel downstream that was further jammed up by small branches emplaced, in part, by beaver (Figure 12b). The highwater mark of the impoundment is demarcated along the high left bank by a color change on the ground (marked by red arrows on Figure 12a) with a thin gray film of fine silt draping the lower slope and right bank floodplain. The impoundment has since drained as the channel has migrated around the fallen tree. One small tree has fallen across the channel within the formerly impounded area (at red arrow furthest to right in Figure 12a) and may act as a log sill to improve flow complexity within this upper portion of the reach with otherwise little wood. The channel is better defined with higher banks downstream of the formerly impounded area. While few mature trees are found on the narrow floodplain, particularly in the impounded area, forest growth on the higher adjacent surfaces provides a good canopy over the entire channel (Figure 12).

Figure 12. The upper portion of Reach H3 was a) impounded by b) a fallen large tree jammed with smaller branches further downstream.

Given the relatively undisturbed condition of the stream, restoration is not critical for much of the reach. Outreach to the landowner is recommended to discuss conservation, so the reach can remain in a fairly pristine condition. With landowner permission, Reach H3 would be an excellent candidate for chop and drop given the large stand of mature

trees growing on the high ground near the channel and the upper portion of the reach that is largely devoid of in-stream wood (Figure 12a).

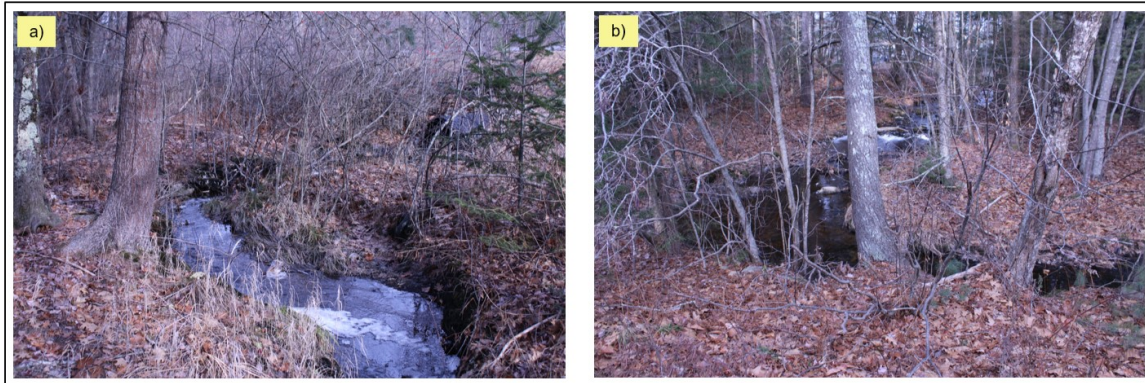
Immediately below Route 9, Reach M1 flows in a well defined sinuous channel (Figure 13a) with a substrate of clean pea-sized gravel. Within 250 ft of Route 9, the channel quickly transitions into a wetland with a poorly defined channel that comprises most of the reach's length. The impounded flow condition is enhanced by a small culvert passing under a private driveway but wetland conditions are present on both sides of the culvert. A well defined channel reemerges as the channel becomes increasingly confined by higher ground. The channel, behind a residential home, appears to have been altered by human activity with a large meander cutoff and the channel now straight. At the downstream end, a sharp right angle bend is present (Figure 13b) at the edge of Olde Blackwood Way as part of a realignment of the channel to flow through the culvert. In-stream wood is creating good flow complexity at the downstream end of the reach with jams forming as leaves and smaller branches are trapped behind larger fallen trees. A mature forested buffer is growing at the upstream and downstream ends of the reach (Figure 13). The channel through the wetland area is bordered by low growing alders.

Figure 13. The upper part of Reach M1 has a) a well defined sinuous channel while the end of the reach has b) a sharp bend indicating the channel was realigned to pass through the culvert.

The private driveway culvert could be enlarged to reduce backwatering in the wetland area. The culvert under Olde Blackwood Way could be repositioned to better align with the preexisting flow path and, thus, eliminate the sharp bend (Figure 13b) that could create erosion problems by the road during a large storm. Chop and drop or wood additions could be used to increase flow complexity at the upstream and downstream ends of the reach, but will require landowner permission.

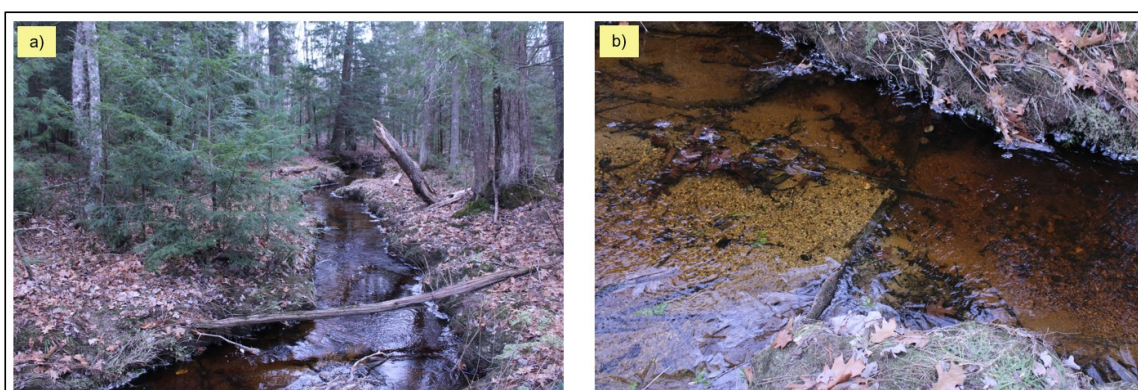
Reach M4 has a sinuous channel with a substrate ranging in size from pea gravel to sand. The upper reach has a low width:depth ratio and relatively high banks due to minor incision, in part associated with scour at undersized culverts at Long Creek Way and a private driveway, that transitions to a channel with a higher width:depth ratio, lower banks, evidence of abandoned meanders on the floodplain, and greater sinuosity. High amplitude meanders, similar to Reach M3 (Figure 15a for Reach M3), become more frequent downstream as the stream becomes backwatered upstream of the bedrock falls. A few small sand bars have formed along the margins of the channel. While wood is largely absent from the channel despite a well forested buffer with several tall mature trees (Figure 16a), wood that is present, even very small pieces, help to trap sand and fine gravel (Figure 16b) and create good flow complexity.

Figure 16. Wood is a) largely absent from Reach M4 despite a well forested buffer but, where present, b) even small pieces of wood help trap sediment.

Replacing the two undersized culverts at the upstream end of the reach will improve sediment transport continuity and reduce scour. One is under a small road and the other a private driveway. These projects are likely feasible but they are not creating major problems so are considered a low priority. Greater improvements reach wide would be achieved by completing chop and drop wood additions that would immediately improve aquatic habitat. This is a long wooded reach that should be a high priority for land conservation as conditions will improve over time if no actions are taken.

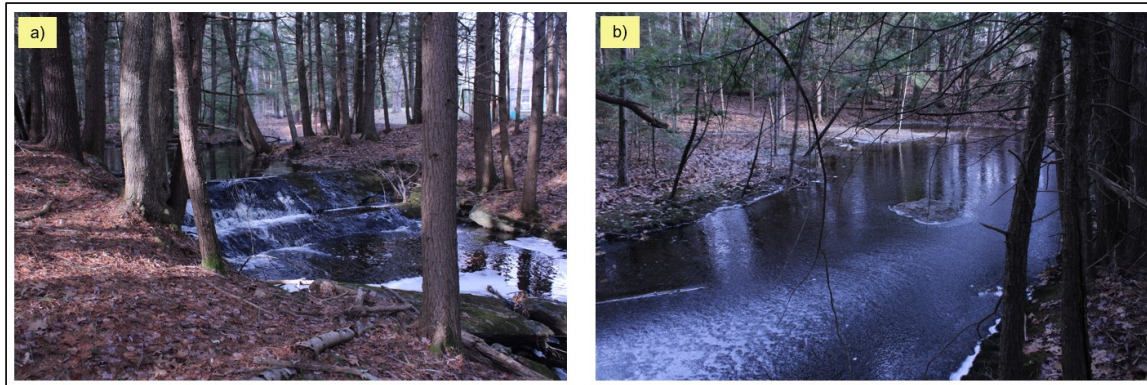
the steeper confined sections dominating the reach. A well forested buffer with tall trees provides a full canopy throughout the reach.

Figure 17. Reach M5 has a series of a) bedrock falls with an intervening b) a wide low-gradient backwatered area with a sand delta at a tributary confluence.

Reach M5 is in excellent condition with limited need for restoration. Chop and drop could be completed in the short wider section where wood is more likely to be retained without anchoring but is considered a low priority.

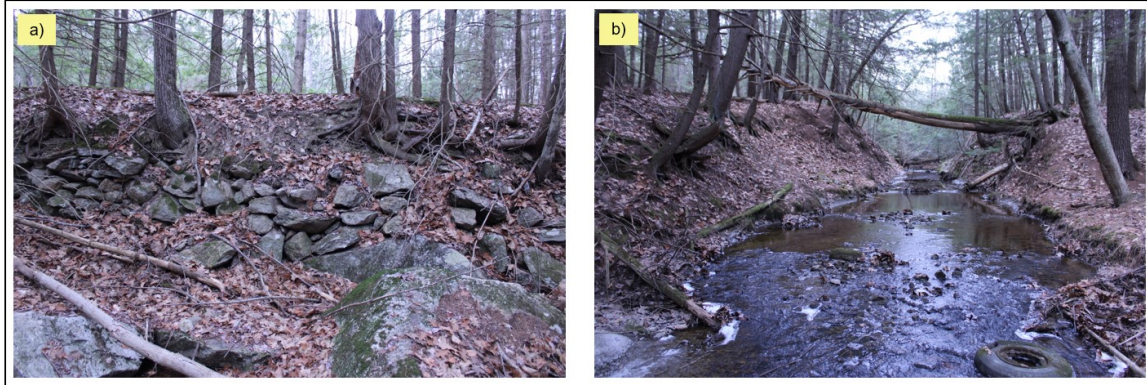
Reach M6 is largely a sinuous channel with a high width:depth ratio, eroding banks, and, in most locations, a wide floodplain. The channel occasionally bifurcates around islands. A hardpan clay outcrops on the stream bottom in many places while in others a cobble and gravel substrate is present with bedrock occasionally observed. In some areas, the gravel particles are actually composed of clay derived from the hardpan (referred to as rip-up clasts of clay). Small bedrock steps are present at the lower end of the reach. An old remnant dam occurs within the reach (Figure 18a) with the stream having carved a deep gully through high banks of clay around the flanks of the dam with trees falling and/or slowly sliding into the channel from the top of the gully walls (Figure 18b). The gully is straight but the original sinuous channel is still present downstream of the dam. Numerous log jams fully or partially cross the channel, although long sections are devoid of wood despite the forested floodplain that provides a full canopy over the channel along the entire reach. The elliptical-shaped culvert at the downstream end of the reach spans the entire width of the channel, so no signs of backwatering (i.e., excessive deposition of fine sediment) are present.

Figure 18. Reach M6 has a) an old dam with b) a gully carved through clay around the dam's flank.

In addition to chop and drop through the entire reach to supplement the existing in-stream wood and enhance aquatic habitat, the remnant dam (Figure 18a) could be removed and the channel realigned into the former sinuous channel to prevent further fine sediment from eroding from the clay banks through the deep gully (Figure 18b). A lot of wood could be placed in the gully to prevent further erosion but could remain as an overflow channel during large floods. The gully could be Given that the Middle Road culvert already closely matches the channel's width, no action needs to be taken.

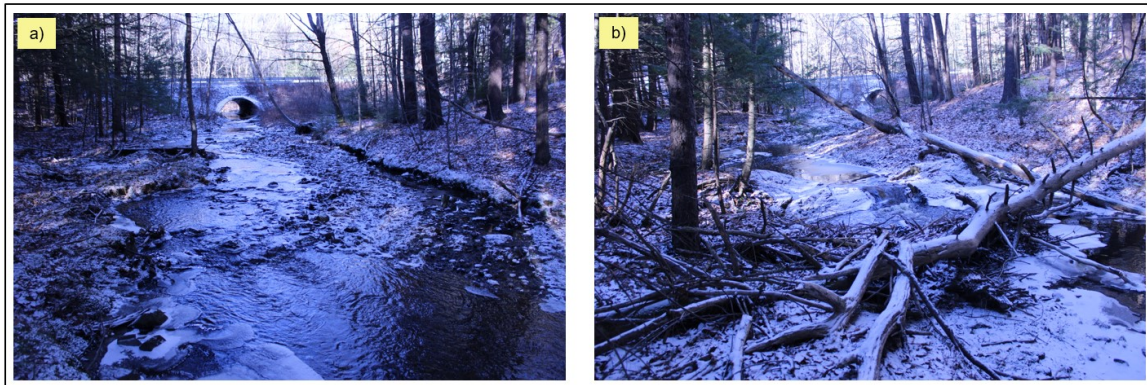
No scour is present downstream of the Middle Road culvert outlet, but a large gravel bar has formed just downstream (Figure 19a) that is more likely the result of backwatering upstream of some bedrock falls (Figure 19b) than due to impacts associated with the culvert. Most of the reach flows through a confined bedrock gorge with periodic low bedrock falls. A rocky channel with a high width:depth ratio is present in lower gradient sections in between the falls. An old remnant dam is at the top of one of the falls. Wood is abundant in the channel with several log jams present (Figure 19b) with a well forested buffer present providing a full canopy over the channel throughout the reach.

Figure 19. At the outlet of the Middle Road culvert a) a large gravel bar has formed but is more likely related to b) the bedrock falls just downstream.

Reach M7 is in excellent condition with no need for restoration. The old remnant dam is having no morphological impact and can remain in place. Abundant wood is already in the channel, so chop and drop would provide little added benefit. Attempting to conserve the land around the channel through the reach would prevent future development that might threaten the stream's excellent condition. Discussions with the landowner at the upstream end of the reach indicated his interest in conserving his parcel, so outreach to him might prove beneficial.

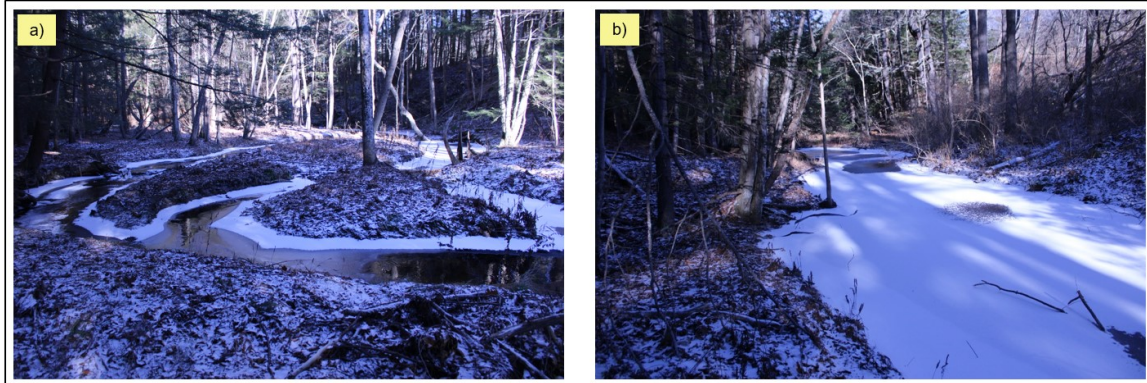
As the channel becomes less confined at the downstream end of the bedrock gorge, the expansion of flow has created a bifurcated channel with one of the channels creating a large meander (Figure 20a). Further downstream, a single wide channel forms with minimal in-stream wood (Figure 20b). The left bank of the channel at the downstream end flows against the railroad grade and approaches the railroad culvert at a right angle, although no observable impact is associated with this sharp approach angle. A forested buffer provides a canopy over the entire reach, including along the railroad grade.

Figure 20. a) The stream bifurcates around an island at the upstream end of Reach M8 but becomes b) a wide single-thread channel at the downstream end (railroad grade on right side of photo).

Chop and drop is recommended along the reach to immediately improve wood loading and aquatic habitat. Given the railroad culvert just downstream, a log strainer should be built to catch any mobile wood to prevent blockage at the inlet of the culvert. While better realigning the railroad culvert with the stream would restore full geomorphic function, implementation would likely be cost prohibitive and no significant negative impacts resulting from the poor alignment are evident.

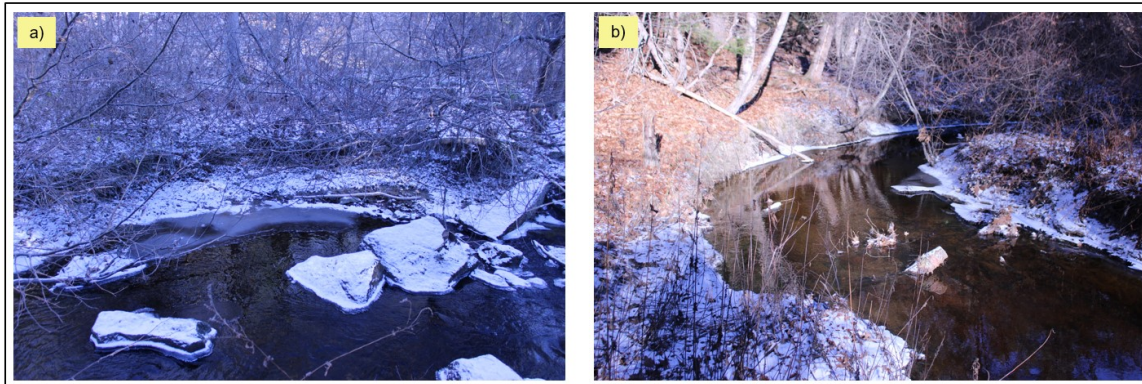
Significant scour is present at the outlet of the railroad culvert with erosion leaving boulders in the channel that formerly lined the bank for protection (Figure 21a). The reach is characterized by high-amplitude meanders where scour on the outside bends of meanders is relatively minor. Near the downstream end of the reach, the channel takes a sharp bend and becomes straighter where approaching and then flowing against a high bank. At the end of the high bank, the channel takes another sharp bend (against more high ground opposite the high bank) that is severely scoured (Figure 21b) and then encounters a jumble of large boulders that partially block the channel before entering the I-295 culvert. The origin of the boulders is uncertain and could be natural or placed by humans (either part of a remnant dam or the result of I-295 construction). The double culvert under I-295 appears well sized and no evidence of backwatering was observed. Aside from the boulders at the downstream and upstream (Figure 21a) ends, the substrate is largely composed of sand. Limited wood is found in the channel and large trees are found only on the higher slopes with smaller trees and shrubs present on the floodplain.

Figure 21. Scour in Reach M9 is most severe a) at the outlet of the railroad culvert and b) at a sharp bend against a high bank.

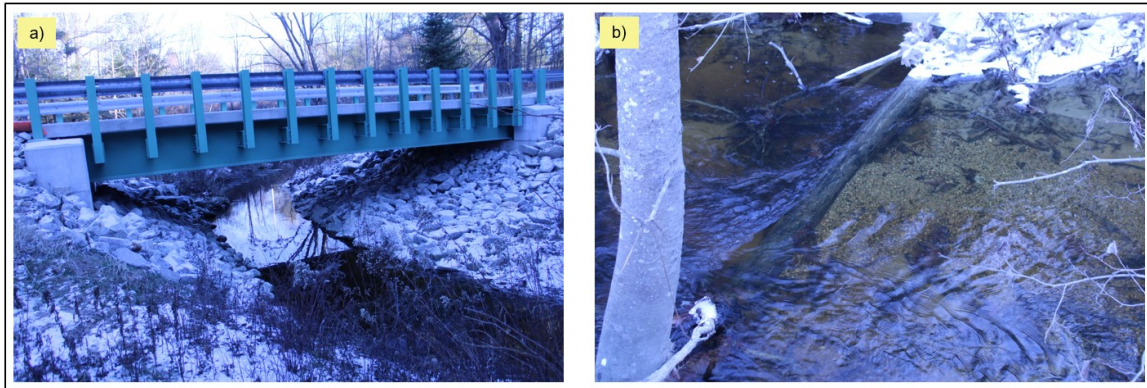
Figure 22. a) a bridge crossing the channel spans the channel but the rock armor partially constricts the channel and b) a log sill is trapping pea-gravel upstream and creating flow complexity.

Some chop and drop could be completed in the reach but the number of available trees is limited and considerable in-stream wood is already present. While the bridge (Figure 22a) fully spans the channel, pulling back some of the armor to reduce or eliminate the constriction of the channel is recommended if approval is given by the landowner. The culverts at the upstream and downstream end closely match the channel width and show no signs of morphological adjustment, so, while not ideal, are a low priority for replacement.

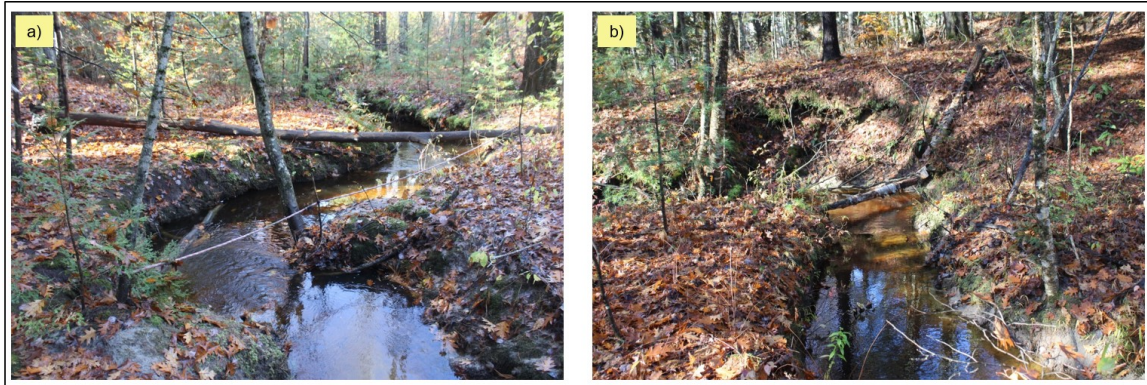
Figure 24. Reach N1 is a) a sinuous channel with b) erosion where channel impinges on uplands.

The reach is largely in excellent condition with dynamic changes, flow complexity, and plentiful wood to ensure numerous habitat types in close proximity. Additional wood could be added through chop and drop in areas with low wood loading but given the present condition, this is considered a low priority. Bank erosion (Figure 24b) is not prevalent and need not be treated as no infrastructure is threatened and contributes wood and sediment to the channel that sustain the dynamic nature of the stream. The stream, or at least the land on the left bank, is already conserved and under the control of a local land trust.

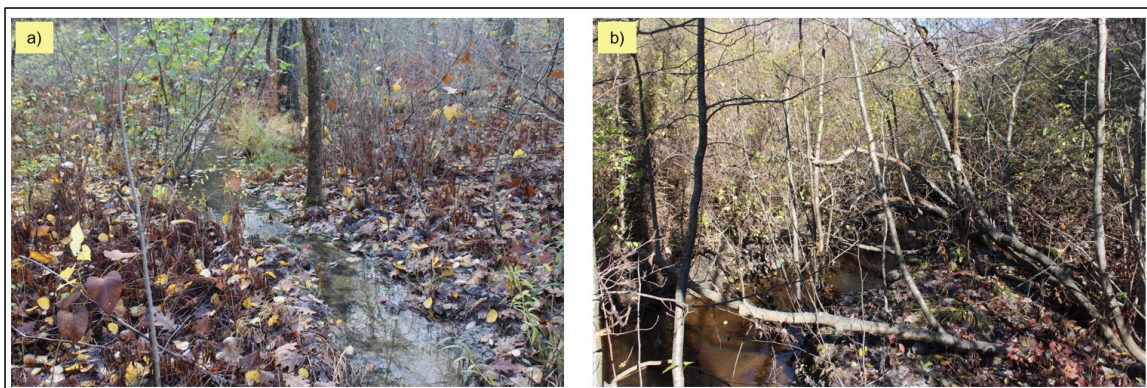
Reach N2 is only slightly sinuous and may have been artificially straightened in the past, in part, and is now naturally reforming incipient meanders (Figure 25a). A portion of the straight channel flows against artificial fill extending 50 ft out onto the floodplain behind the Street Cycles building. Two steps in the stream profile occur along this section, one composed of broken asphalt pieces and the other of boulders presumably both derived from the fill. The artificial fill extends downstream to just upstream of the European Bakery and Tea Room where the floodplain widens out again. The substrate is sandy with some gravel, perhaps derived from the fill. Limited wood is found in the channel, because the floodplain is dominated by shrubs with few tall trees, providing a dense low canopy over the stream channel (Figure 25b). The density of the shrubs increases downstream, perhaps, in part, due to the backwatering effects upstream of the Johnson Road culvert that does not include any relief culverts across the wide floodplain.

Figure 25. Reach N2 a) may have been artificially straightened with incipient meanders now naturally reforming and b) has a dense growth of shrubs providing a low canopy over the channel.

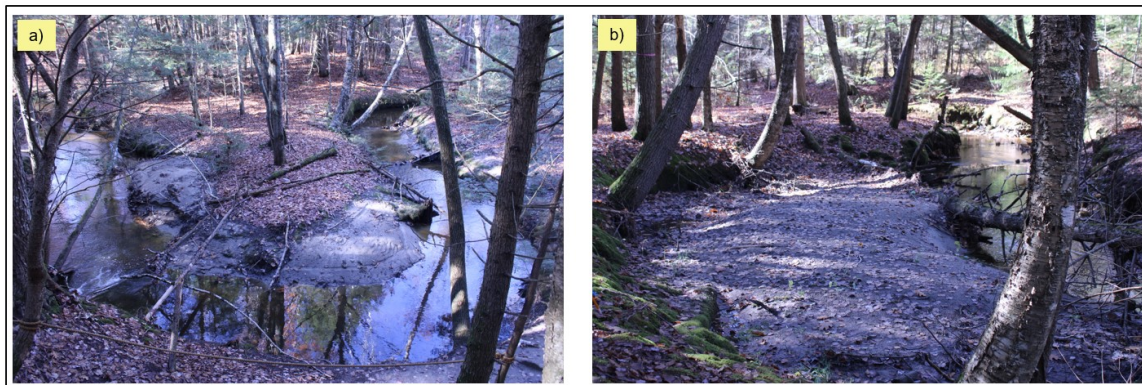
The headwall at the outlet of the Northbrook Drive culvert has similar, but not as severe, problems as the inlet as described above for Reach N3. A scour pool and eroding banks just downstream of the outlet are resulting from the undersized nature of the culvert. The channel through the reach is slightly incised with high-amplitude meanders (Figure 27a) that are most prevalent at possible backwatering sites such as upstream of the Mill Creek confluence (with tidal influence) and upstream of an apparent old crossing to the gravel pit where fill blocks the floodplain (with two old displaced culvert pipes remain in the stream nearby). Significant deposition is occurring locally even on the outside bend of a meander where a tributary enters and a large log helps trap the sediment (Figure 27b). Plenty of wood is in the channel, particularly where meanders impinge on higher slopes and cause mass failures. However, long stretches of stream have no wood (Figure 27a). A wide forested floodplain is present throughout the reach with a full canopy over the channel, although the floodplain is blocked at the inferred crossing to the gravel pit and constricted by artificial fill on which the Sullivan Tire store is built.

Figure 27. a) High-amplitude meanders and b) sand deposition (even on the outside bends of meanders) characterize Reach N4.

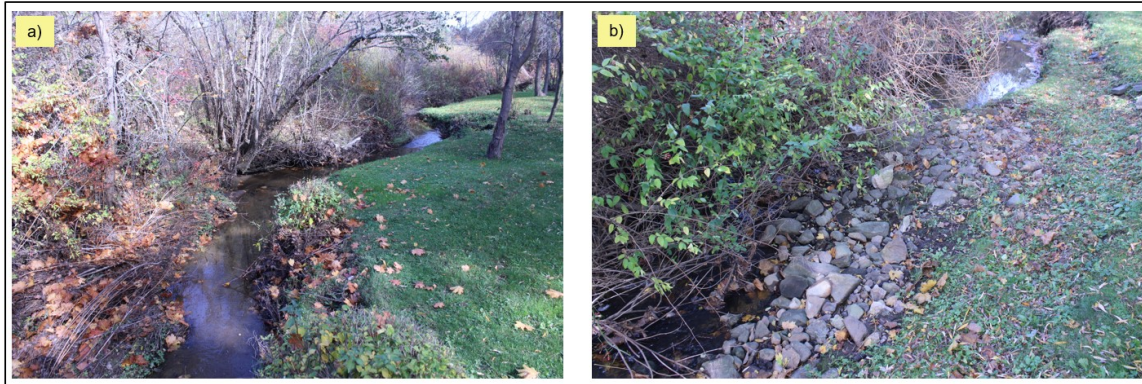
impoundment and accumulation of organic material (i.e., leaves and small branches) upstream. With a lawn on the right bank and largely shrubs on the right bank, a canopy over the channel is largely absent and no large wood is present in the channel.

Figure 29. Reach W2 flows a) in a straightened channel now naturally reforming meanders along the edge of the lawn with b) a large cobble bar and eroding banks downstream of the Depot Road culvert.

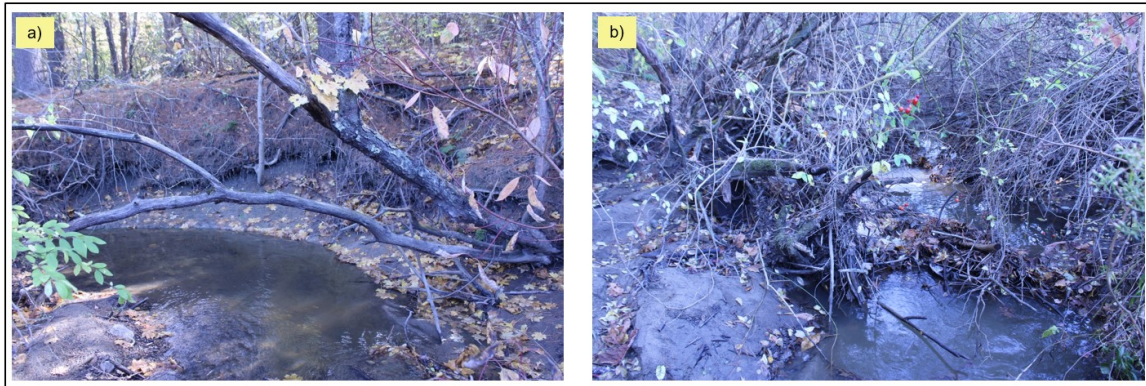
Figure 30. Reach W3 is a) sinuous with erosion on the outside bends of meanders and sand deposition on the inside bends in the upper part of the reach while b) flow complexity is maintained in the straighter downstream part of the reach by jams formed by small sticks.

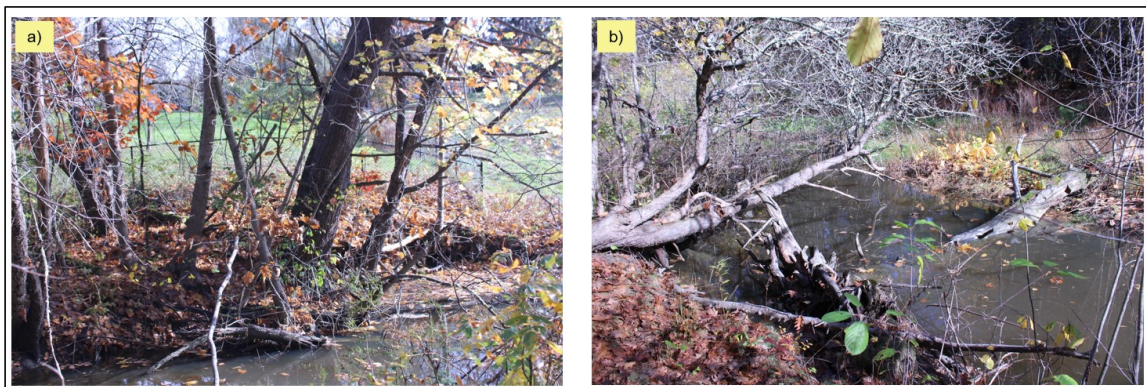
Figure 31. In Reach W4 a) localized erosion is undermining trees that ultimately b) causes large trees to fall across the channel.

No in-stream restoration recommendations are available. Residential property owners might be approached to discuss the environmental benefits of planting a buffer of trees

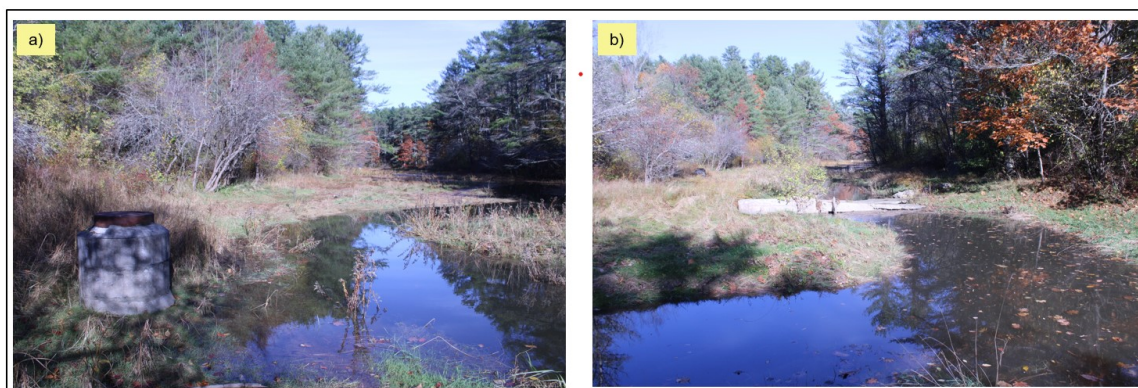
Figure 32. In Reach W5, a) meanders approach the sewer line at the edge of the marsh and b) a collapsed concrete bridge crosses the channel.

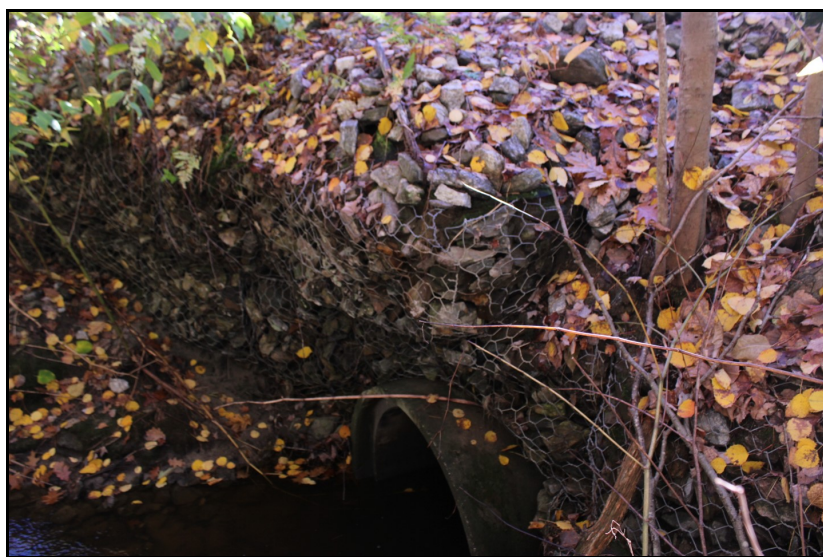
Figure 33. Gabion baskets on the headwall of Northbrook Drive are sliding down slope above the culvert inlet.
