CUMBERLAND COUNTY
SOIL & WATER
CONSERVATION DISTRICT

Highland Lake Watershed-Based

Management Plan

2020-2030

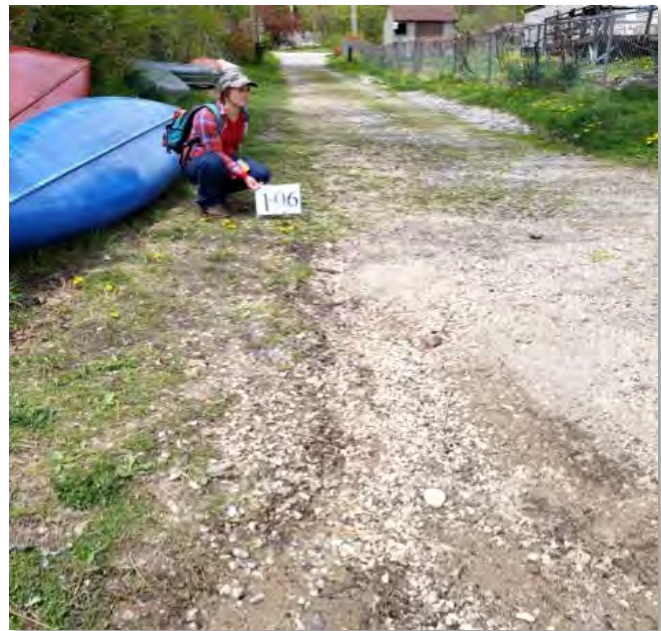
Erosion Documented through 2018 Watershed Survey

Conducted in May 2018 through HLA; primarily documented erosion sites throughout the watershed and properties with minimal vegetated buffers. 129 erosion sites were documented with 71 sites being residential and driveways and 27 sites being private roads. During this time, agricultural sites were also identified, and one-on-one outreach was made to these properties. All of these sites are listed in a Highland Lake 'Site Tracker', a database with corresponding photos and site locations, maintained by HLA which prioritizes sites based on estimated impact to the lake's water quality and keeps track of sites needing to be addressed versus sites that have been addressed. The watershed survey methods and specific survey sites identified can be found in **Appendix B. 2018 Highland Lake Watershed Survey Report**.

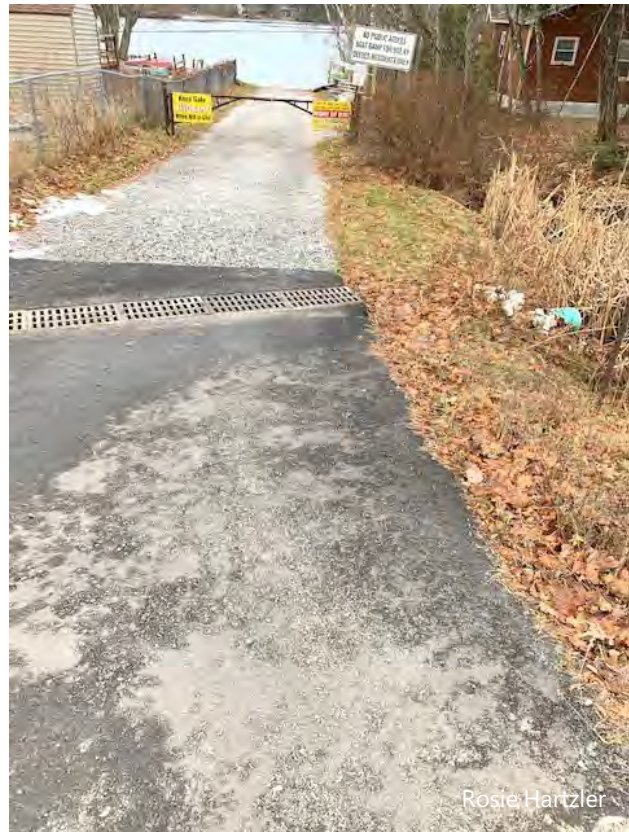
Infiltration Trench at Swan Road’s Right-of-Way

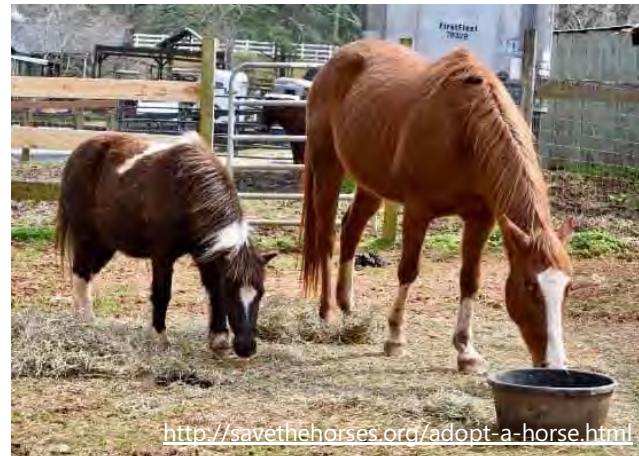
Manure From One Horse Can Contribute Approximately 18 Pounds of Phosphorus Per Year

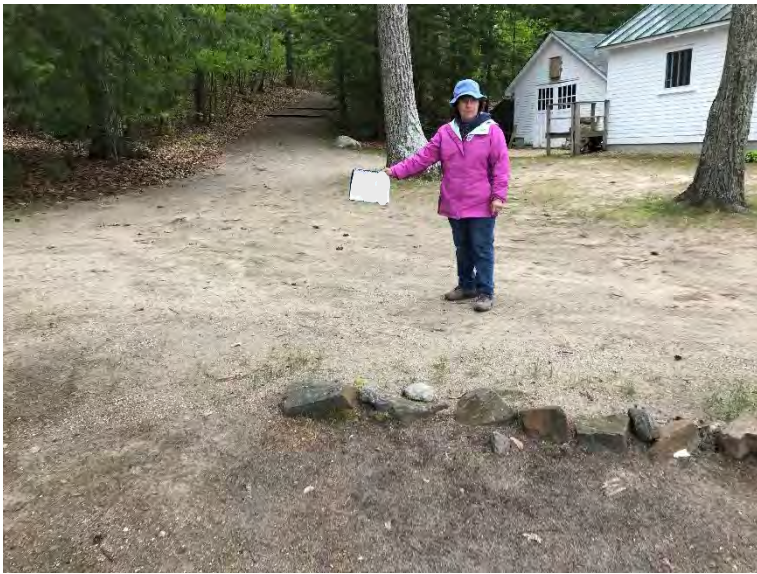
Residential

This site is representative of several residential group land uses where the combined runoff from each has caused significant sheet erosion in the yard and along the shoreline. Runoff from the lower driveway combined with runoff from the roof and compacted bare soil in the yard is discharging sediment directly into the lake. In addition, without a delineated and stable path for beach access, vegetation is unable to take root and stabilize the shoreline.

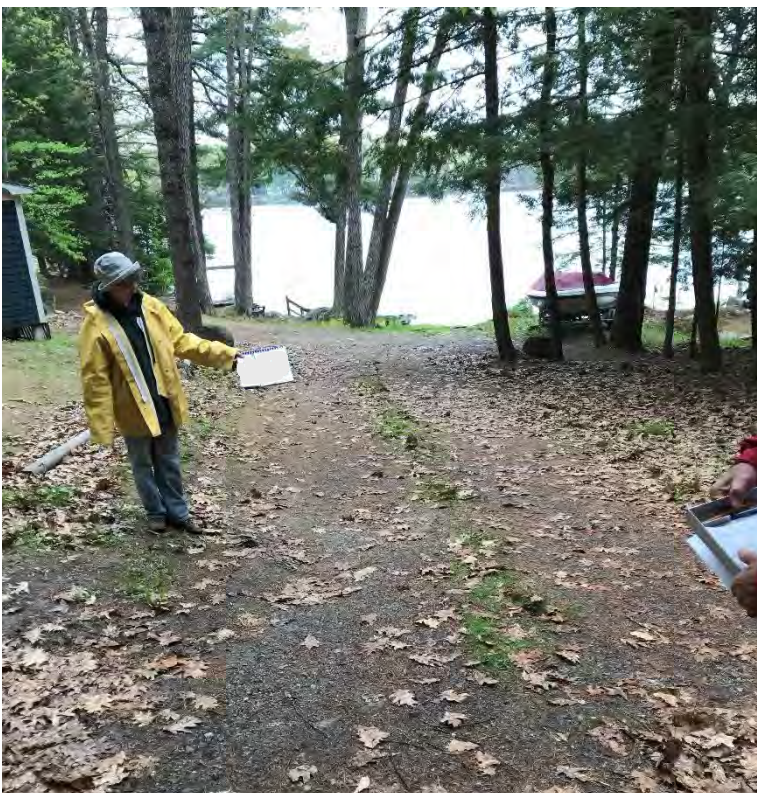
Driveways

This site is representative of typical driveway problems that can occur when runoff flows directly down the driveway, gaining in both velocity and volume as it nears the lake. These two factors combine to erode the driveway surface material and the resulting sediment is deposited into the lake. Because driveways see light vehicular use relative to roads, runoff diverters can be placed across driveways at intervals, breaking up the flow of water and sediment and depositing it into adjacent wooded areas rather than the lake.

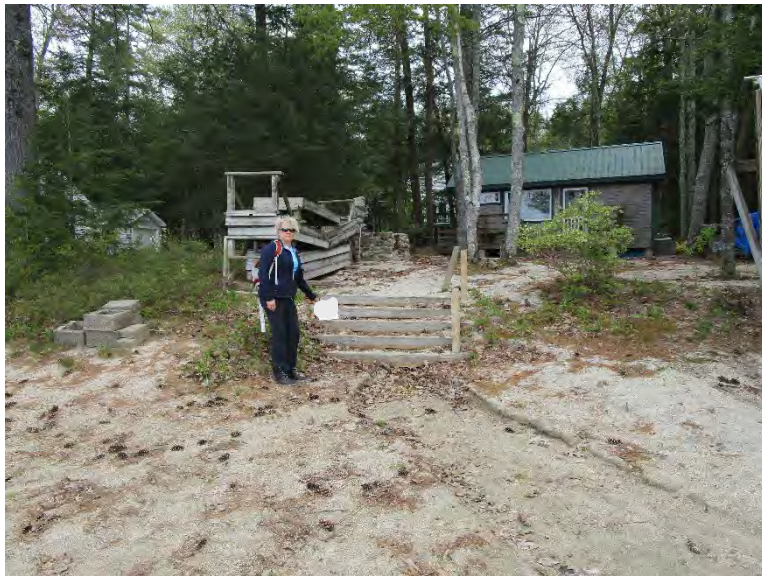
Beach Access

This site is representative of problems that can occur when runoff from upper areas of a lot is allowed to flow unimpeded to the beach. Beaches are very susceptible to erosion as is apparent by the severe rill erosion that can be seen below the steps. To protect the beach from erosion, runoff from the upper lot area must be diverted into a vegetated buffer that can slow and infiltrate runoff. In the absence of an adequate buffer, infiltration practices can be constructed to collect and infiltrate runoff.

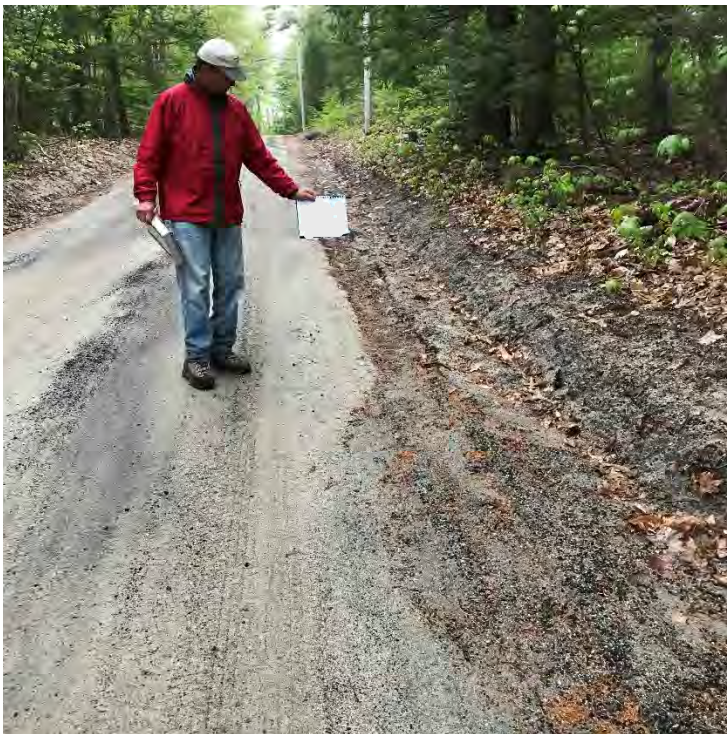
Private Road

This site is representative of several private road problems observed around the lake. Sheet flow from the road surface concentrates along the edge of the road and, in the absence of a stable drainageway, runoff is cutting into the road shoulder producing rill and gully erosion. Winter sand that has accumulated on the road surface and the road bank is washed down to the bottom of the hill by the force of the flowing water. Because the road is sunken relative to the surrounding landscape, there is also no place to divert or “turnout” the water into the adjacent wooded area.

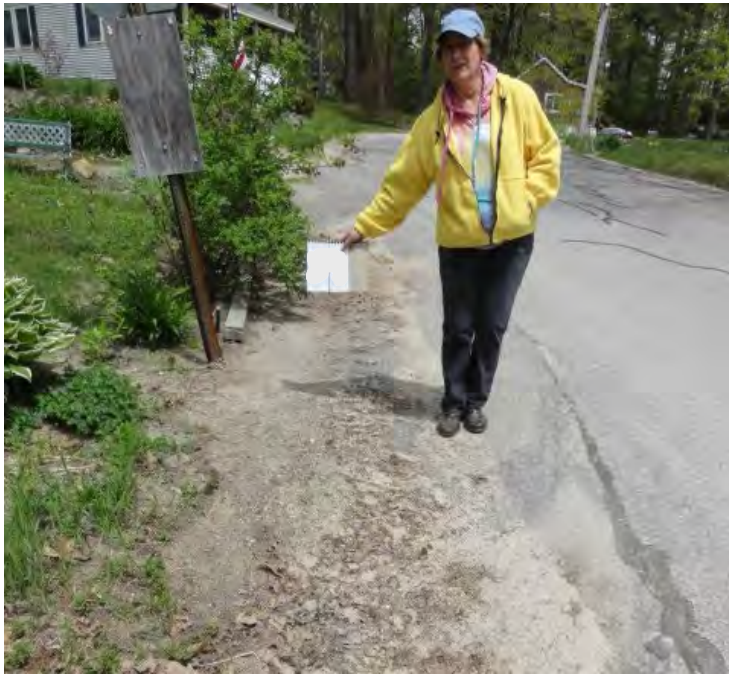
Town Road

This site is representative of some of the problems observed along town roads. Although town roads where problems were observed are paved and therefore resistant to erosion, the ditches running alongside the roads are very susceptible to erosion if they aren't vegetated or lined with stone. Also, ditches along town roads can fill with winter sand (shown here) as they do along private roads, potentially resulting in erosion problems downstream. Ongoing ditch maintenance is key to preventing these types of problems.

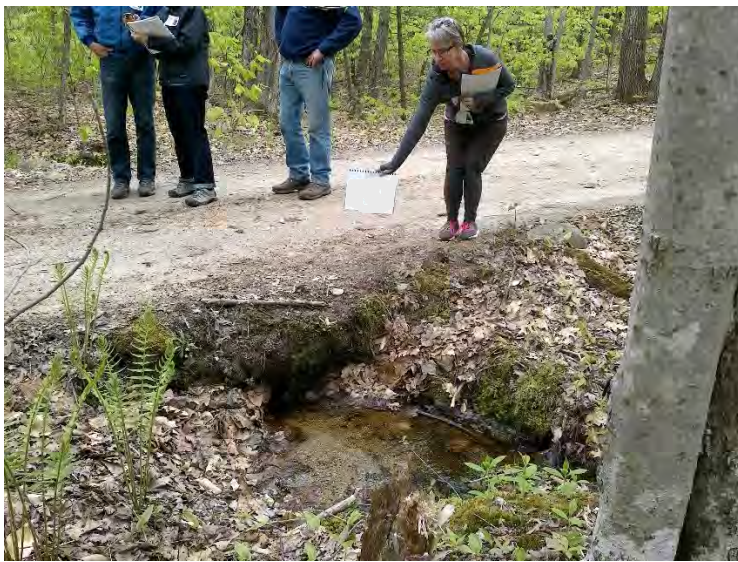
Stream Crossing

This site is representative of the problems that can occur where roads cross over streams. Runoff from roads can erode slopes around culvert inlets and outlets if they are not stabilized with stone and/or vegetation, particularly if the stream crossing is at a low point in the road. Also, as more road material gets pushed to the edge of roads, the culverts can become clogged. The velocity of water flowing through a culvert can also lead to erosion of stream bottoms and banks.

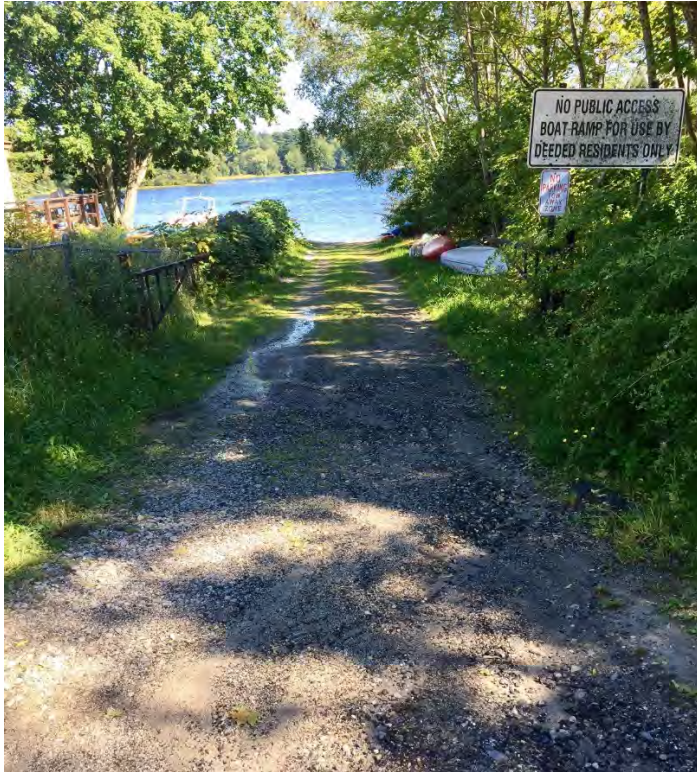
Boat Access

This site is representative of boat access problems caused by runoff flowing straight toward the lake over a loose aggregate surface. Flow is concentrated in wheel ruts created by heavy vehicular and trailer traffic. By the end of the ramp, the volume and velocity of the flow is often enough to wash out the end of the ramp. Large quantities of sediment enter the lake this way as evidenced by the deltas that sometimes extend into the lake from boat ramps. Similar to problems on many private roads, there is no ditch or areas where the water can get off the ramp and into vegetation bordering the ramp.

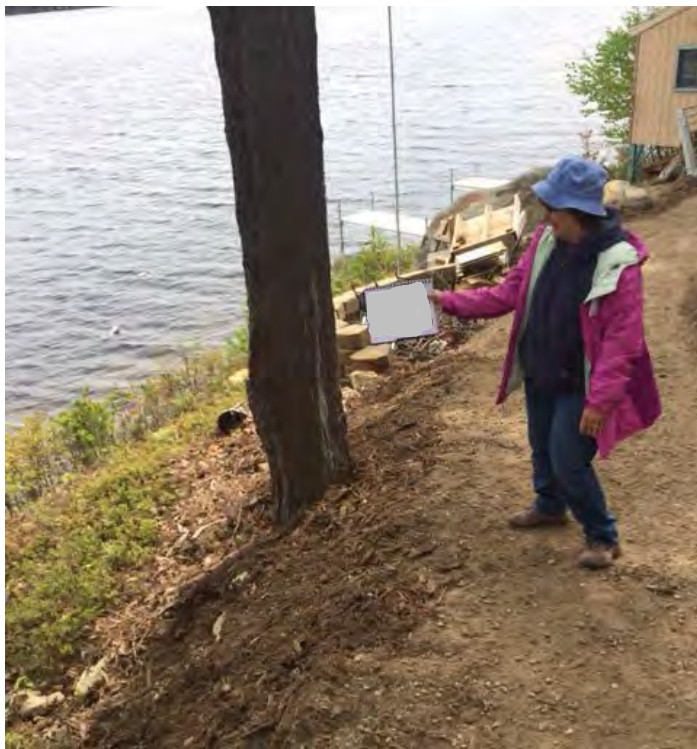
Construction Site

This site is representative of construction sites where the absence of a sediment barrier such as silt fence or an erosion control mix berm could potentially lead to direct discharge of sediment into the lake. Prior to construction, erosion control plans must be prepared and approved by the towns and erosion and sedimentation controls installed. Contractors must maintain the controls over the course of construction to ensure they remain effective. Under the Erosion and Sediment Control Law, landowners and/or contractors could potentially be fined for failing to comply with requirements of the law.

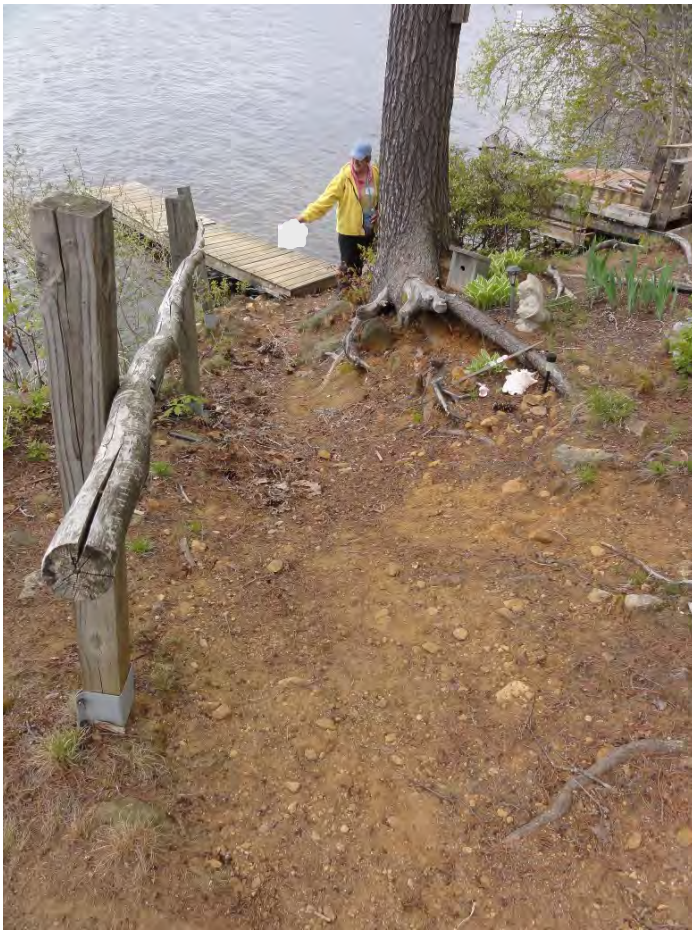
Trail or Path

This site is representative of problems with trails or paths that typically lead to the lake. The combination of a steep bank, bare soil, and no vegetated buffer for runoff to be dispersed results in a chronic erosion problem. Non-Residential Group trails or paths with problems identified during the survey are used by several landowners with deeded access, consequently, the amount of foot traffic is higher and the damage greater than on paths used by individual homeowners. Practices to protect the ground and surrounding vegetation must be installed to protect the slope and allow runoff to infiltrate before it reaches the lake.

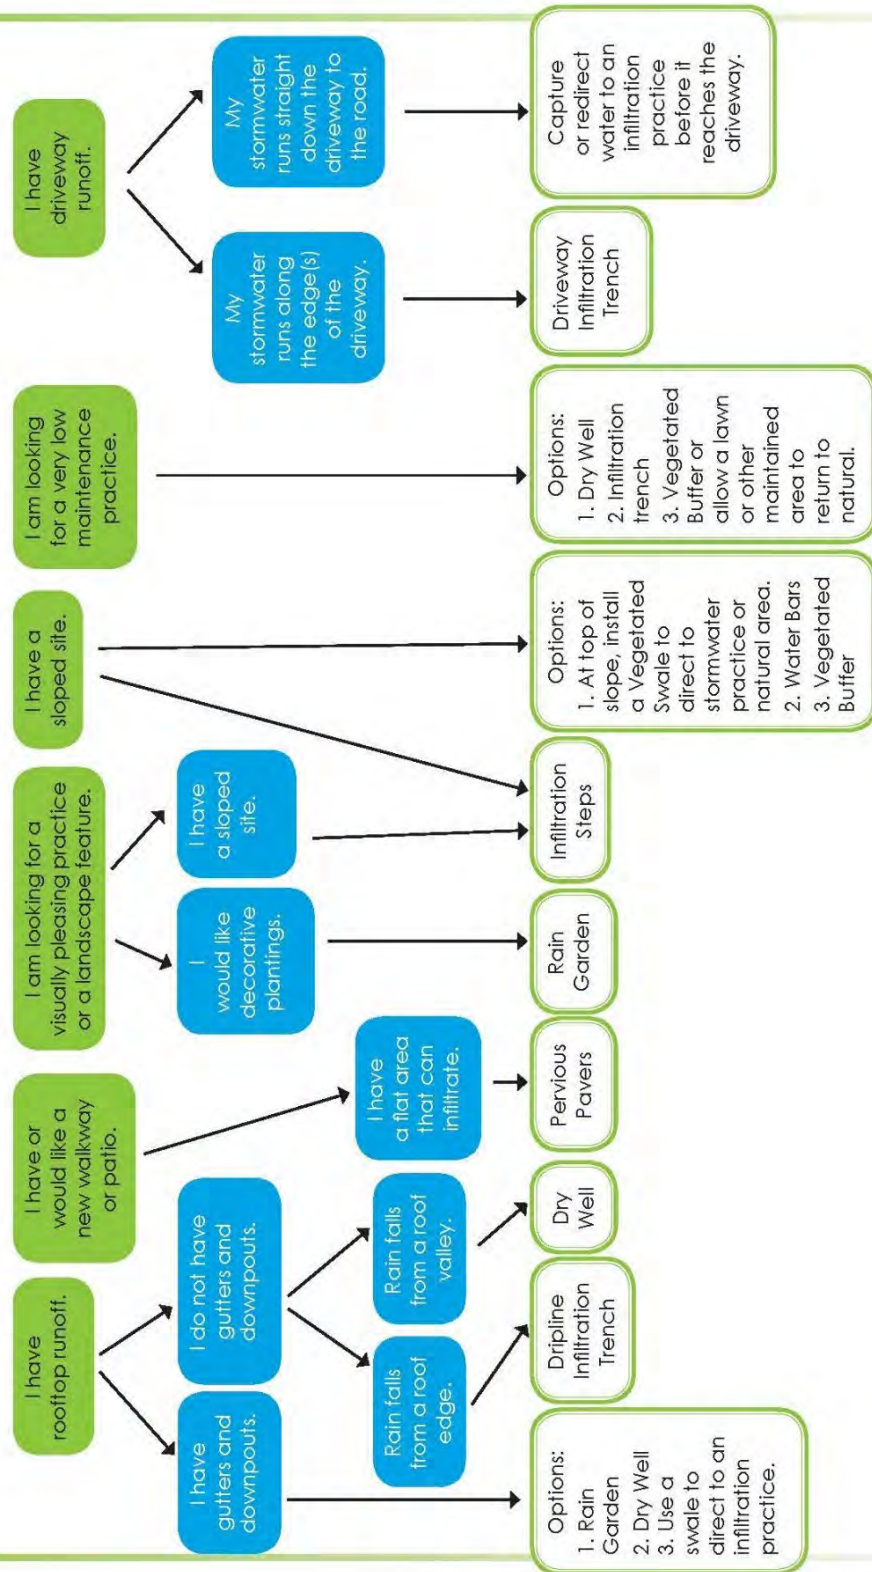
Stormwater Practice Selection Flow Chart for INFILTRATION PRACTICES

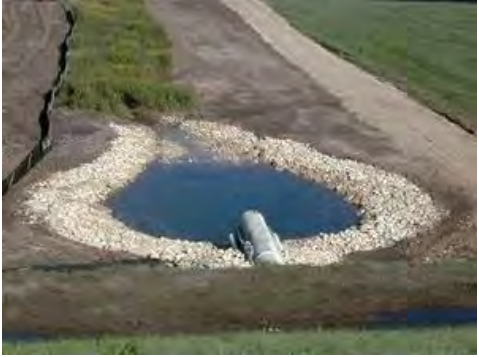
<p>Install Plunge Pool</p>	<p>Plunge pools are installed where there is a need to dissipate the flow of high velocity water exiting a culvert in order to prevent channel erosion at the culvert outlet. They are typically armored with stone. Plunge pools should NOT be installed in a stream channel without first obtaining a permit.</p>

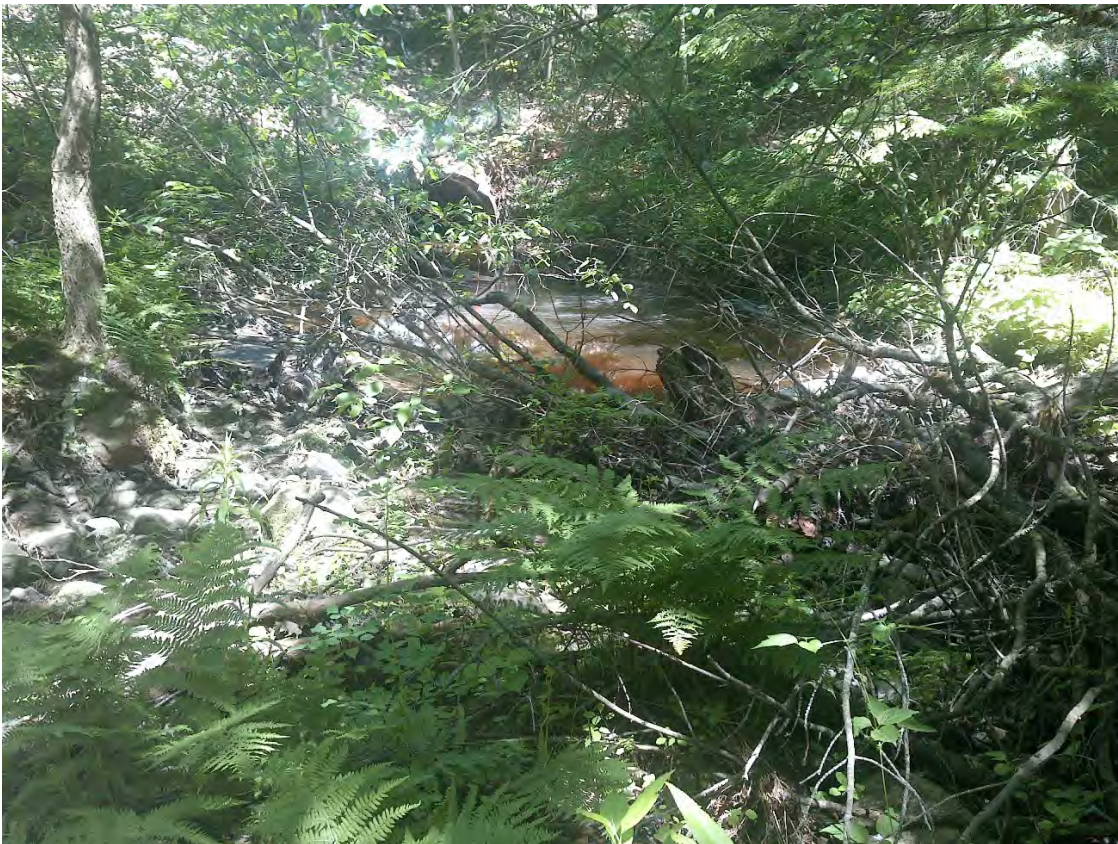
Description: A large and very effective debris dam below the culvert diverts high flows to a newly formed and unstable side channel is causing significant bank erosion and likely discharge of sediment downstream.

Site 1. View of debris dam looking upstream

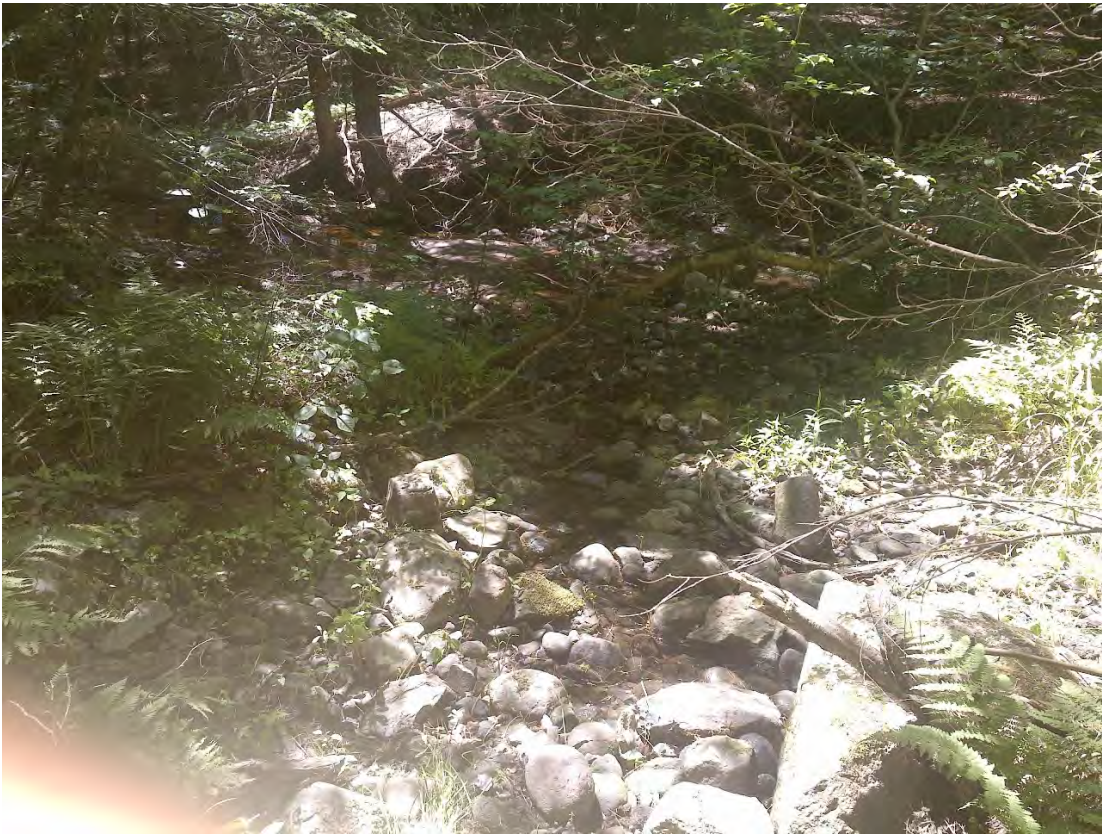
Site 1. Side channel looking upstream

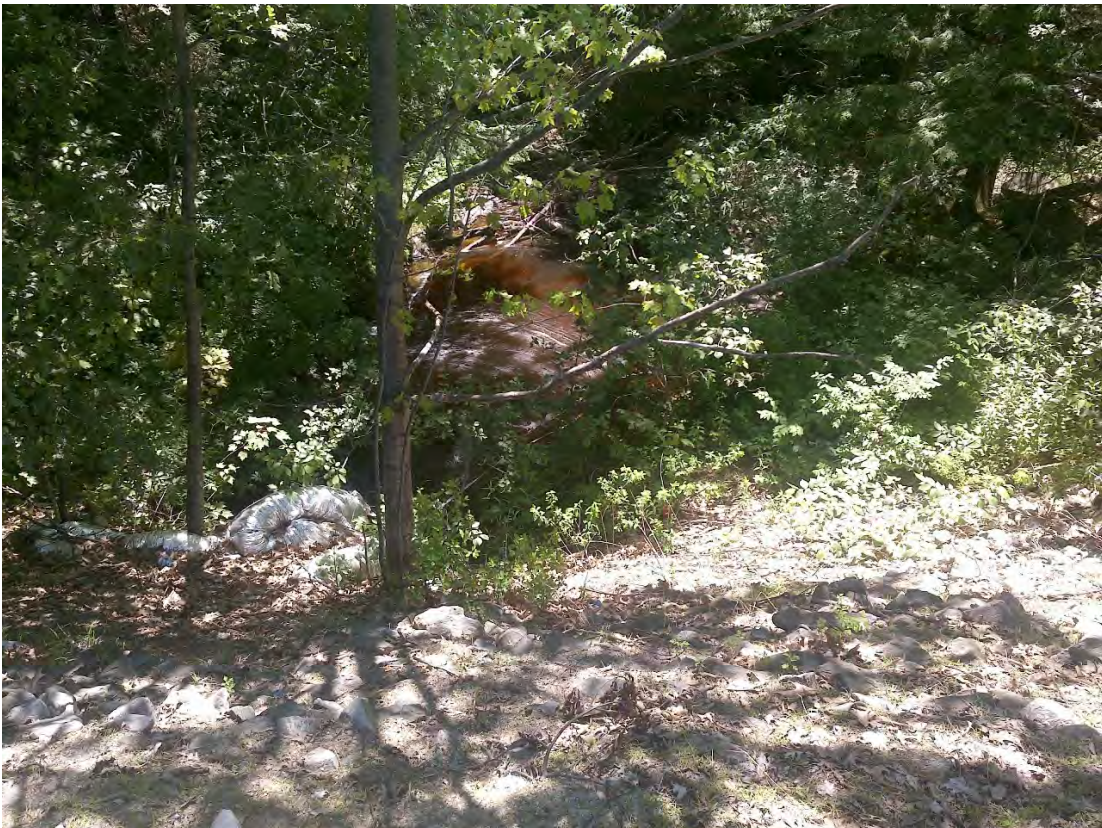
Site 1. View downstream from Albion Road. Side channel is to the right of the debris dam.

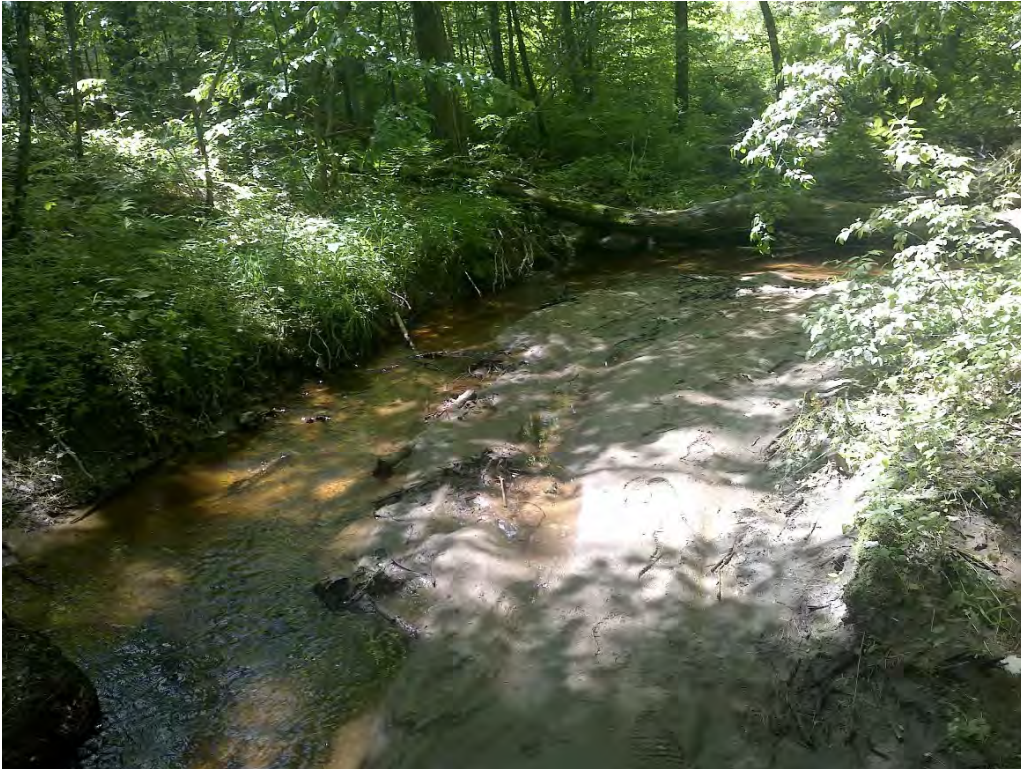
Site 2. Sediment deposition in over-widened channel looking downstream.

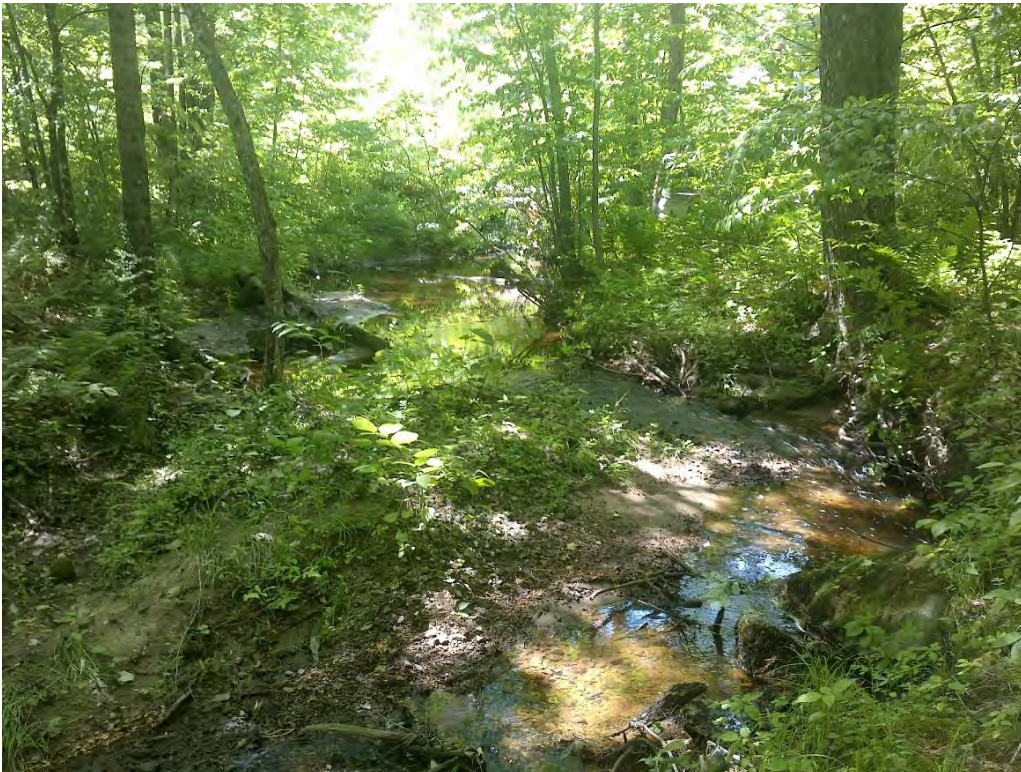
Site 2. Looking upstream to culvert.

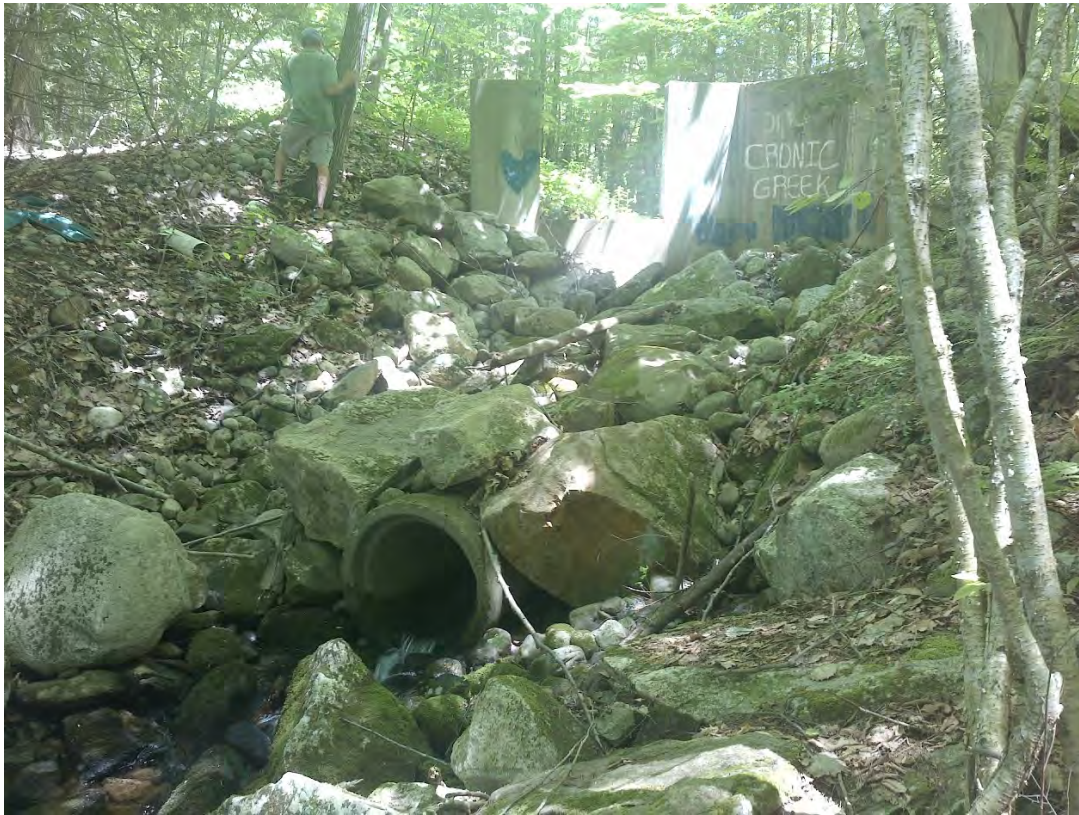
Site 3. View of detention basin dam and culvert outlet looking upstream from below the dam.

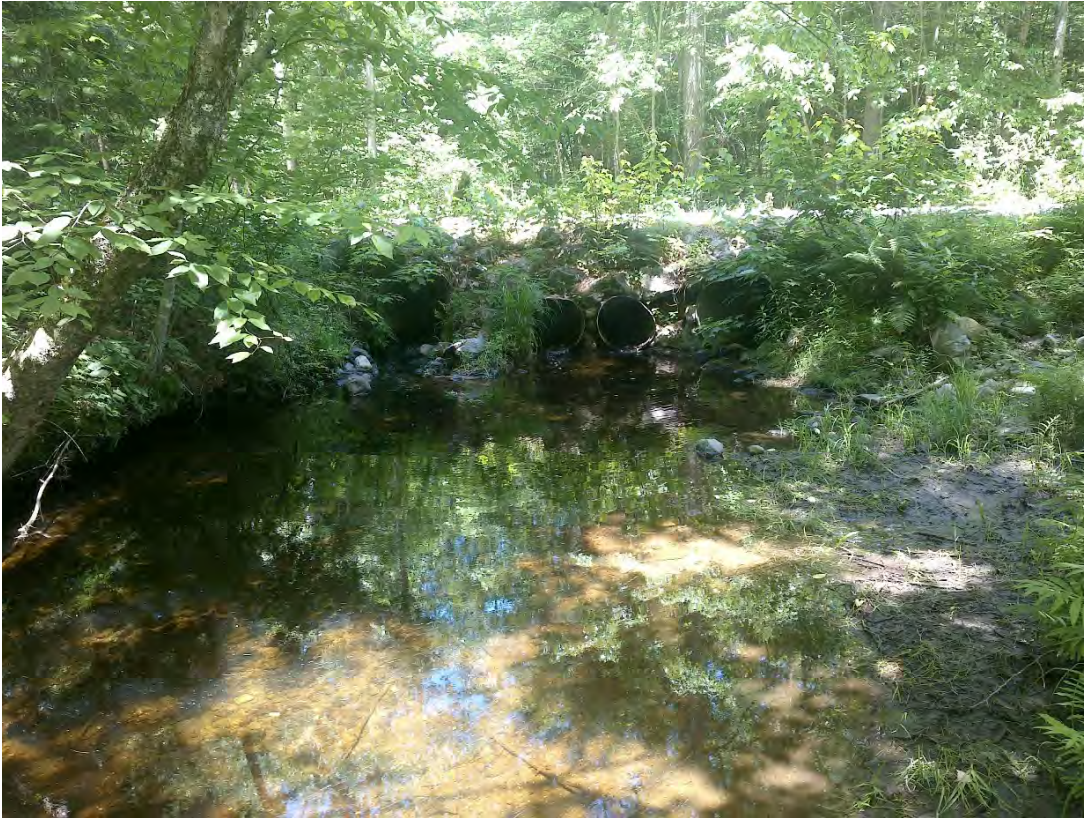
Site 4. Looking upstream at four culverts and over-widened somewhat unstable channel.
