Route 1 Falmouth Commercial District

Stormwater Management Plan

Town of Falmouth, ME

January 2013

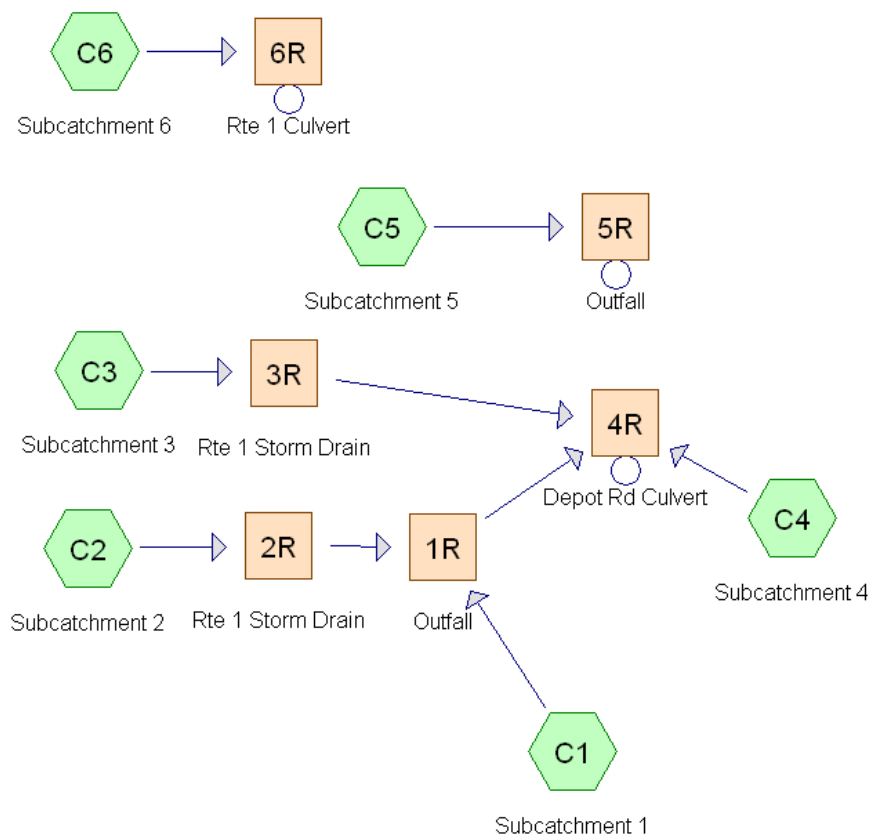
Figure 4-1: Webes Creek Subwatershed Drainage Diagram

Table 4-2 is a summary of the projected flow rates in each catchment, and the drainage system's available capacity. It should be noted that, in some cases, multiple catchments may impact a single piece of the Town's drainage infrastructure. Figure 4-1 shows a drainage diagram of the subwatershed.

We would recommend that the critical infrastructure areas 1, 3, and 4 be further evaluated and potentially improved as part of the Town's current/ongoing Route 1 Planning Study or as a part of future developments in Catchment C1, C2, and C3. Even though Catchment C6 was not identified as a potential site for future development, the improvement of the critical infrastructure in this area may still be beneficial to improve the existing condition.

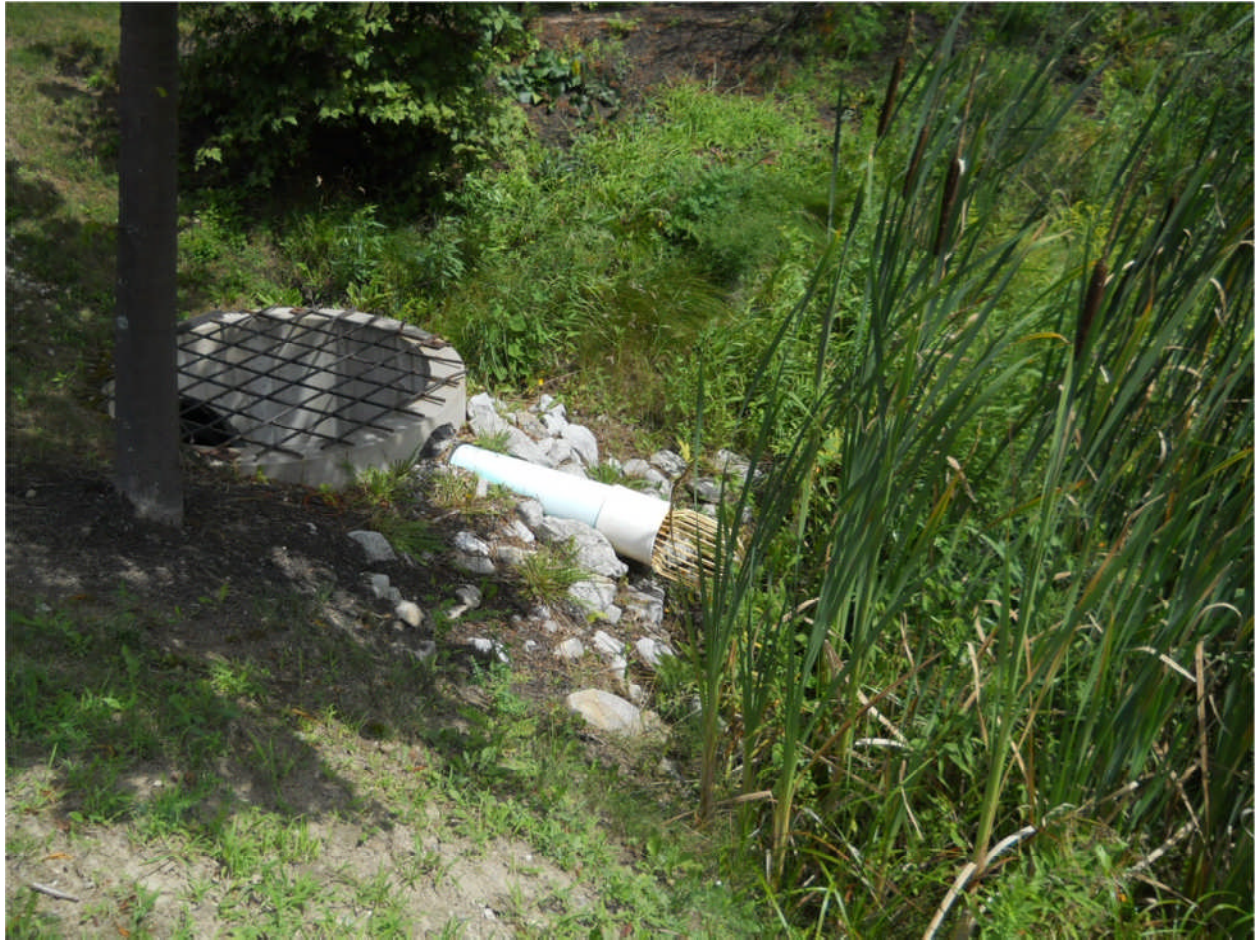
Fundy Circle (Dry Detention Basin 2) Parcel ID: U11-035C

The second of the two Dry Detention Basins located in series at Fundy Circle (as noted above) is located slightly north of the walking path between the two ponds. It accepts discharge from two outlets, one from Pond 1 and the other from a catch basin in a more northern part of the lot. The pond has an outlet control structure. The outlet of the pond consists of a catch basin with overflow pipe, a trash rack, and an emergency spillway. The low-flow inlet from the pond to the outlet structure could not be located in the field; it may be submerged and potentially clogged. Both inlets into the pond have much less sedimentation than Detention Basin 1, but still have excessive vegetation growth in front of the culvert. Just as in Pond 1, there was approximately 1-foot of sediment deposit, about 1.5-feet of standing water, and approximately 90% vegetated cover consisting largely of cattails. In addition to having an oily sheen, the water in this pond had evidence of suspended solids and algal blooms.

Based on the condition of the pond's water (which appeared slightly better than Detention Basin 1), its historic issue with sediment, and the excessive vegetation and standing water (which are not components of properly constructed Dry Detention Basin), this pond was evaluated as Fair.

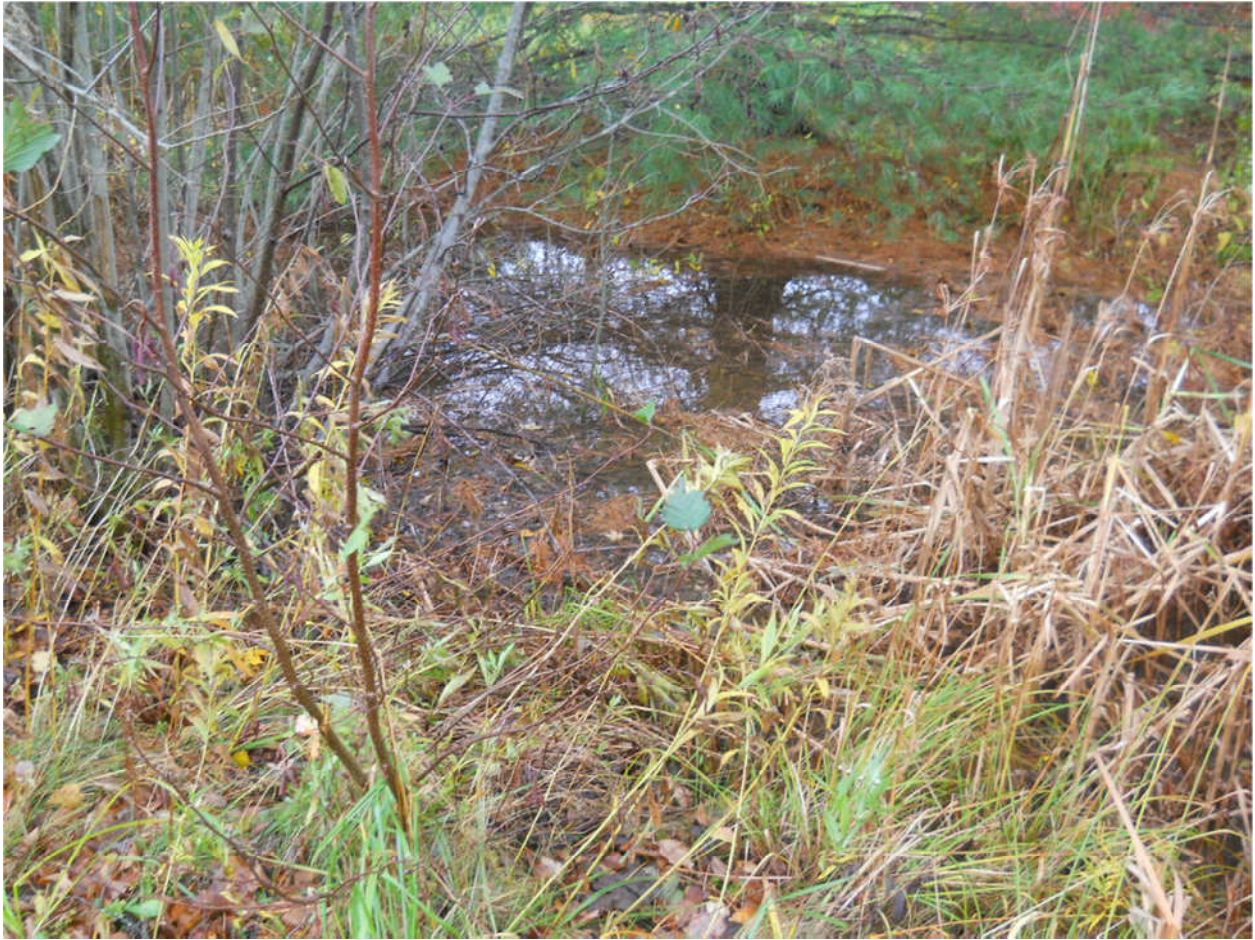
Fundy Road (Dry Detention Basin 3) Parcel ID: U11-035D

Based on the condition of the pond's water and embankments, and the presence of vegetation and standing water (which are not components of properly constructed Dry Detention Basin), this pond was evaluated as Good.

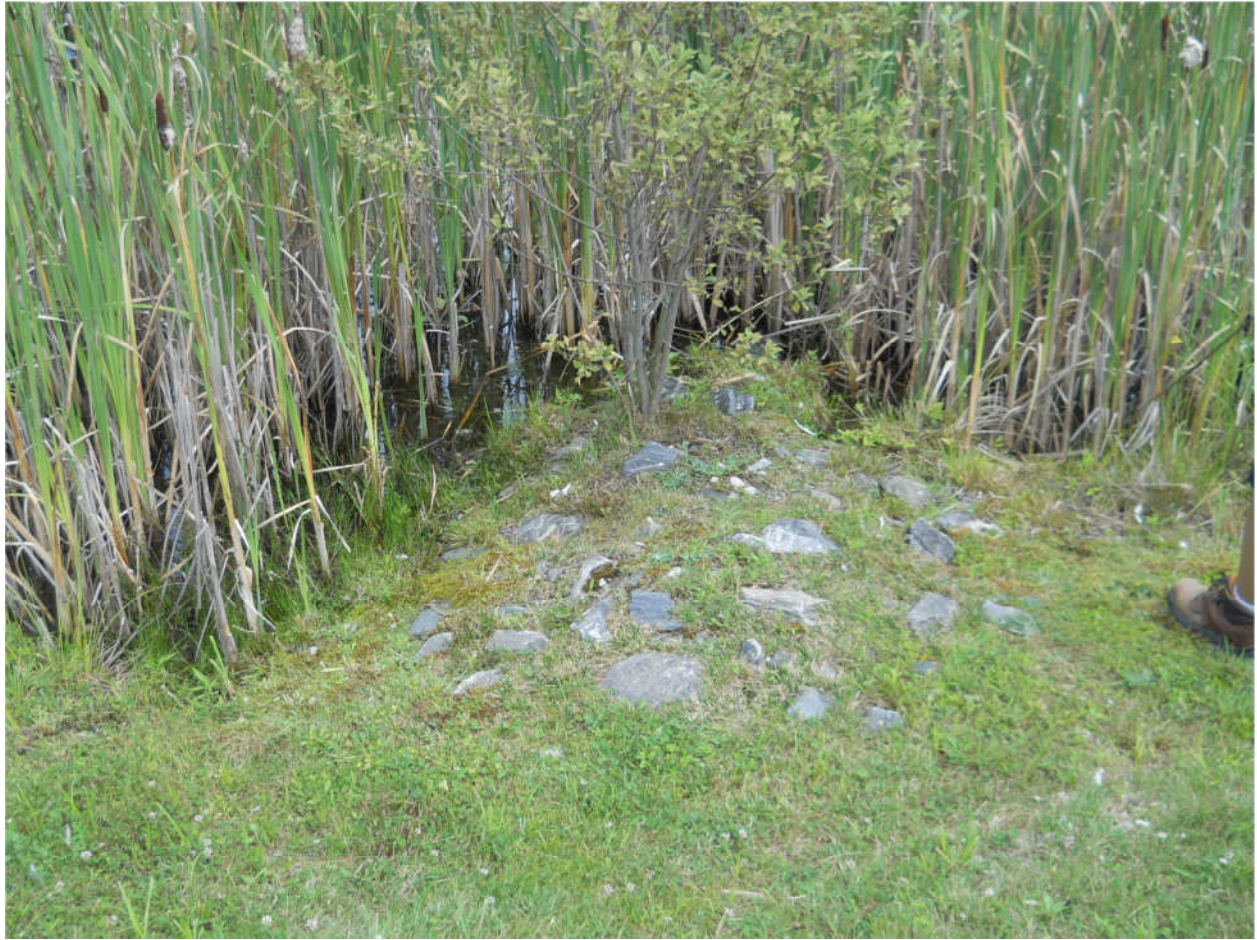
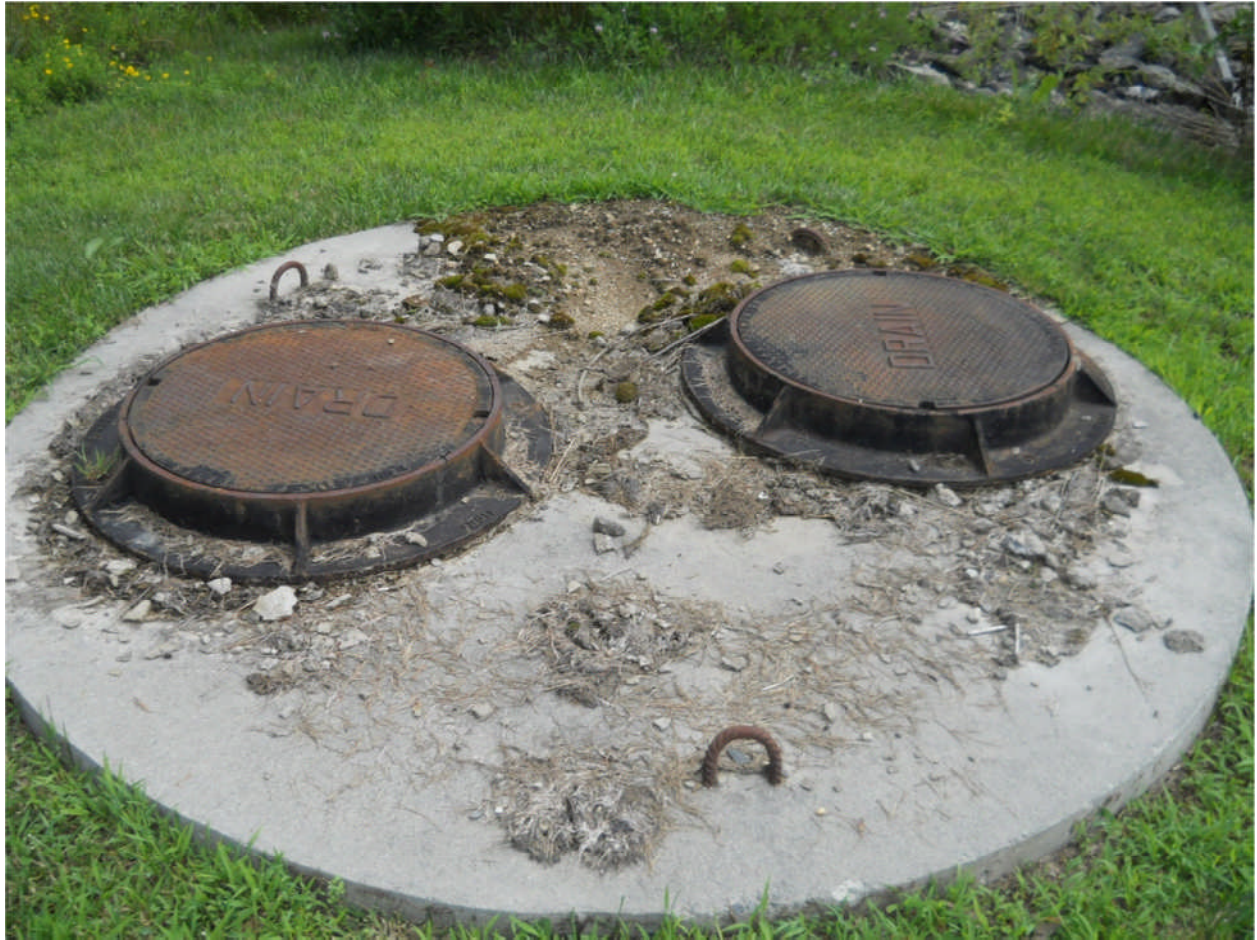
Morong Service Center (Dry Detention Basin) Parcel ID: U52-001B

Based on the condition of the pond's water, and the shape of the pond, the presence of vegetation and standing water (which are not components of properly constructed Dry Detention Basin), this pond was evaluated as Good.

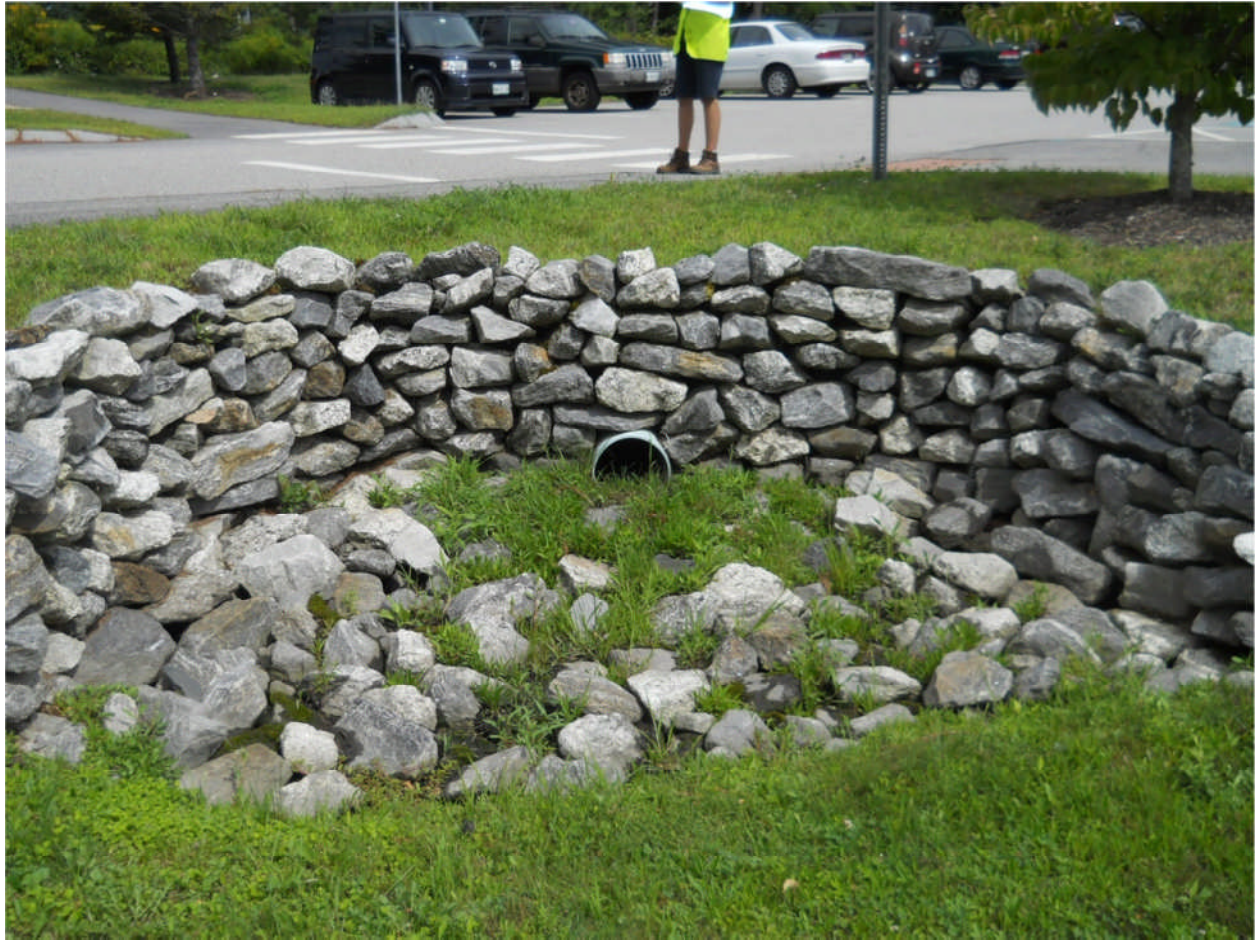
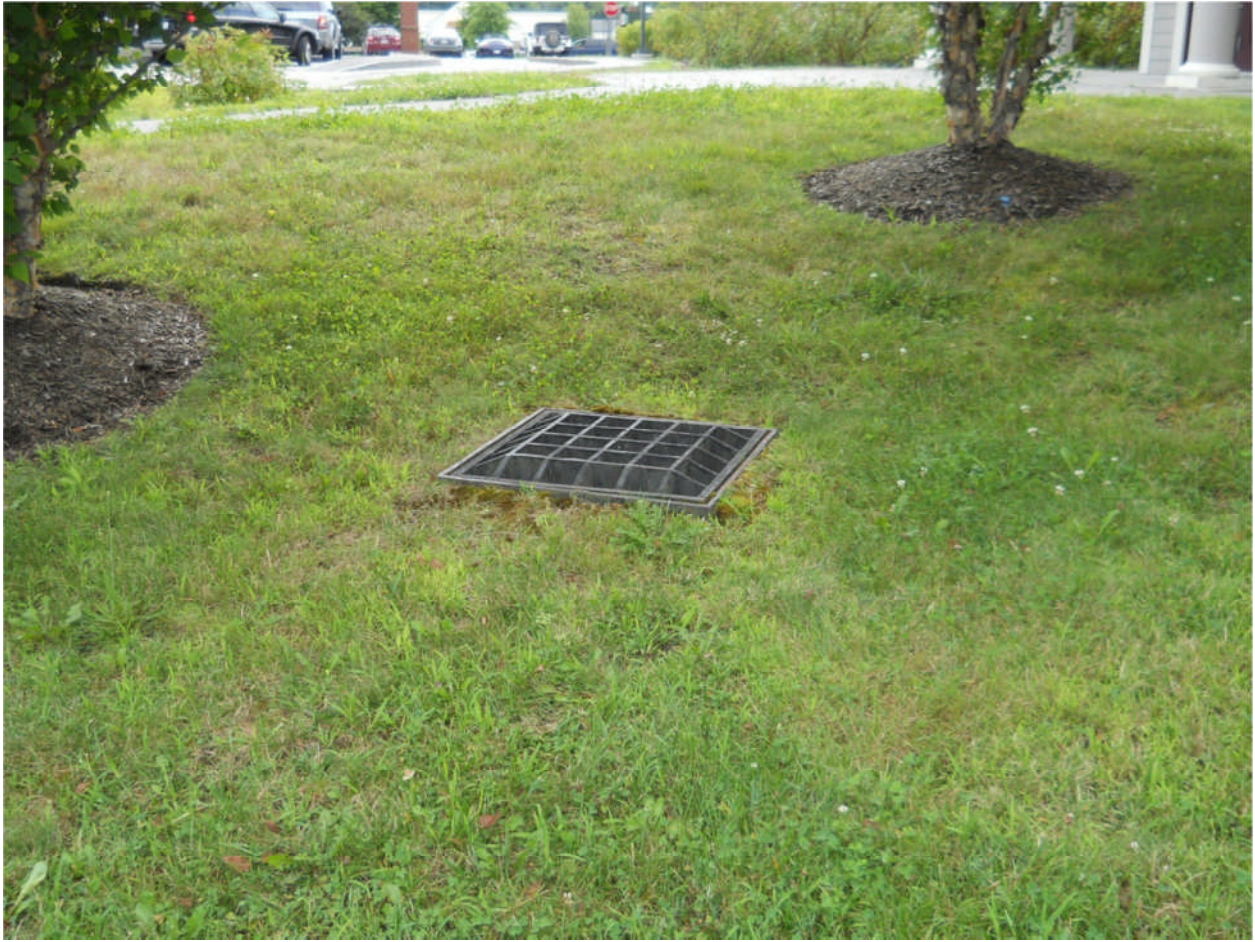
Key Bank (Soil Filter 1) Parcel ID: U58-006

The stormwater management facility at Key Bank is comprised of two Underdrained Soil Filters (USF). USF 1 is the smaller of the two and has one inlet and one outlet with an outlet control structure located in the southern end of the basin. There is very minor sedimentation at the inlet pipe. The outlet control structure which this soil filter discharges to was found to have two unknown connections; these connections could not be identified on the plans and should be investigated, as it is unclear as to whether the site plans are out-of-date, or if the systems have adequate capacity to accept these additional flows. There was also evidence of minor sediment deposition at the discharge point of the outlet structure.

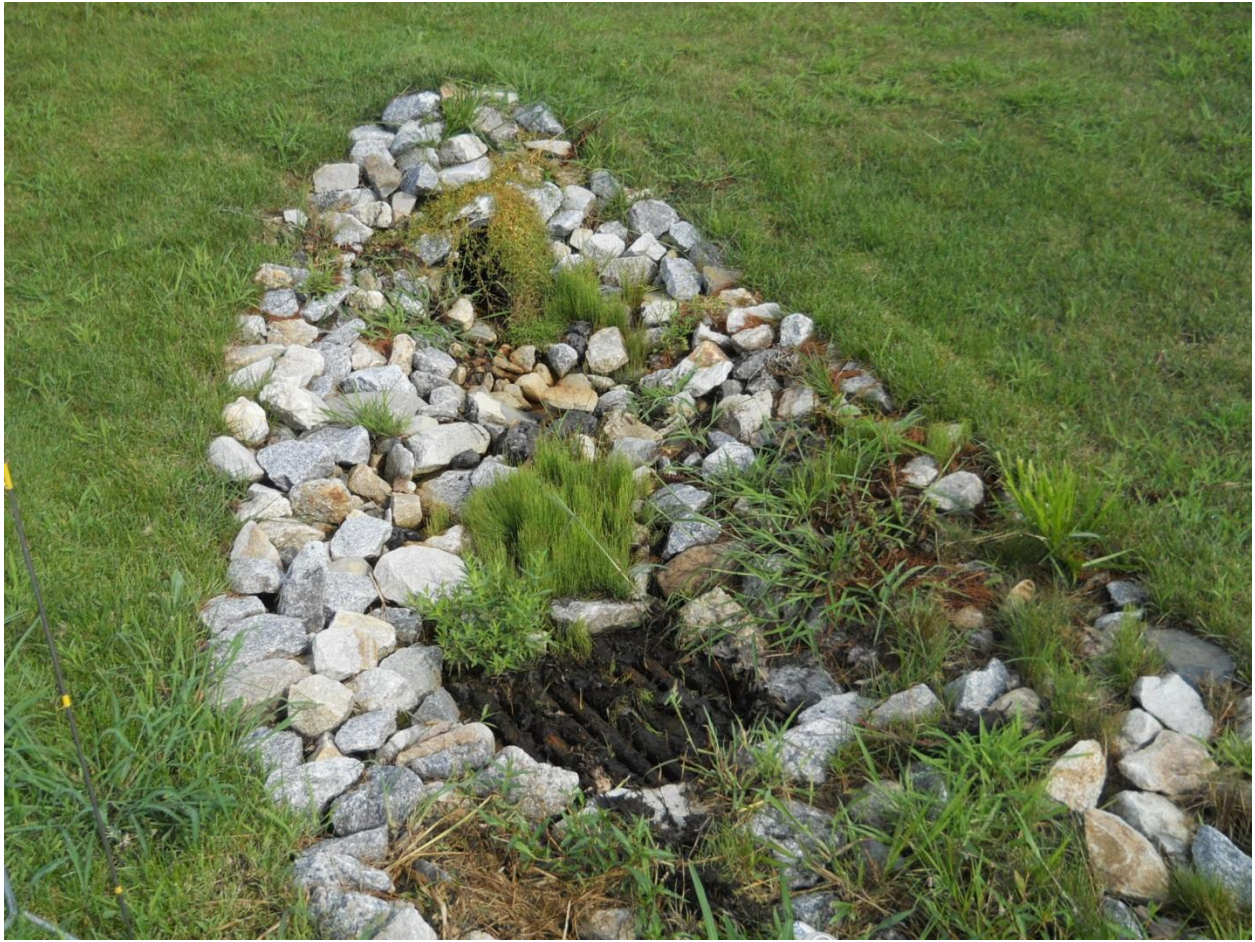
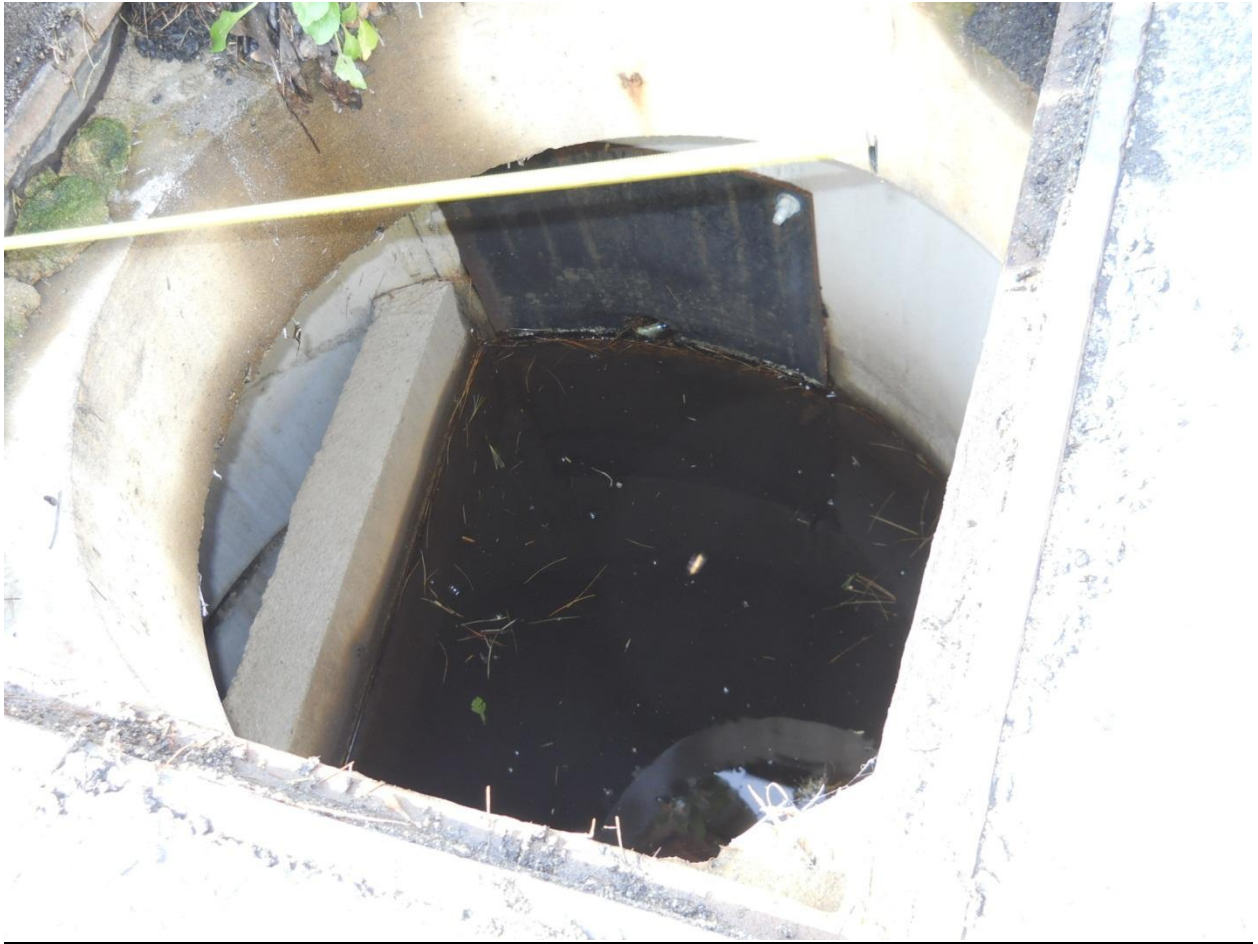
Norway Savings Bank (Below-Grade Stormwater Management Facility) Parcel ID: U58-010-A1

As previously noted, due to access limitations, the below-grade stormwater management facilities located at the Shops at Falmouth Village and Norway Savings Bank were not evaluated. It is assumed that both systems provide at least peak flow attenuation and perhaps other stormwater management benefits.
