APPENDIX B: PRIVATE STORMWATER MANAGEMENT FACILITY INSPECTION FORMS & PHOTOGRAPHS

Stormwater Treatment: Assessment and Maintenance

Field Data Sheet for Level 1 Assessment: Visual Inspection Dry Ponds

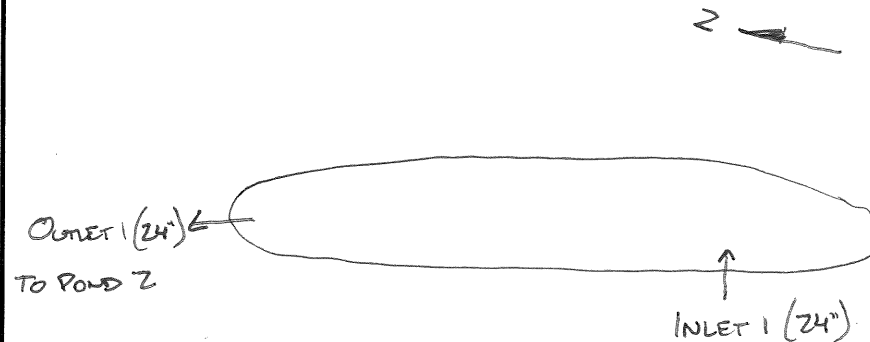
Site Sketch (include inlets, outlets, north arrow, etc.)

Water in parking lot CB leading to Pond 1 had oily sheen

Major cattail growth within pond

About 1' of deposited sediment in pond

Inlet to Pond 1 almost completely plugged with sediment and plant growth
