# Mackworth Island

Conceptual Utilization  
Master Plan

Final Report

January 27, 2023

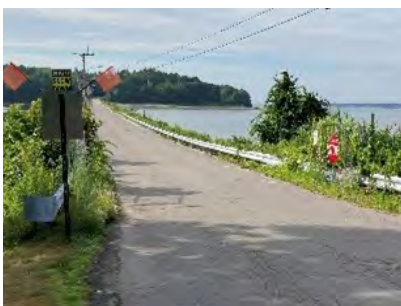
CAUSEWAY

The causeway, a stone armored filled construction, has immediate, short-term and long-term improvement needs. It is low and overtopped by wave action during significant storm events. It is reported that the low portions of the causeway are overtopped by seawater more than once per year. Each overtopping event undermines the integrity of the causeway by pulling fine material from the composition and leaving gaps which accelerates settling. Immediate concerns include utility pole damage, and transverse steel beam play at one of the bridge support locations. Short-term needs include repair and stabilization of the two locations where the marine mattresses have failed, and settlement of the causeway has occurred. Long-term needs include reducing vulnerability from sea level rise and storm surge. This may be achieved by rebuilding the causeway at a higher elevation, partial replacement of the causeway, or complete replacement with a bridge. Recommended modifications include raising the causeway between 6 feet and 10 feet above its current road height to meet the Maine Climate Council's (MCC) 'Commit to Manage' (C2M) and/or the more conservative 'Prepare to Manage' (P2M) design criteria. Depending on the forecast, the causeway and bridge will be underwater throughout the year within 27 or 47 years.

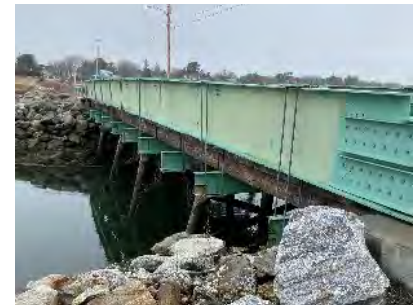
BRIDGE

The bridge, overseen by Maine Department of Transportation (MDOT), was rehabilitated in 2011 by adding structural steel above and below the existing timber structure. It is posted with a weight limit of 22 tons. Aside from creating limitations of island access by large, heavy vehicles, the bridge is in good working condition. GEI recommends an investigation to determine whether it is cost-effective in the short-term to increase the load capacity of the bridge to fully accommodate construction traffic associated with campus improvements. In the long term, a new raised bridge will be needed to accommodate sea level rise (see MCC projections above).

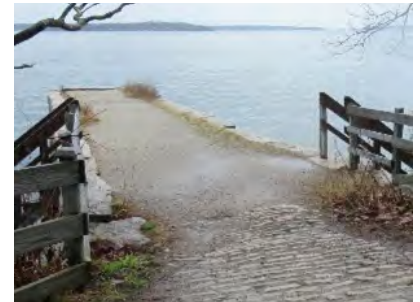
STONE PIER

The Stone Pier, a historic component of the original Baxter property, is in relatively good condition but lacks deep-water access. An extension to deep-water is needed to provide an effective boat landing and might be accommodated with the addition of a ramp and float for seasonal

access and/or a fixed pier for year-round access. Such alterations are not recommended since no specific need was identified to support it. No use beyond pedestrian recreation has been presented as a viable use for the pier in its current condition during the Master Planning process.

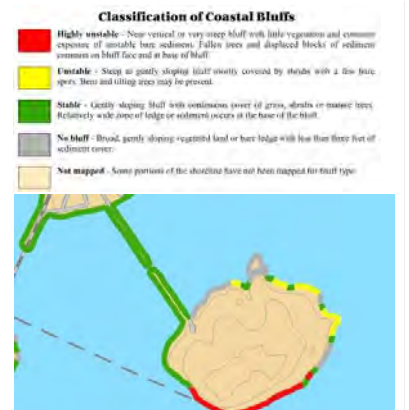
COASTAL BLUFFS CONDITION

A review of the coastal embankments identified a history of embankment armoring at several areas of active erosion that should be monitored. Imported rip rap armoring supplements areas of natural armoring such as ledge. The most cost-effective long-term resiliency response will be to introduce a program of regrading, replanting and relocating trails and overlooks to increase the setback to the top of bank.

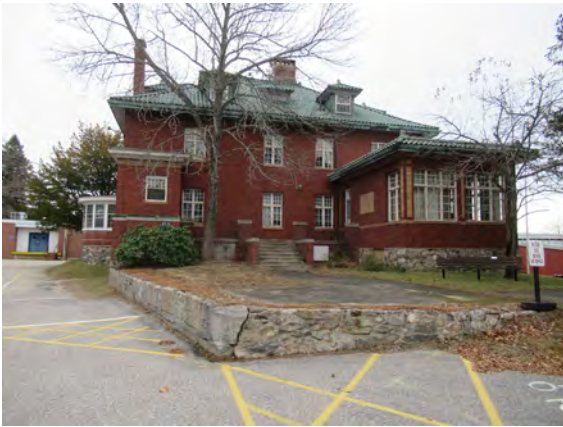
**MANSION: BUILDING A**

Year Constructed **1917**  
 Use **Office**  
 Building GSF **7,988 GSF**  
 Number of Floors **2 + Attic & Basement**  
 Construction type **Masonry & Wood (Porch floor is Concrete & Steel)**  
 Average rating (scale of 0-5) **3.5**  
 Overall Condition Rating **Good**

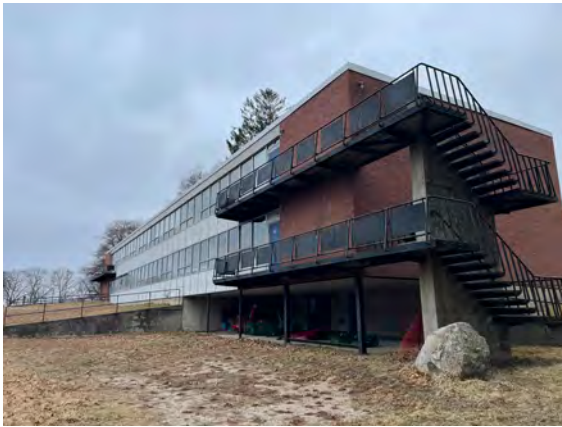
### YOUNG HALL: BUILDING B

Year Constructed **1959**  
 Use **Dormitory**  
 Building GSF **15,580 GSF**  
 Number of Floors **2 + Partial Utility Basement**  
 Construction type **Masonry & Steel**  
 Average rating (scale of 0-5) **1.2**  
 Overall Condition Rating **Very Poor (Remove)**

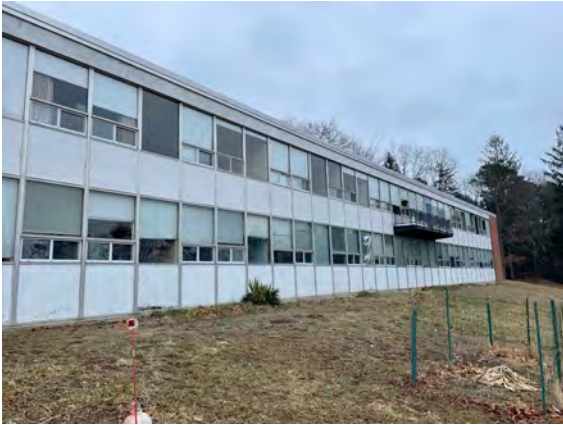
**TAYLOR HALL: BUILDING C**

Year Constructed	1958
Use	Office & Dormitory
Building GSF	13,460 GSF
Number of Floors	2
Construction type	Masonry & Steel
Average rating (scale of 0-5)	2.2
Overall Condition Rating	Fair

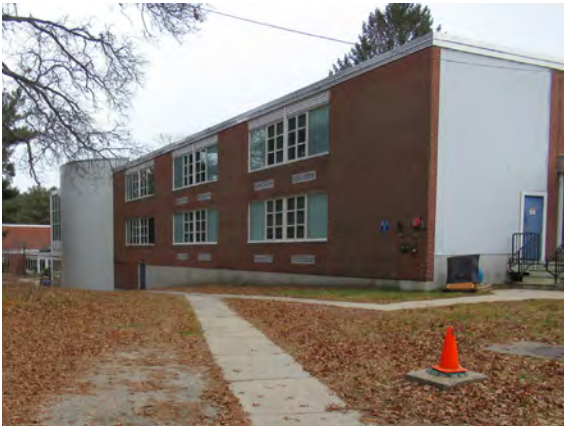
### GREENLAW: BUILDING D

Year Constructed **1959/ Renovated 1996**  
 Use **Classroom & Office**  
 Building GSF **21,504 GSF**  
 Number of Floors **3**  
 Construction type **Masonry & Steel**  
 Average rating (scale of 0-5) **3.4**  
 Overall Condition Rating **Good**

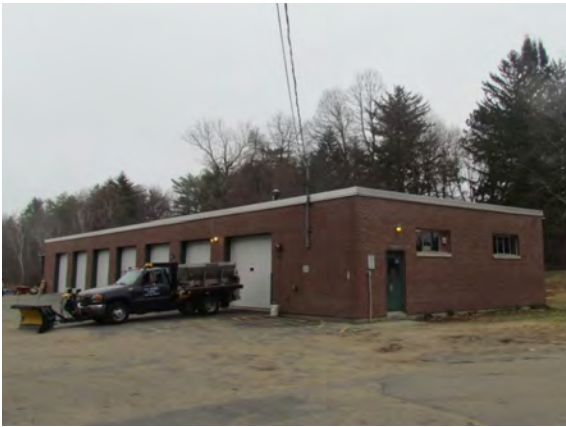
**INMAN GARAGE: BUILDING E**

Year Constructed **1961**  
 Use **Maintenance Garage**  
 Building GSF **4,800 GSF**  
 Number of Floors **1**  
 Construction type **Masonry & Steel**  
 Average rating (scale of 0-5) **2.1**  
 Overall Condition Rating **Fair**

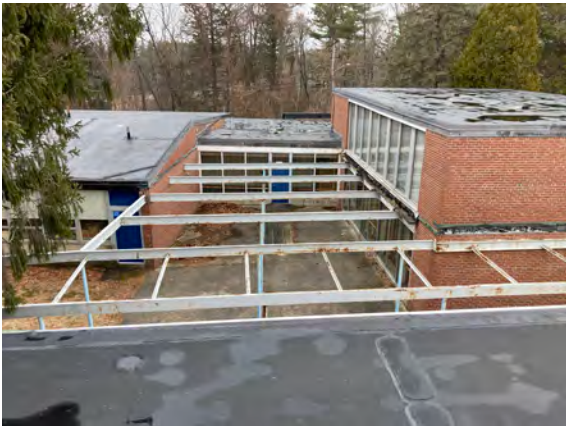
### CARTER: BUILDING G

Year Constructed **1957**  
 Use **Classroom, office, and Gym**  
 Building GSF **17,600 GSF**  
 Number of Floors **1**  
 Construction type **Masonry & Steel**  
 Average rating (scale of 0-5) **1.84**  
 Overall Condition Rating **Poor**

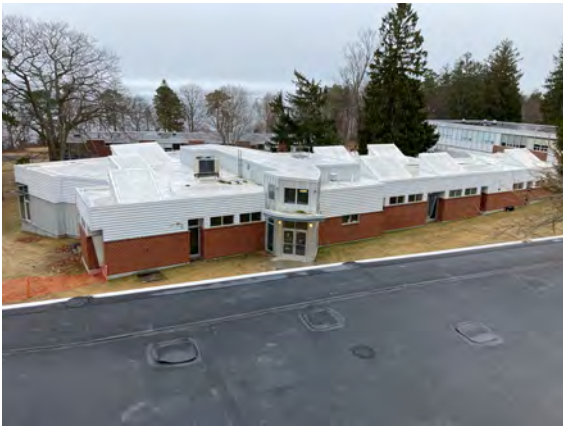
### BREWSTER: BUILDING H

Year Constructed **2004**  
 Use **Classroom, Library, Office**  
 Building GSF **9,000 GSF**  
 Number of Floors **1**  
 Construction type **Steel Frame**  
 Average rating (scale of 0-5) **3.9**  
 Overall Condition Rating **Very Good**

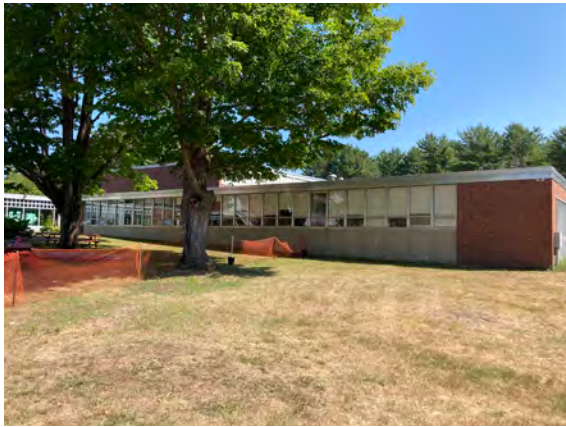
### **PATRICK HALL: BUILDING I**

Year Constructed **1958**  
 Use **Classroom & Office**  
 Building GSF **1,900 GSF**  
 Number of Floors **1**  
 Construction type **Masonry & Wood**  
 Average rating (scale of 0-5) **2.69**  
 Overall Condition Rating **Fair**

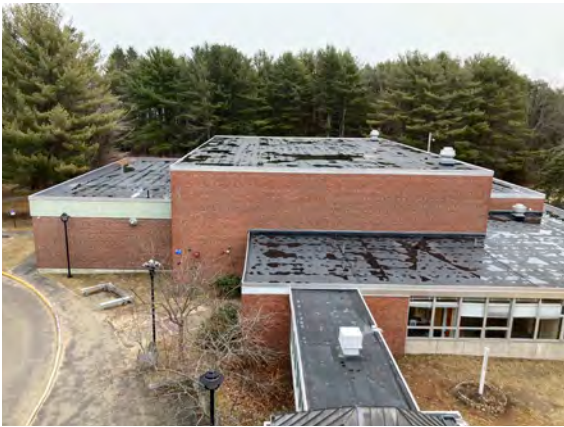
### DRAPER HALL: BUILDING J

Year Constructed **1958**  
 Use **Office & Gym/Assembly**  
 Building GSF **12.370 GSF**  
 Number of Floors **1**  
 Construction type **Masonry & Wood**  
 Average rating (scale of 0-5) **2.4**  
 Overall Condition Rating **Fair**

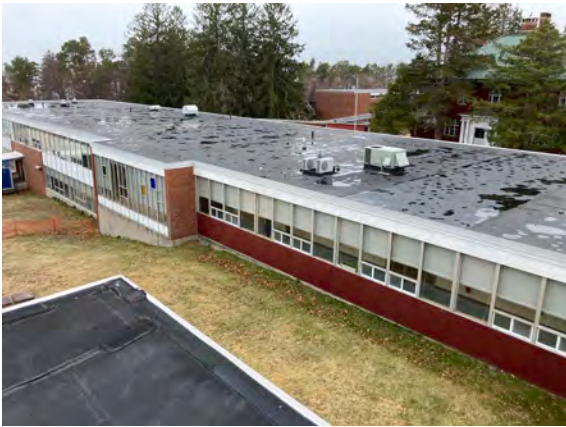
### SANDERS HALL: BUILDING K

Year Constructed 1959  
 Use Kitchen, Dining, Museum  
 Building GSF 34,800 GSF  
 Number of Floors 2  
 Construction type Masonry & Steel  
 Average rating (scale of 0-5) 2.31  
 Overall Condition Rating Fair

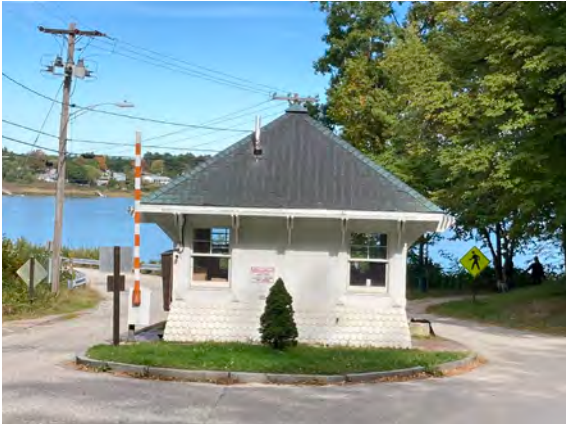
### GATEHOUSE

Year Constructed **1973**  
 Use **Office**  
 Building GSF **160 GSF**  
 Number of Floors **1**  
 Construction type **Masonry & Wood**  
 Average rating (scale of 0-5) **2.1**  
 Overall Condition Rating **Good**

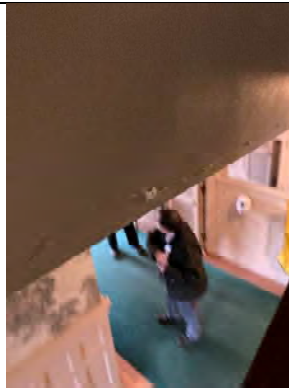
*Plaster damage.*

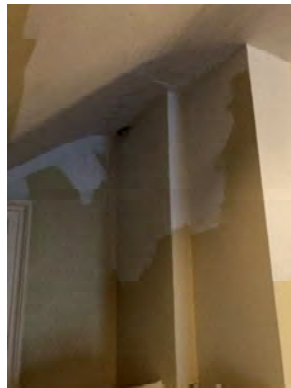
*Water damage at Chimney.*

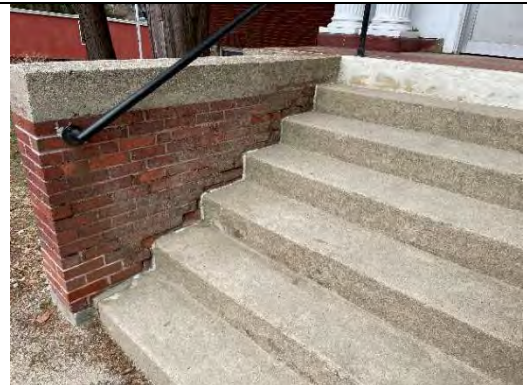
The existing façade is comprised of load bearing masonry walls with mortared fieldstone foundation and brick walls. Window openings are supported by painted steel lintels and sills are made of shaped stone. Moderate pointing is needed throughout the building. Higher levels of mortar deterioration were observed around the side entrance (near door A2). Recent pointing does not appear to be in keeping with the original masonry construction and should be redone, if possible, to match the original building elements.

*Mortar deterioration near door A2*

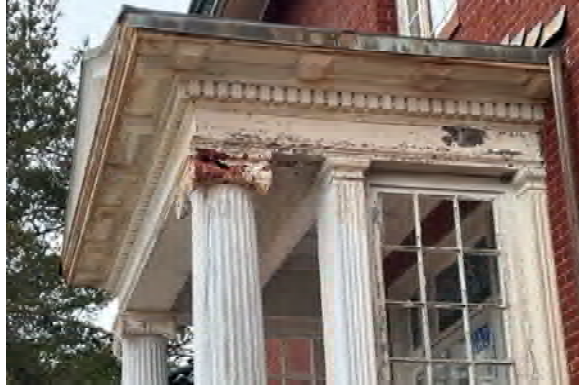
Exterior trim and detail elements are painted wood with copper flashing at roof edges. Significant signs of rot were observed. Due to the historic significance of the building replication of rotted elements is recommended. All exterior wood trim and detail surfaces need painting. Existing paint should be tested for lead prior to scraping and prep.

*Wood deterioration near door A2*

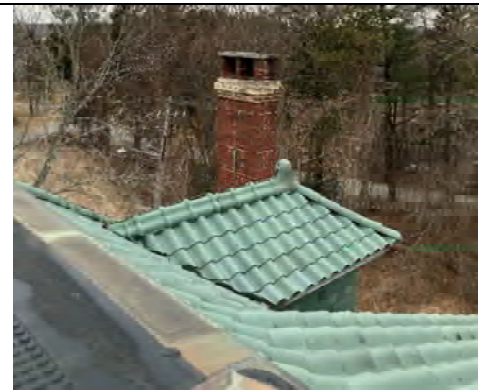
*Roof tile & EPDM.*

The roof was not easily visible from the access skylight. Photography through the skylight revealed areas of EPDM roofing in addition to the clay tiles that cover most of the sloped roof areas.

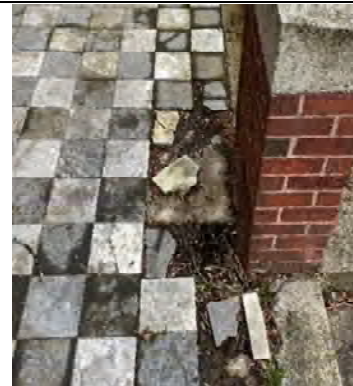
*Hardscape deterioration at exterior patio*

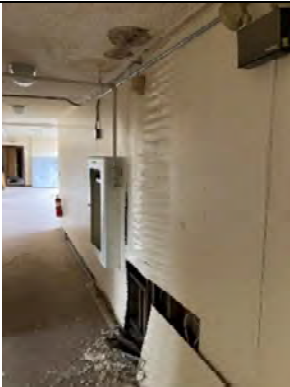
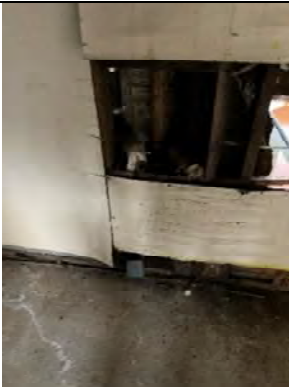
<b>Interior Systems</b>	
<p>Overall interior is in poor condition. Roof has caused major water damage throughout building. Many areas of interior finish have been stripped and most remaining interior finishes are beyond repair. The building has a posted sign declaring the interior spaces will expose occupants to asbestos containing building materials (ACBM).</p>

<p>Water damage.</p>	<p>Water damage.</p>

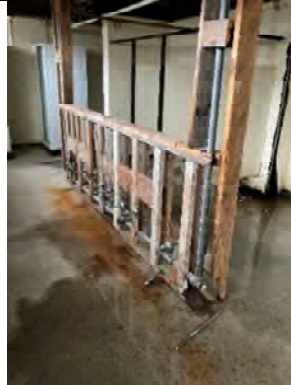
*Standing water.*

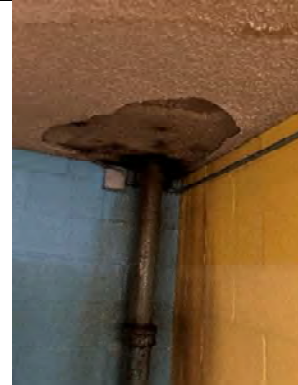
*Roof leak.*

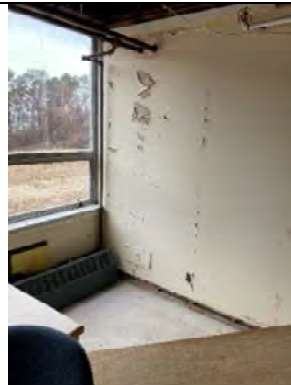
*Deterioration at existing partition wall.*

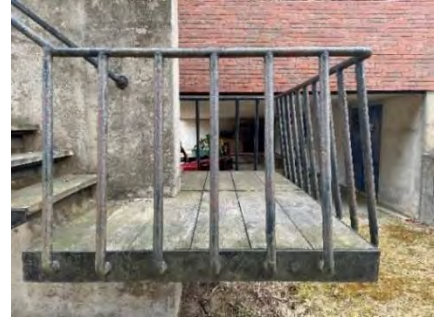
Steel egress stairs and balconies are in in dangerous condition.

*Exterior stair detail*

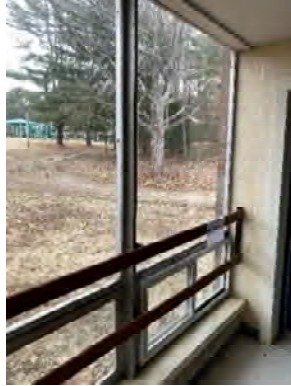
*Single pane aluminum windows.*

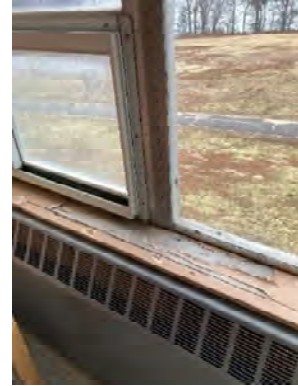
*Water damage.*

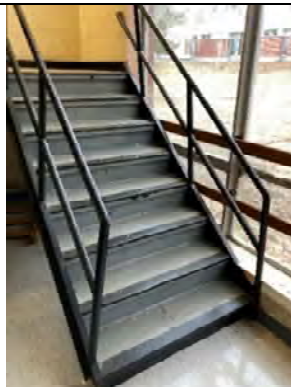
*Egress Stair with non-compliant railing system.*

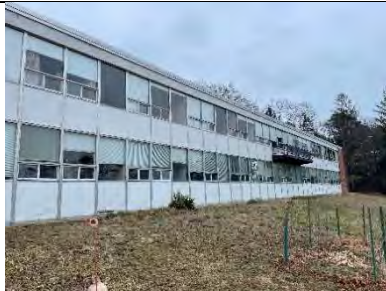
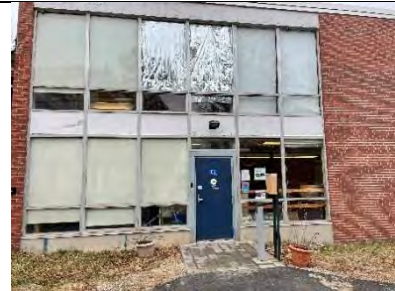
Existing brick veneer and cast in place concrete foundation are in good condition. Non thermal aluminum curtainwall is in poor condition and is comprised of single pane glass and transite panels. Transite panels are highly likely to contain asbestos.

*Existing Aluminum Curtainwall.*

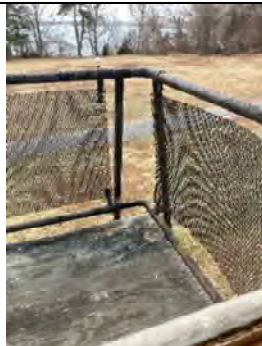
Steel egress and balconies are in dangerous condition.

*Steel and Plywood Balcony.*

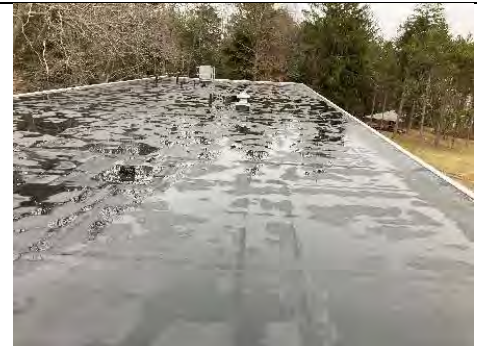
EPDM roofing and aluminum roof edge flashing are in good condition.

*EPDM Roofing.*

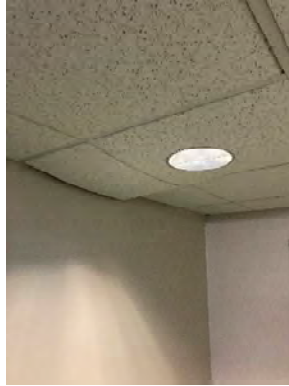
*Sagging Ceiling.*

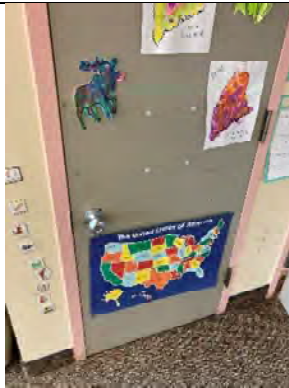
*Knob-style door hardware.*

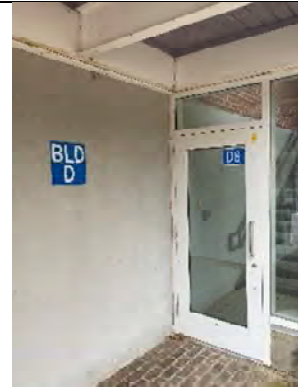
Steel members at overhangs need repainting .

*Steel overhang.*

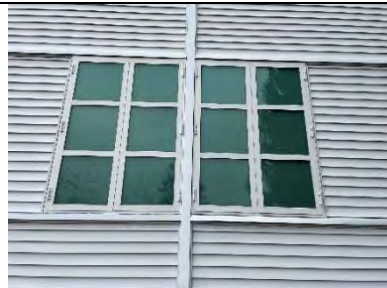
Exterior of building is in very good condition overall. Some metal siding has been damaged along with Minor brick repairs throughout.

*Metal siding / windows*

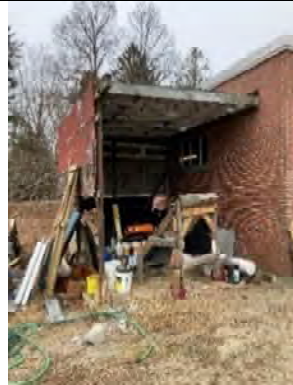
Lean to structure is in poor condition and should be replaced.

*Lean-to structure.*

<p><i>Overhead door typ.</i></p>	
<b>Recommendations Summary</b>	
<ul style="list-style-type: none"> <li>• Replace lean-to structure.</li> <li>• Replace steel single paned window.</li> </ul>	
<b>Building G: Carter</b>	
<b>Introduction</b>	
<p>The original building was constructed in 1957 by Stevens and Saunders Architects of Portland, Maine. It is 1 story with a total area of 17,60 GSF. The building is part of the original school campus planning and construction initiative and is designed in the modern style. The building is vacant, and the architectural condition is poor to fair in most assessment categories. See accompanying Building Condition Summary Table for additional information.</p>	
<b>Interior Systems</b>	
<p>Interior walls and base are in good condition throughout. Ceilings vary in conditions from good to fair. Sills show some water damage at windows and exterior doors.</p> <p>Door approached typically do not have adequate clearance for ADA compliance. Knob hardware is located throughout.</p> <p>Toilets are lacking grab bars throughout.</p>

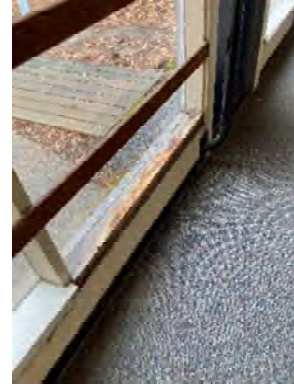
*Water damage at sill.*

- Repair water damage at sills.
- Upgrade all door hardware to lever type.
- Install Handrails in restroom.
- Address non-ADA compliant approach to doors.
- Replace curtain walls and windows.
- Repair overhangs.

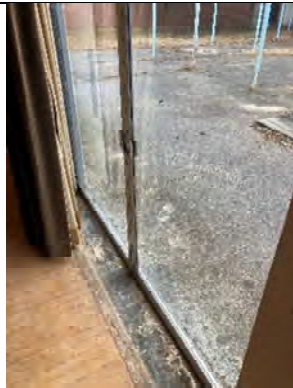
*Moisture penetration at exterior doors.*

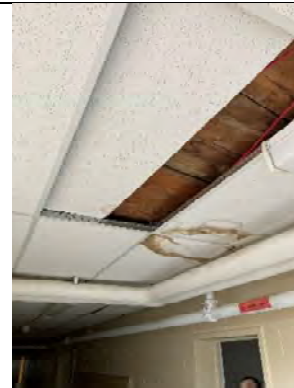
*Damaged ACT*

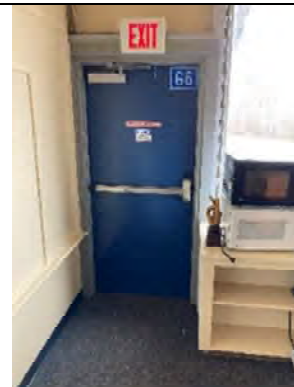
*Non-ADA compliant approach at exterior door.*

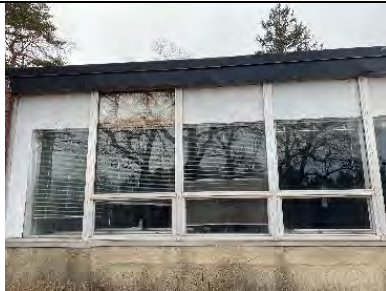
Cast in place foundation and brick veneer exterior walls are in good condition. Aluminum non-thermal windows and curtain wall consist of single glass and transite panels are in poor condition.

*Aluminum windows.*

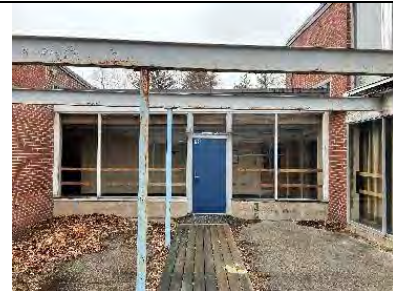
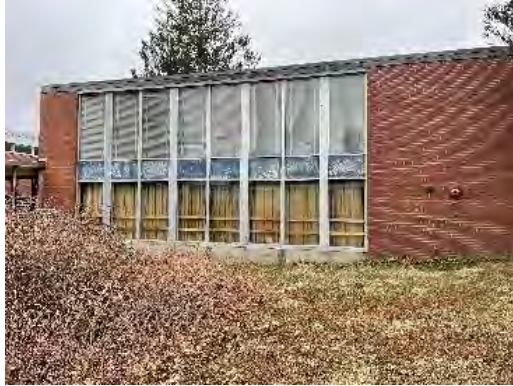
*Aluminum curtainwall.*

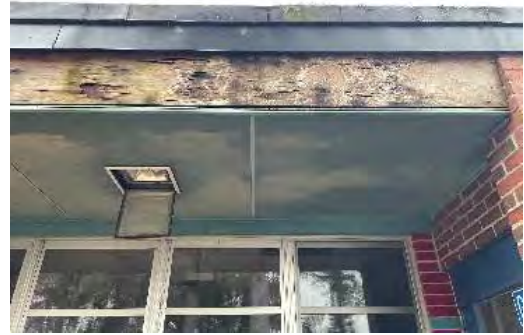
Aluminum composite panels failed and missing at overhangs.

*Overhang.*

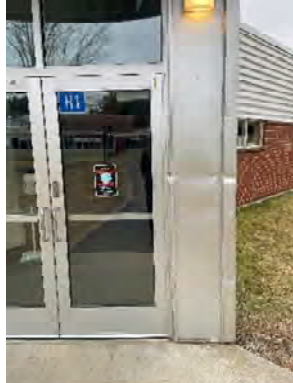
Overall building is in very good condition. Many Metal siding panels have been damaged in various locations.

*Damaged siding.*

- Replace damaged metal siding.

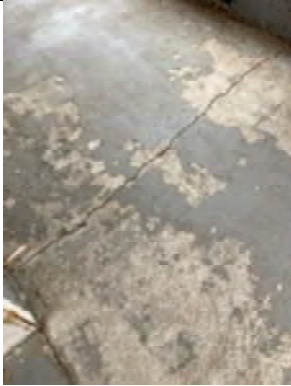
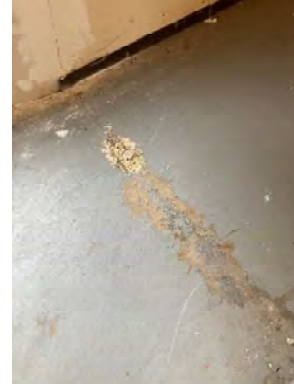
<i>Cracked floor slab</i>	<i>Interior</i>

*Cracked floor slab*

Connector finishes are in fair-to-poor condition. Floors are in poor condition and require repair. Building systems including hot water heating, domestic water, sprinkler piping, and electrical run through connector interiors.

- Replace connector or remove it completely. Building systems and utilities will need to be relocated and redistributed.

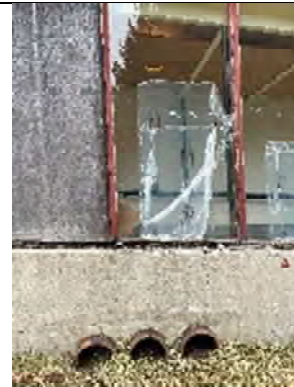
Grade: Site drains underneath through 3 pipes  
Foundations: Cast in place concrete  
Walls: T-1-11  
Windows: Site built wood frames with glass infill  
Doors: Hollow metal in metal frames.  
Canopies/Overhangs: Remove roof, retained steel frame  
Roof/Flashing: Aluminum roof edge flashing  
Connector needs to be replaced.

*Typical drain pipes at grade.*

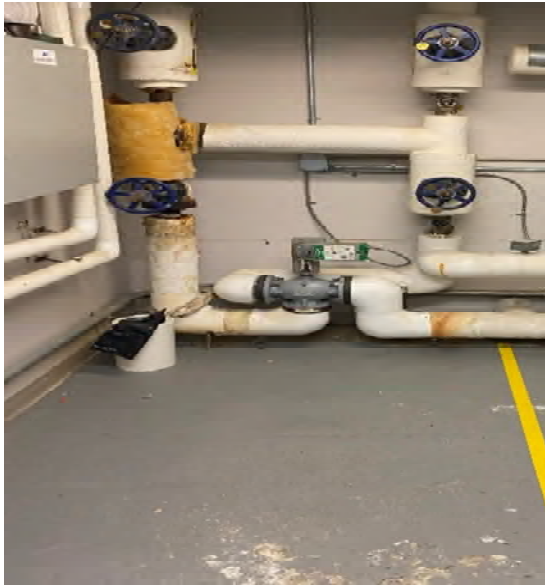
<p><i>Figure 2 - Booster Pump</i></p>	
<p>There is no central cooling system for the building.</p>	
<p>The condition of the mechanical systems are very good.</p>	
<b><i>Recommendations Summary</i></b>	
<ul style="list-style-type: none"><li>• <i>Consider replacing existing unit ventilators</i></li><li>• <i>Repair and replace intake and relief louvers at the ground floor.</i></li><li>• <i>Review cooling requirements with the Owner and evaluate options for a central cooling system.</i></li></ul>

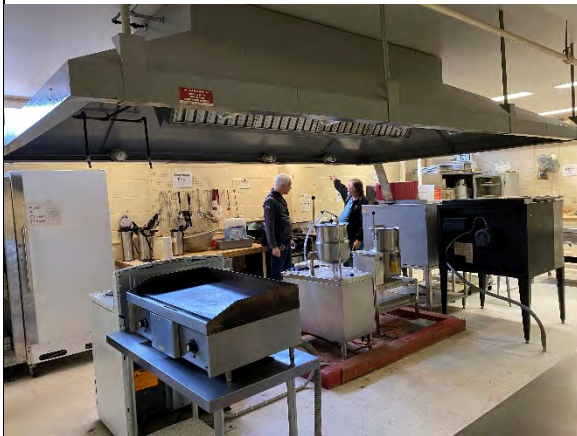
The building contains a commercial kitchen with an island type hood that is oversized for the amount of cooking equipment under it. The kitchen freezer and cooler condensing units are located in the basement in a mechanical room which can be exhausted when the space gets too warm.

*Figure 6 - Kitchen Hood*

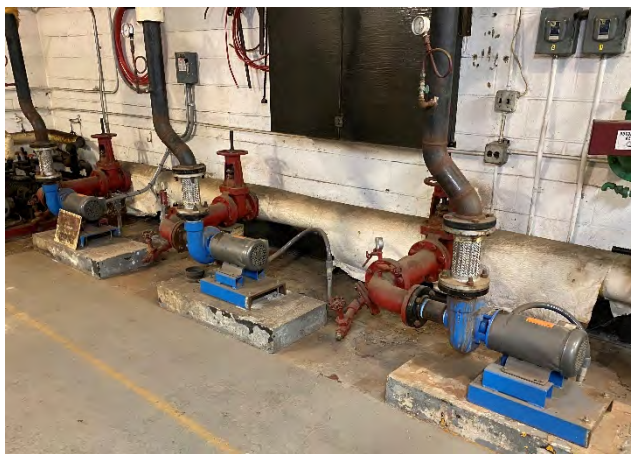
*Figure 7 - Main Heating Pumps*

Three base mounted pumps circulate water from the boiler plant to the heating loop that extends to each building on campus.

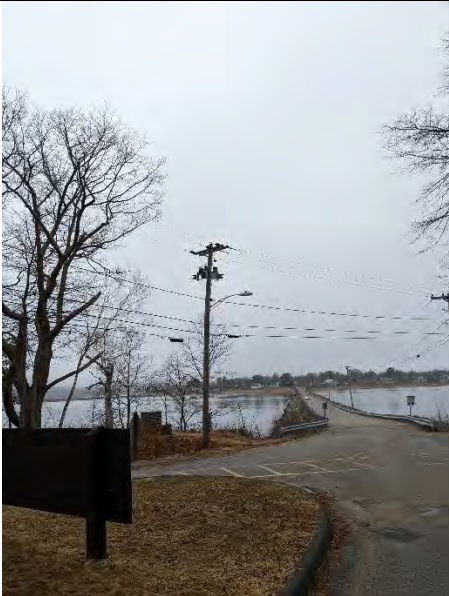
<i>Incoming Power and transformers at Gatehouse</i>	<i>Main Island Meter at Gatehouse</i>
<b>Building A: Mansion</b>	
<i>Electrical Systems</i>	
<p>Power distribution – the building is provided with power directly from the island overhead poles into the building main power panel at 120/240V, 1PH which is located on the second floor. There is an additional electrical panel in the basement. GFCI receptacles were located at appropriate</p>

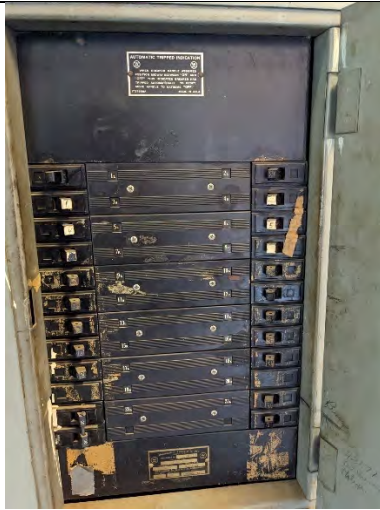
*Deteriorated Panelboard*

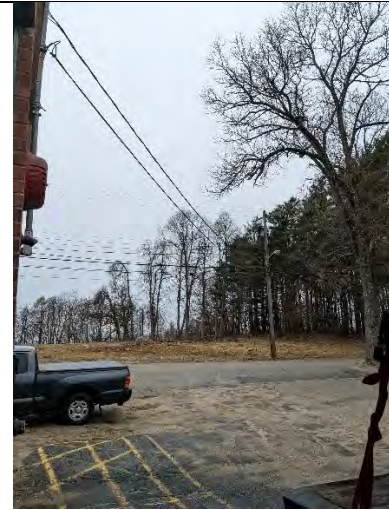
This building is powered via overhead connection from the campus pole system. Both a normal power and an emergency power panel are provided. Emergency power appears to also be run to the building via the overhead lines, separated by about 12” of space on the poles. The emergency panel is 100A, newer panel (less than 10 years). The normal panel is quite old and degraded and will need replacement. The panels are often exposed to weather as one side of the building has large garage bay doors that are frequently open.

*Incoming Overhead Power*

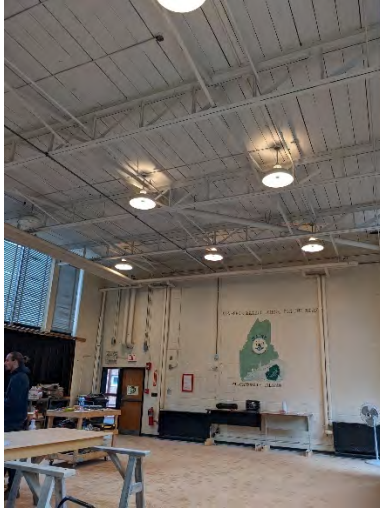
*Existing Low Bay Light Fixtures*

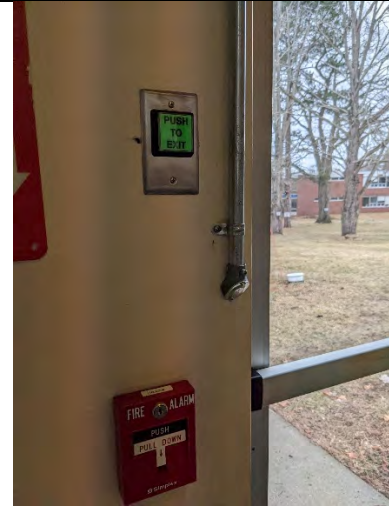
*Push to Exit Button.*

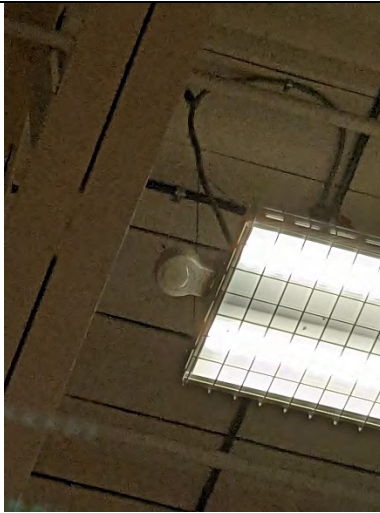
Lighting in the main gymnasium is high bay type with guard rails and on-luminaire occupancy/vacancy sensors that slowly dim fixtures based on percentage. Additional theatrical lighting is provided at the stage area. All fixtures appear to be fluorescent type, pendant or rail mounted. Reuse of these fixtures is possible, utilizing LED replacement bulbs. Stage lighting if still required, appears functional and able to be re-used.

*Gymnasium fixture with Controls*

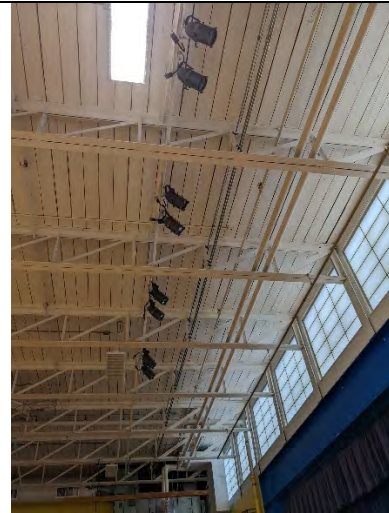
*Stage Lighting*

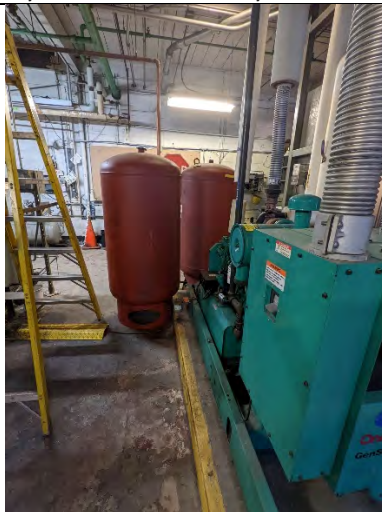
*Generator Adjacent to Expansion Tanks*

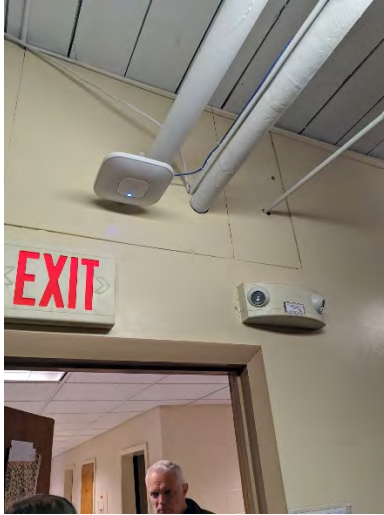
Emergency lighting is existing battery units (EBU) appear original to building in some cases. Old fixtures should be replaced, and newer fixtures and will need to be tested to ensure compliance with NFPA 101 life safety code.

*Exit Sign, WAP, Battery Light*

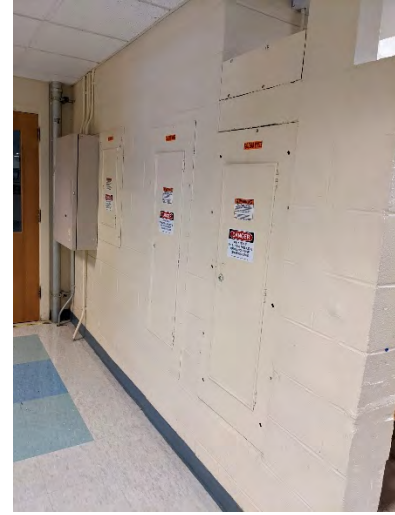
*Ex. Inaccessible Panels Serving Kitchen*

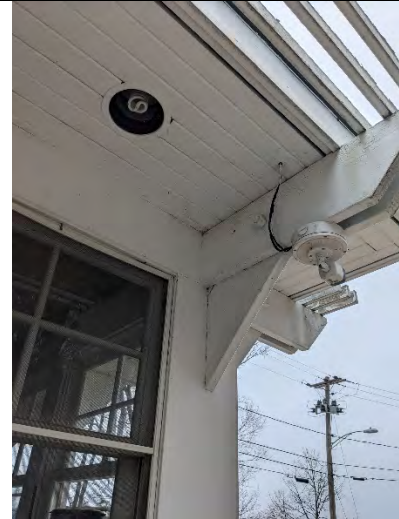
A security camera system is installed on the exterior of the gatehouse.

*Ext Lighting and Security Camera*

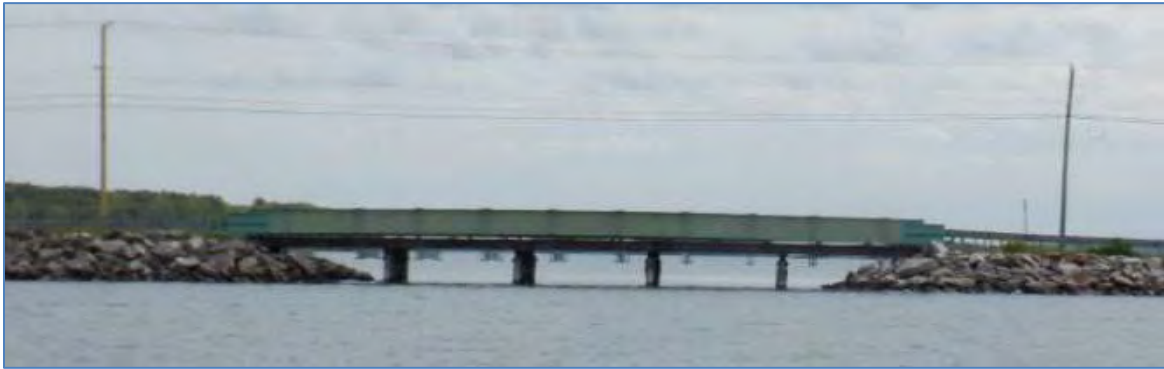
**Fig. 9. Mackworth Island Bridge Looking East from Boat**

MaineDOT inspects the causeway bridge every two (2) years with the most recent inspection dated 05/26/2022. Features of the bridge (railing, guardrail, load capacity) are listed as substandard and it is noted that the bridge abutment armoring, and piles are subject to channel tidal flow scour. The bridge load capacity was upgraded in 2015 with the addition of new exterior girders that provide additional support to the bridge superstructure. In its current configuration with the added exterior girders, the bridge is listed as ‘fracture critical’ meaning there is little redundancy in the structure if these members fail or are damaged. All these factors contribute to the load rating of 22 Tons.

The original bridge structure is still intact but has been strengthened with extensive repairs in 1981 and 2015. This included deck reinforcement (1981) and exterior girders with independent abutments (2015). Refer to Table 4 for a chronology of recorded storm damage and repair history.

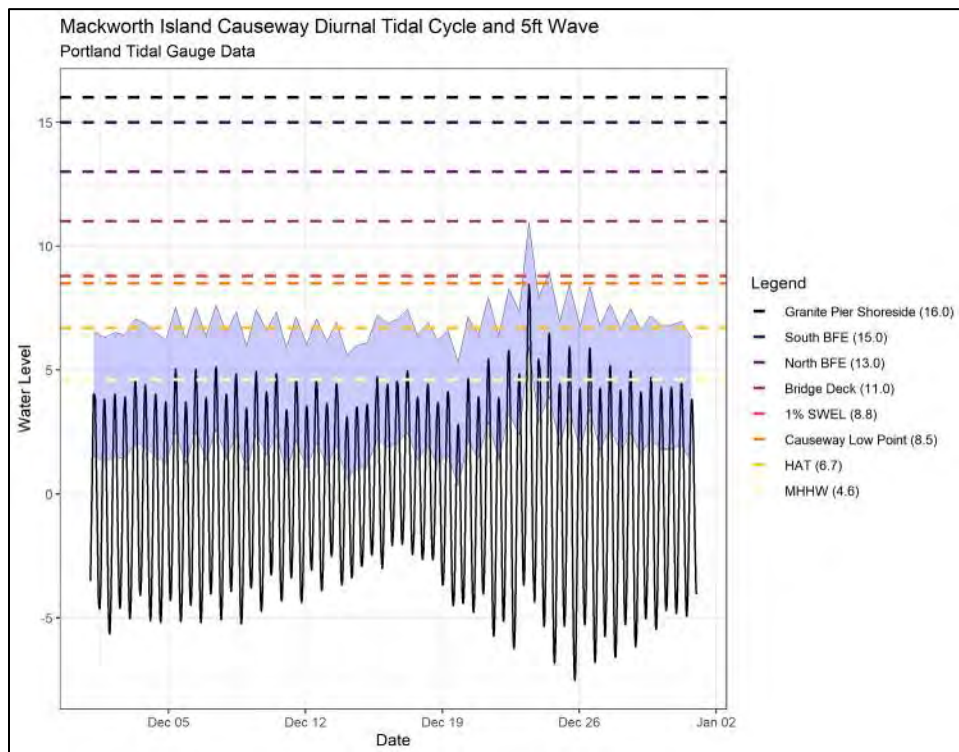
The flooding of the causeway, pier, and bridge is also graphically depicted by Fig. 17 using data from the recent *December 23, 2022 Storm Event*. The characteristics of this storm are detailed in *Section 4.2*. Pictures and reports of conditions at the site that occurred during the event serve to validate the elevation data presented for the site and support the following observations regarding causeway, bridge, and pier vulnerability to flooding.

3. The December 23, 2022 storm inundation elevation estimate at the Mackworth Island Causeway (11.0 NAVD88) falls marginally short of the 2018 FEMA BFE model that predicts the bridge will be submerged by approximately two (2) to four (4) feet in a storm with a probability occurrence of 1% (the 100-year storm).

Fig. 17. Mackworth Island Causeway- Tidal Data + 5-ft Wave, No Sea Level Rise

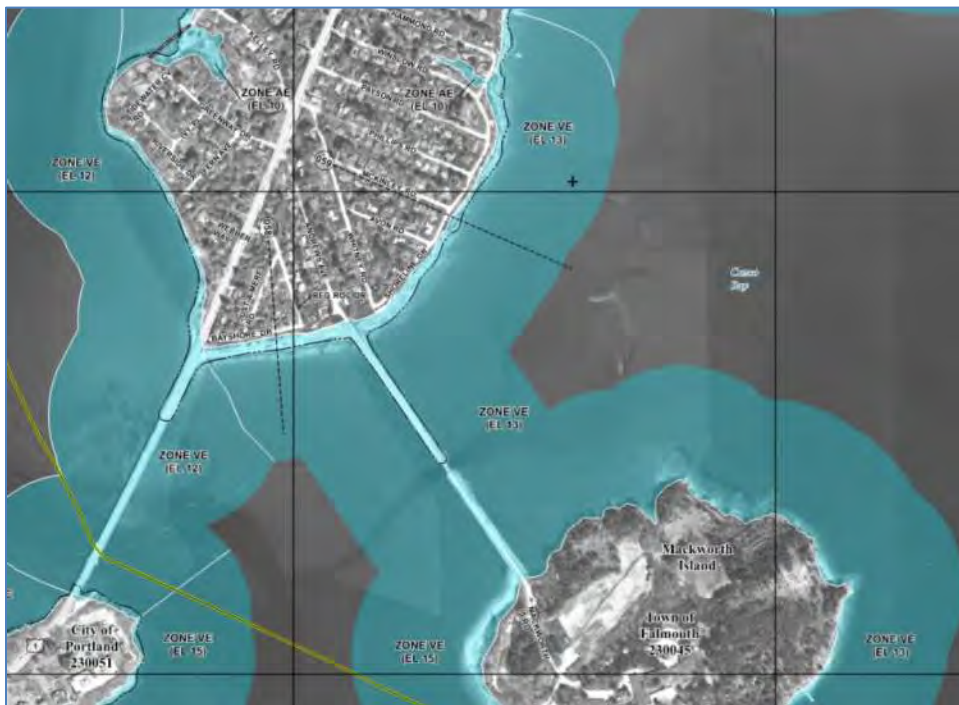
Fig. 18 shows the FEMA flood modeling results for the “100-year storm” overlaid on an aerial image of the site. This storm is predicted to have a 1% chance of occurring in any given year, also known as the Base Flood Elevation (BFE). The BFE on the north side of the causeway is VE EL 15.0 NAVD88. The VE designation indicates the wave height that contributes to the BFE is greater than 3 ft.

Fig. 18. FEMA Flood Insurance Rate Map (Preliminary)

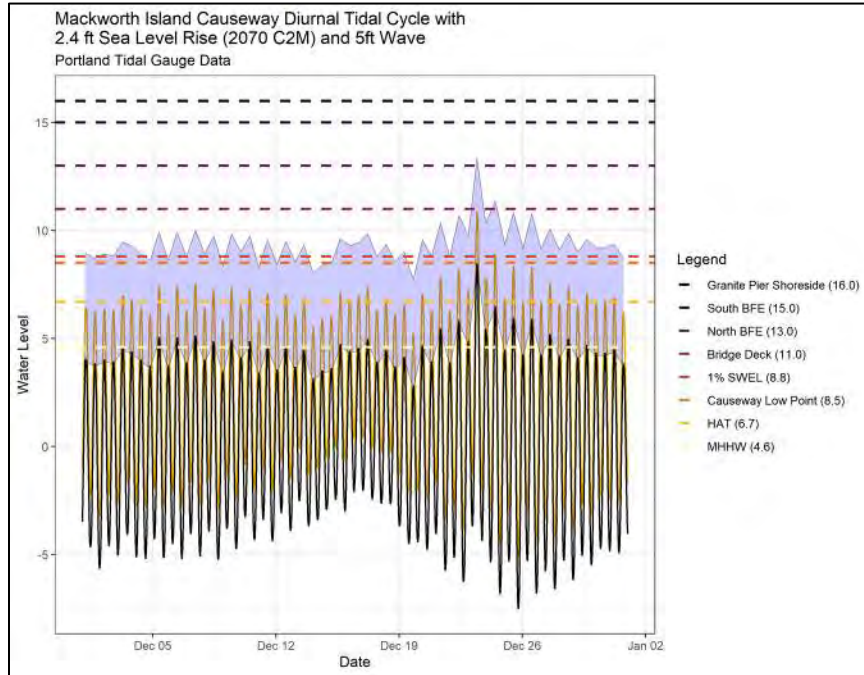
Figs. 22 and 23 superimpose the MCC 2070 sea level rise predictions on the current flood model (See Fig. 17) as it would be reasonable to expect that a causeway, bridge, or pier when improved or replaced would have a design life of 50-years.

**Fig. 22. Mackworth Island Causeway- Tidal Data + 2.4-ft SLR (2070 C2M) + 5-ft Wave**

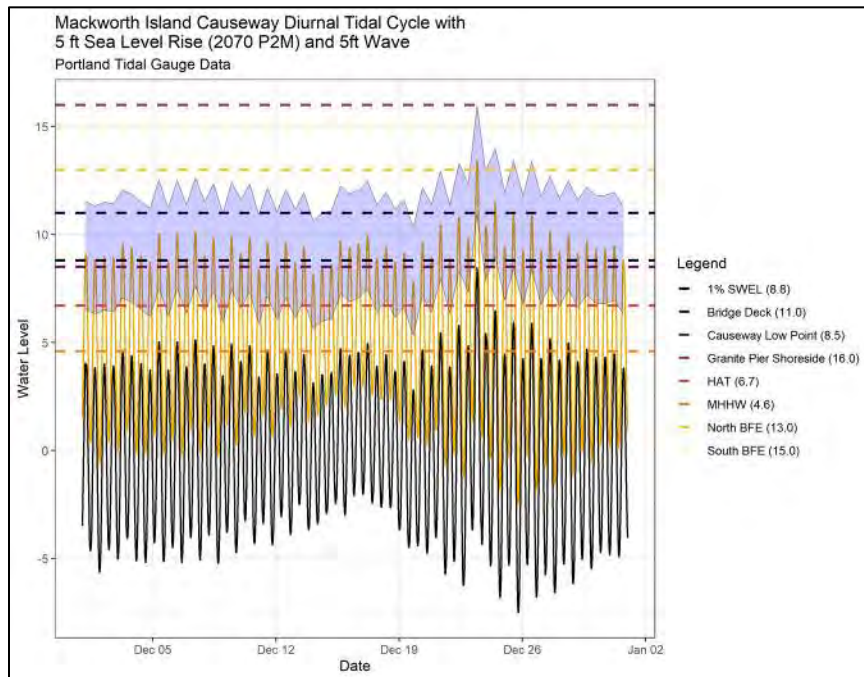
**Fig. 23. Mackworth Island Causeway- Tidal Data + 5-ft SLR (2070 P2M) + 5-ft Wave**
