Geomorphic Assessment and Restoration Recommendations for Five Streams in Falmouth, Maine

Prepared for
Town of Falmouth (Maine)

Prepared by
Dr. John Field
Field Geology Services
Portland, ME

June 2023

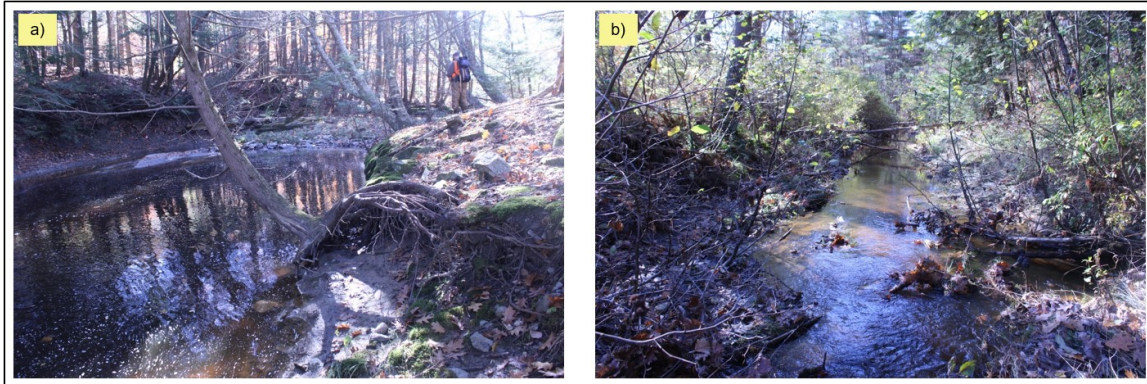
Severe scour of the banks is evident at the outlet of the railroad culvert (Figure 4a) with the bed substrate stripped away to hardpan clay and a large cobble bar formed downstream that has infilled the channel, forcing the channel to shift into an eroding bank. Beyond the scour area, the channel has been artificially straightened against the I-295 road grade, perhaps resulting in the cutting off of a now abandoned meander that is located just upstream of a constricting ridge of higher ground on the right bank floodplain (looking downstream). The straightened channel has a sandy substrate for most of its length and minimal wood, pools, and flow complexity are present (Figure 4b). The high road grade of Interstate 295 is composed of large boulders at its base, but the right bank floodplain is quite wide in most areas. The floodplain is forested with mature trees, providing a good canopy despite only a few mature trees on the I-295 road grade.

Figure 4. Reach C2 a) exhibits severe scour downstream of the railroad culvert and beyond the scour b) is artificially straightened with minimal wood, pools, and flow complexity in the channel.

Severe scour at the outlet of the railroad culvert (Figure 4a) has more than doubled the channel width relative to unaffected areas (compare Cross Section 2 in Reach C2a with Cross Section 4 in Reach C2b in Table 4 and Appendix 4). The bed of the channel immediately downstream of the outlet has been stripped of sediment, exposing the hardpan clay underneath. The material scoured from the bed and banks of the channel have been redeposited downstream to form a large gravel bar that has caused a shift in the channel’s position and further widening of the channel (Reach C2a Cross Section 3). Scouring of the right bank continues along the new channel. This scour, deposition, and channel migration is in response to a 67 percent constriction of the channel caused by the undersized railroad culvert (Appendix 4 – see Cross Section 1 in Reach C2a).

Given the limited access to the reach, “chop and drop” wood additions could increase wood loading and flow complexity along the straightened channel that comprises nearly the entire length of the reach. Wood additions are likely to immediately improve flow complexity and pool depths where the substrate is sandy. The leaning trees downstream of the railroad culvert (Figure 4a) indicate scour is ongoing and could be treated, if access routes are identified, with log cribbing to reduce erosion and fine sediment inputs into the

channel. Low log sills could be placed on the channel bed to redirect flow away from the scoured banks and trap sediment to provide a substrate above the hardpan clay. Larger marginal log jams could be built along the straightened channel to encourage meander development.

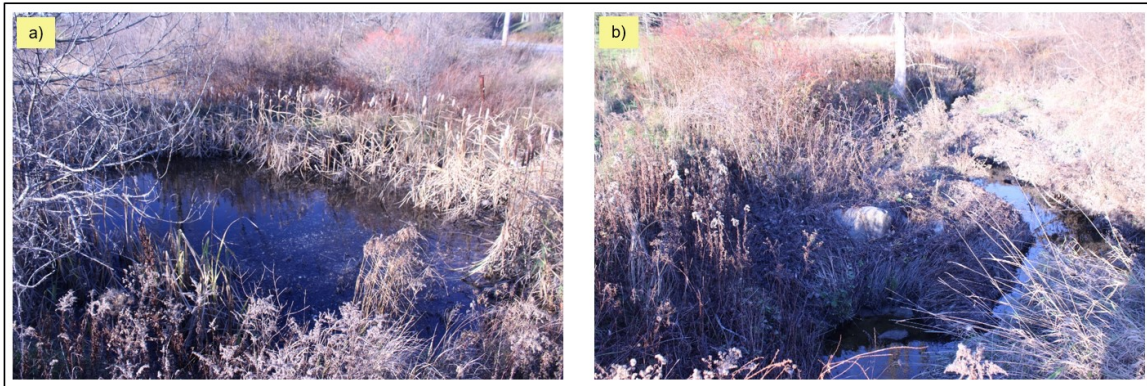
A scour pool lined with cattails is present at the outlet of the 10-foot wide and 4-foot high Gray Road culvert (Figure 11a); the culvert closely matches the channel's dimensions but does block floodplain/wetland conveyance, so has a scouring effect at high flows. The banks throughout the reach are composed of the Presumpscot Formation with the clay forming a hardpan substrate on the channel bottom where not covered by a thin bed of gravel along riffles or soft fine sediment and organics in areas of more stagnant flow. A few isolated boulders are seen throughout the upper half of the reach and may be associated with past farming activities. A low discontinuous floodplain is inset within a

higher continuous floodplain, suggesting channel incision occurred in the reach. The sinuous channel with a low width:depth ratio has little in-stream wood with only a few mature trees growing along the channel that passes through open fields (Figure 11b).

Figure 11. Reach H2 has a) scour pool at the outlet of the Gray Road culvert, but further downstream is b) a sinuous channel with little in-stream wood.

Flow complexity could be increased and sediment deposition enhanced above the exposed hardpan clay substrate through wood additions such as low log sills. Chop and drop could be used in the lower third of the reach where the approaches uplands with mature trees. Any restoration activities would first require the permission of the landowner.

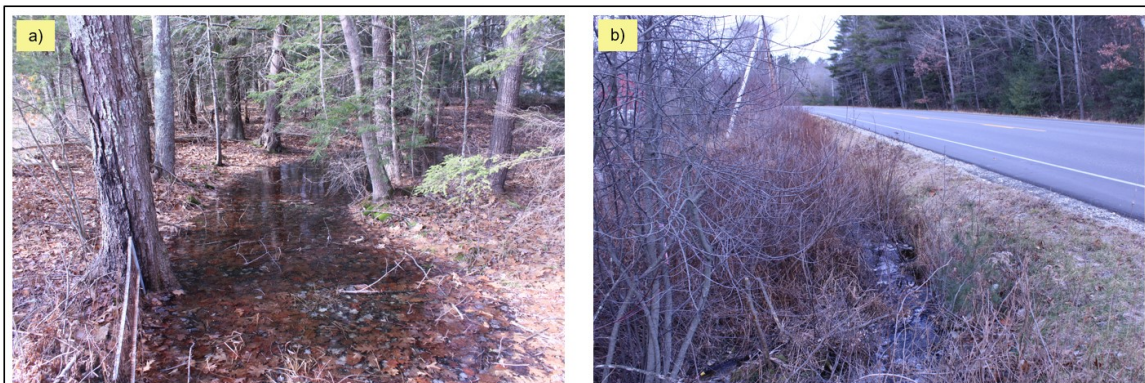
Minor bank scour has occurred at the outlet of the undersized double culvert under Olde Blackwood Way. The straightened channel behind the home and barn in the upper reach has a high width:depth ratio with little in-stream wood. An abandoned meander is present on the right bank (Figure 14a) that extends upstream to Olde Blackwood Way and aligns with the sharp bend in Reach M1 (Figure 13b from reach M1), suggesting the main flow path was moved as part of road construction or prior human activity. Downstream of a small culvert under a field road, the stream transitions into a wetland area dominated by cattails and alders with the straightened channel eventually approaching and then flowing along Route 9 at the end of the reach (Figure 14b). The stream passes through a culvert under Paddington Way before taking a sharp left turn into the culvert under Route 9 that is set a bit low (but does not appear to be problematic). A large tributary enters the stream immediately upstream of the Route 9 culvert. Given the fields behind the home and barn in the upper reach and low shrubs in the wetland, very few large mature trees are present along the channel to provide canopy cover or a long-term source for wood recruitment into the stream for improved habitat and flow complexity.

Figure 14. Reach M2 a) has an abandoned meander in the upper reach and b) flows along Route 9 at the downstream end of the reach.

Restoration opportunities include replacing the field road with a larger culvert or ford and realigning the stream to avoid a sharp bend entering the Route 9 culvert. The channel

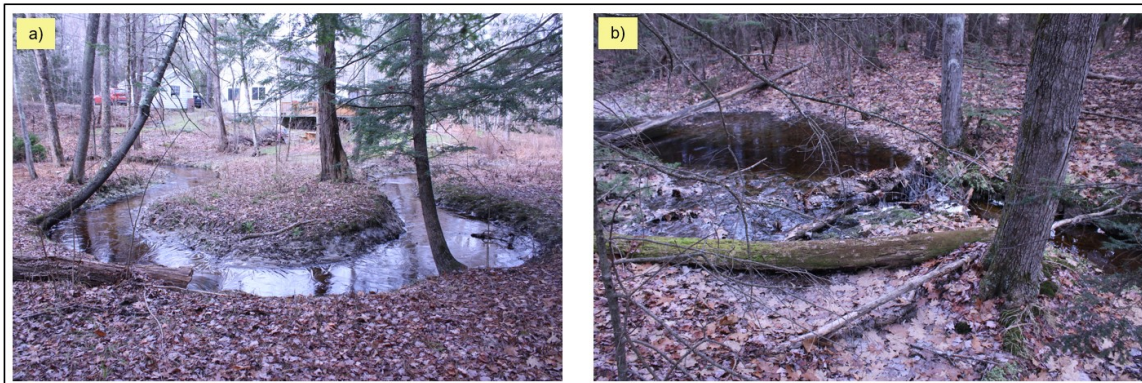
The Route 9 culvert outlets at a sharp bend and flows directly into a left bank composed of ledge and, given the sharp bends at both the inlet and outlet of the culvert, suggests significant modifications to the channel alignment occurred during the construction of Route 9. An overflow chute has formed on the left bank floodplain just beyond the ledge outcrop. The channel flows across a wide floodplain that is slightly constrained by artificial fill on the right bank on which homes have been built along Route 9. The channel has a high width:depth ratio and the upper part of the reach may have been artificially straightened in the past, but three high amplitude meanders have formed in the lower reach (Figure 15a), likely due to a combination of flow impoundment downstream and clay bank materials. The channel substrate contains pea gravel at the upstream end but is predominately sand before reaching the downstream end with occasional small sand bars present along the margins of the channel. For short lengths, in-stream wood is creating good flow complexity with minor flow impoundment upstream, cascading flow over logs, and overflow onto the floodplain (Figure 15b). However, in general, the amount of wood in the channel is minimal despite the forested floodplain with numerous tall mature trees providing a full canopy over the channel. The undersized culvert at the downstream end is paired with an additional small culvert set at the floodplain elevation.

Figure 15. Reach M3 has a) high amplitude meanders and b) good flow complexity where wood is present.

Resizing the Long Creek Way culvert will be simpler than realigning the Route 9 culvert given the size of the roadways. Naturally, wood loading in the forested channel will increase slowly as the forest ages, but a chop and drop project will lead to immediate aquatic habitat improvements. The artificial fill on which several homes and yards are situated is not a severe channel constraint so need not be removed.

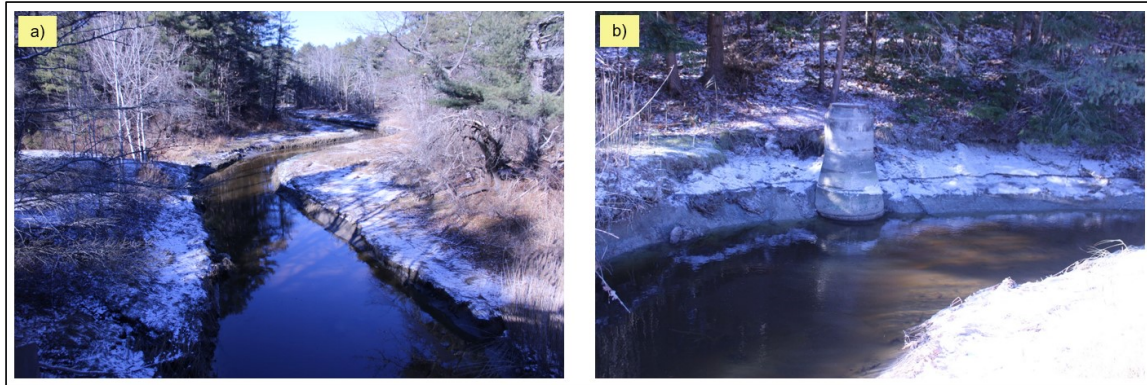
The entire length of Reach M11 is tidally influenced. The reach is initially confined by high banks of clay but downstream of the Norton Brook confluence opens up onto a wide tidal marsh with broad high-amplitude meanders traversing nearly the entire width of the marsh (Figure 23a). The channel just below the Norton Brook confluence appears to have been artificially straightened with a low berm at the top of the right bank and higher ground along the left bank. Daily fluctuations of the water level leads to sapping erosion of the fine-grained bank material along the entire reach with erosion most severe on the outside bends of meanders but occurring nearly everywhere as evidenced by the unvegetated banks and materials slumping into the channel. A sewer line runs along the edge of the marsh for much of the reach's length on the right bank at the base of the uplands. While the sewer line is for the most part quite distant from the channel, at least one manhole has largely become exposed by erosion on the outside bend of a meander (Figure 23b) and others are close to the bank. Wood in the upper confined reach is fairly abundant due to erosion of the high slopes but is much more limited downstream where the channel occasionally impinges on the uplands. The substrate is fine-grained, often rippled, sand. A forested canopy is restricted to the upper reach and the few areas where the channel flows near the uplands.

Figure 23 Reach M11 is characterized by a) broad meanders across the marsh that have b) exposed a manhole through bank erosion in at least one location.

The exposed manhole (Figure 23b) could be protected from further erosion by constructing a marginal log jam around it such that the structure would be in the center of the jam. A series of log jams should be constructed along the eroding meander bend to prevent outflanking of the manhole protection structure. Similarly, a series of log jams could be built along the left bank of the straightened section to encourage meander growth across the marsh. Berm removal should accompany this restoration effort. Additional log structures could be built for habitat enhancement where the channel approaches the uplands, but would not look particularly natural if built in the center of the marsh where wood is unlikely to naturally collect.

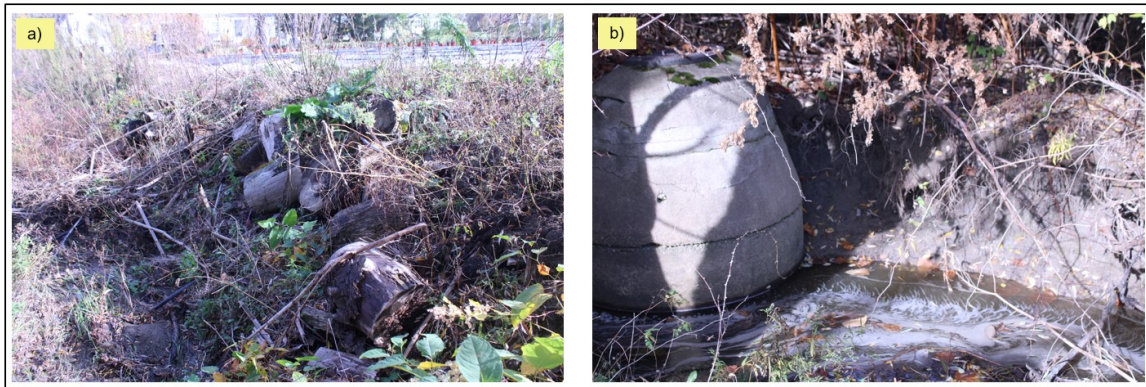
Webes Creek drains the most heavily developed portion of Falmouth (Figure 2, Table 1, and Appendix 1). The upper portion of Reach W1 is straight and confined by high banks of natural clay and is further constrained on the right bank by brush, wood pallets, and concrete blocks discarded over the edge by the greenhouse operations situated on top of

the bank (Figure 28a). Bank erosion is located directly across from the area of greatest constriction where the channel has shifted towards the left bank, exposing the base of a manhole along the sewer line that parallels the length of Webes Creek (Figure 28b). A floodplain is present at the lower end of the reach and the channel becomes slightly sinuous. The double culvert under Depot Road is backwatering the channel upstream where the substrate becomes increasingly soft. Upstream in the confined area the substrate is rocky in places but much of the gravel component consists of rip-up clasts of clay derived from those areas where a hardpan substrate is exposed. Aside from small branches, no wood is present in the channel. The floodplain is dominated by shrub vegetation with few tall trees, so the canopy over the stream is limited.

Figure 28. In Reach W1 a) stumps, branches, and other fill on the right bank have constricted the channel and shifted the channel towards the left bank where b) erosion around a manhole is occurring.

Removal of the largely organic fill on the right bank will reduce flow constriction and reclaim a narrow strip of floodplain in the confined upper reach. After fill removal, the channel could be rerouted away from the eroding manhole with marginal log jams built around the structure as well as upstream and downstream. Low log sills crossing the channel through the reach could trap more sediment and organics on the stream bottom and reduce the percentage of the bed that is either hardpan or clay rip-up clasts. Resizing the Depot Road culvert would reduce backwatering on the floodplain upstream and allow for a planting project to encourage the growth of taller trees that will ultimately provide a better canopy over the channel and supply wood to the channel over time.

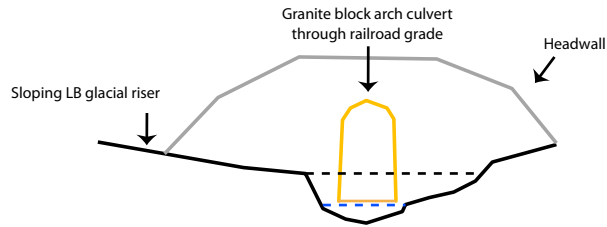
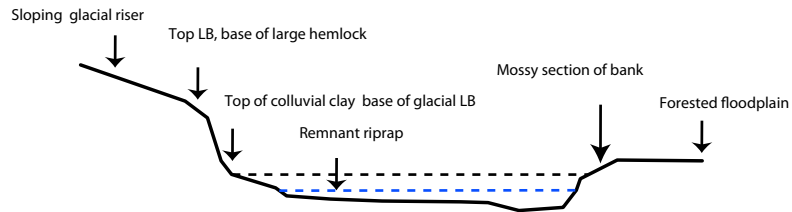
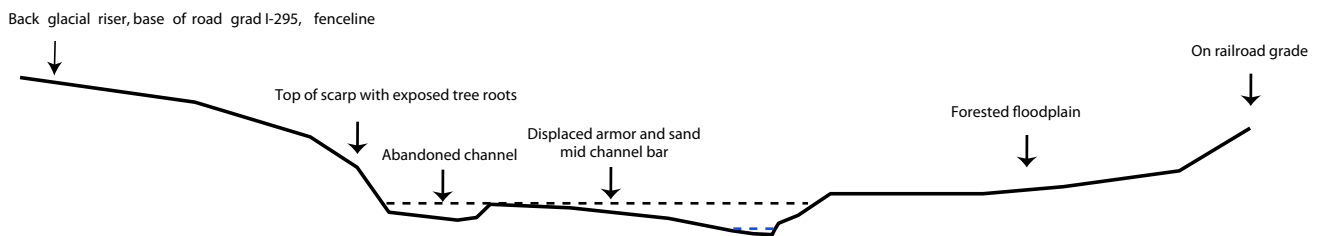
Chenery Brook - Surveyed cross sections. Reach C2a.

Cross Section 1 - Just downstream of railroad culvert outlet

Cross Section 2 - Across wide scour pool from the right bank to the left bank

Cross Section 3 - Across wide mid channel bar

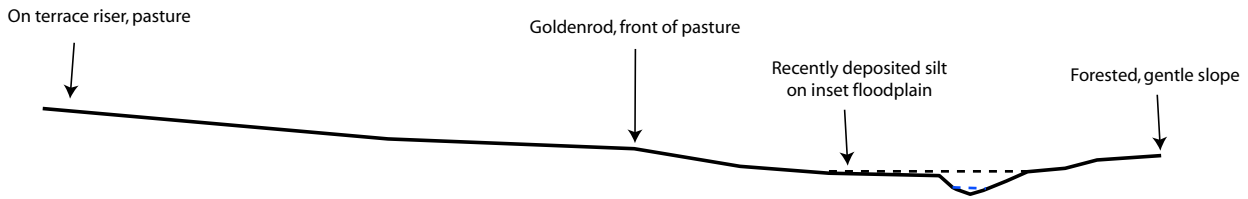
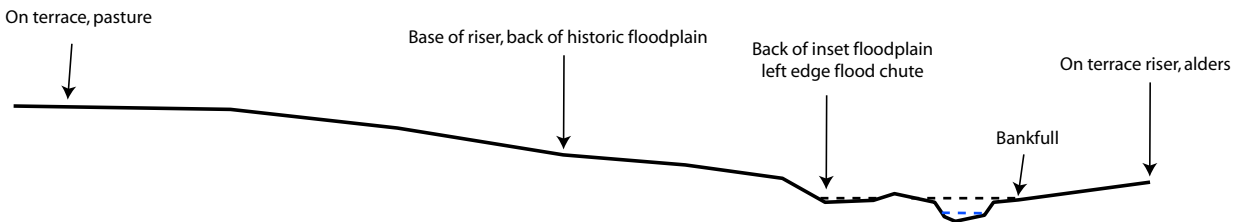
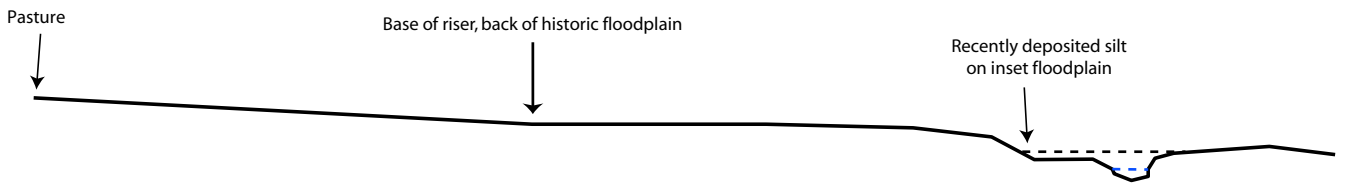
Hobbs Brook - Surveyed cross sections. Reach H2.

Cross Section 1 - Across straight channel

Cross Section 2 - Across meander

Cross Section 3 - Across straight channel and bankfull bench

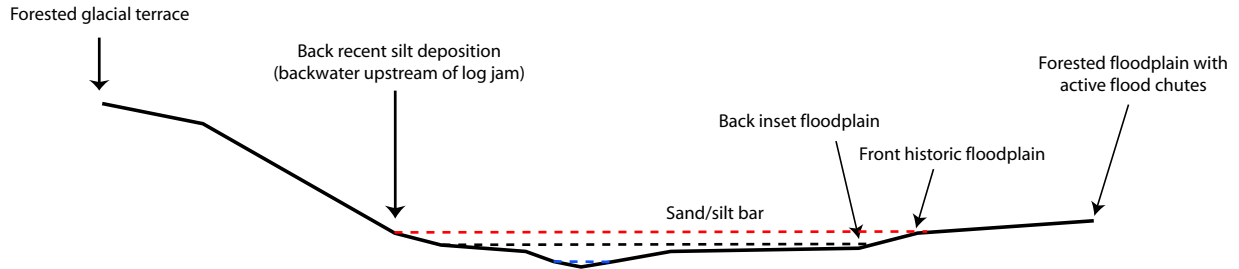
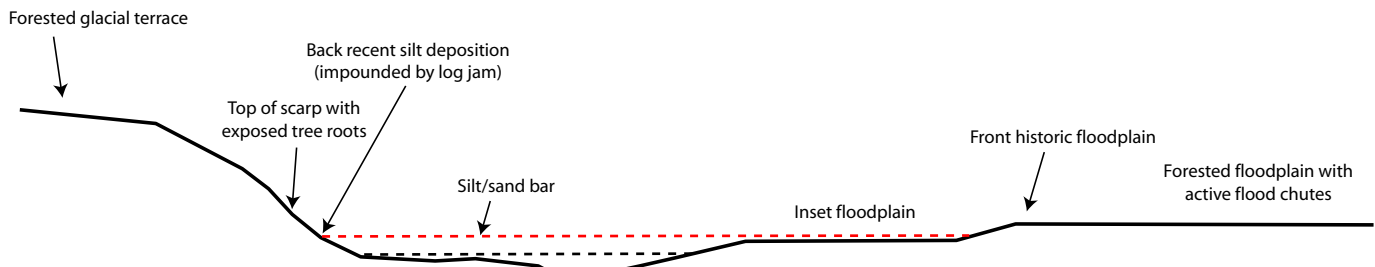
Hobbs Brook - Surveyed cross sections. Reach H3.

Cross Section 1 - Crosses wide side bars upstream of log sill

Cross Section 2 - Crosses straight channel with silt/sand bars

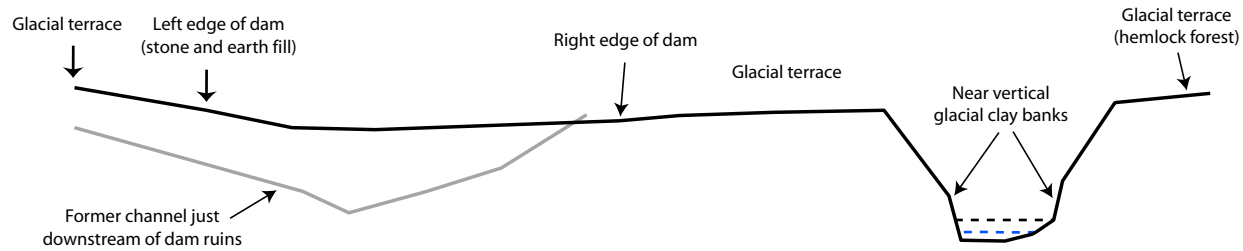
Mill Creek - Surveyed cross sections. Reach M6.

Cross Section 1 - Across dam ruins and avulsion channel cut through glacial clay (current mainstem)

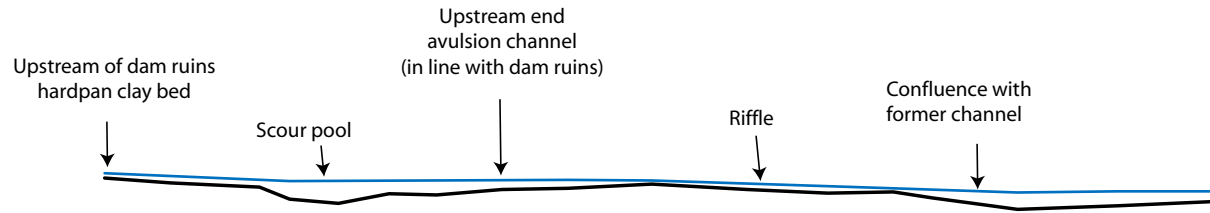
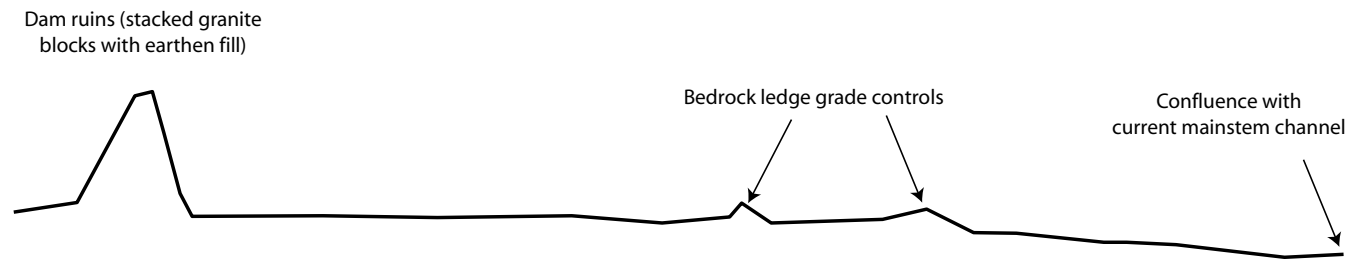
Mill Creek - Longitudinal profile. Reach M6.

Longitudinal profile of current mainstem

Longitudinal profile of abandoned former channel

Note: reduced length of current avulsion channel has increased overall channel gradient (slope of reach)

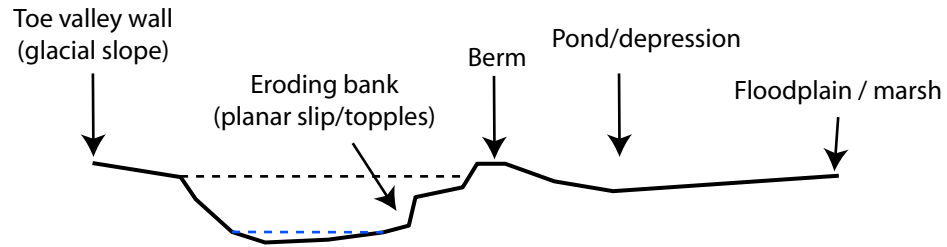
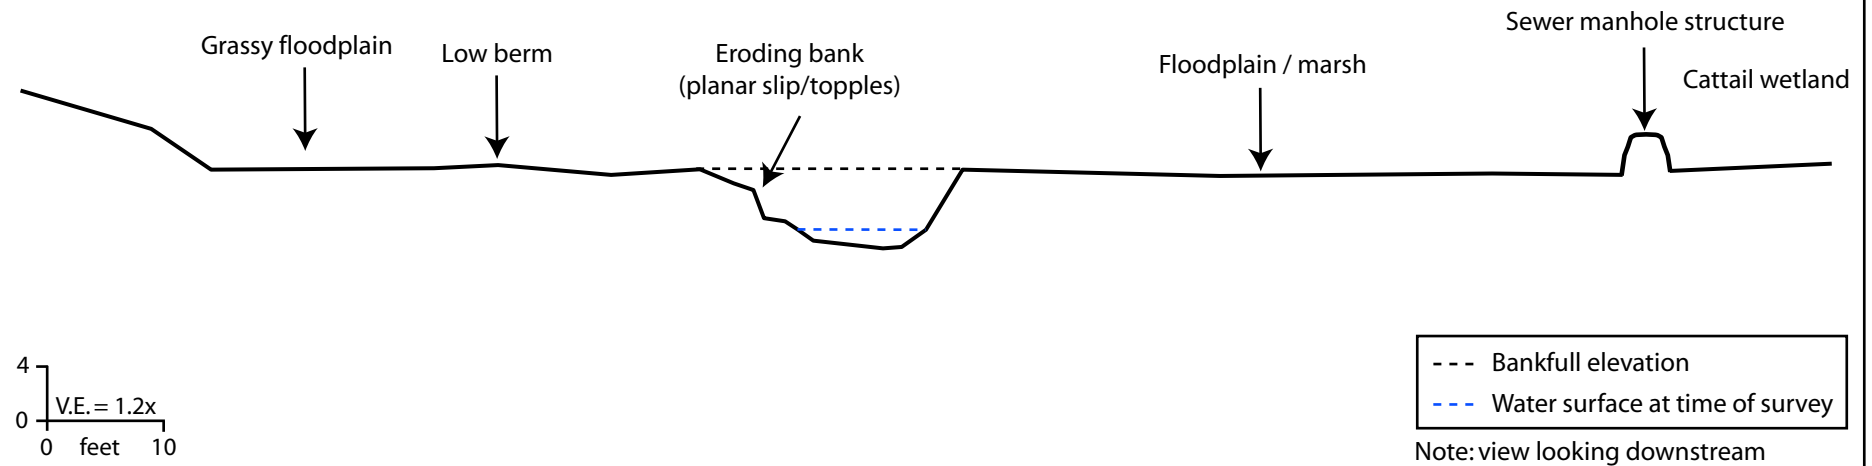
Mill Creek - Surveyed cross sections. Reach M11.

Cross Section 1 - Straight channel (artificially straightened)

Cross Section 2 - Re-meandering channel

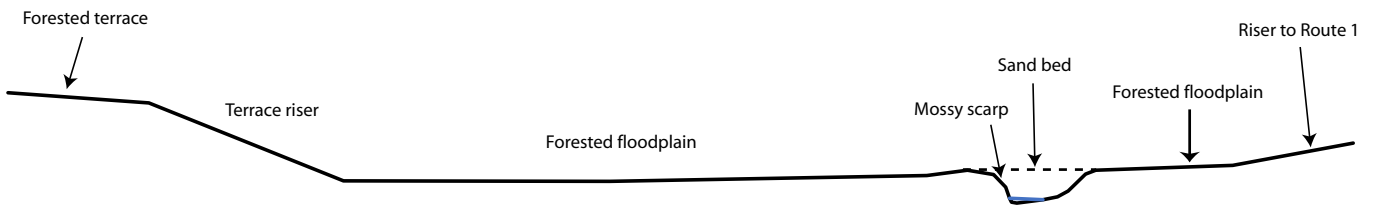
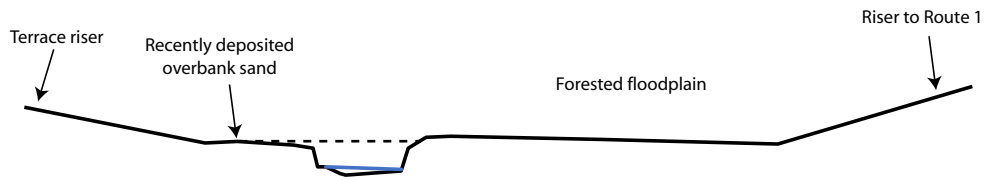
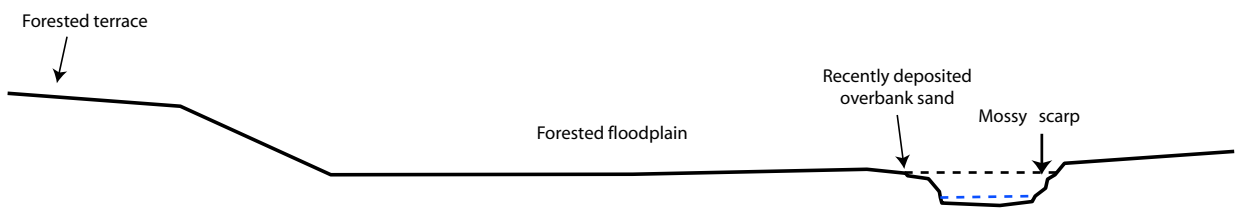
Cross Section 1 - Across wide floodplain and straight riffle

Cross Section 2 - Across sand bed channel with overbank sand deposition

Cross Section 3 - Crosses channel at meander apex

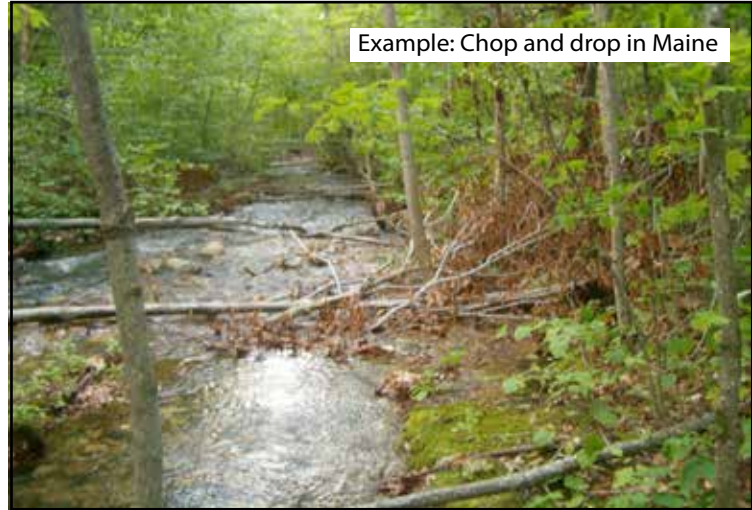
Norton Brook - Proposed conditions for cross sections 1-3.Reach N1.

Chop and Drop
Cross Section 1

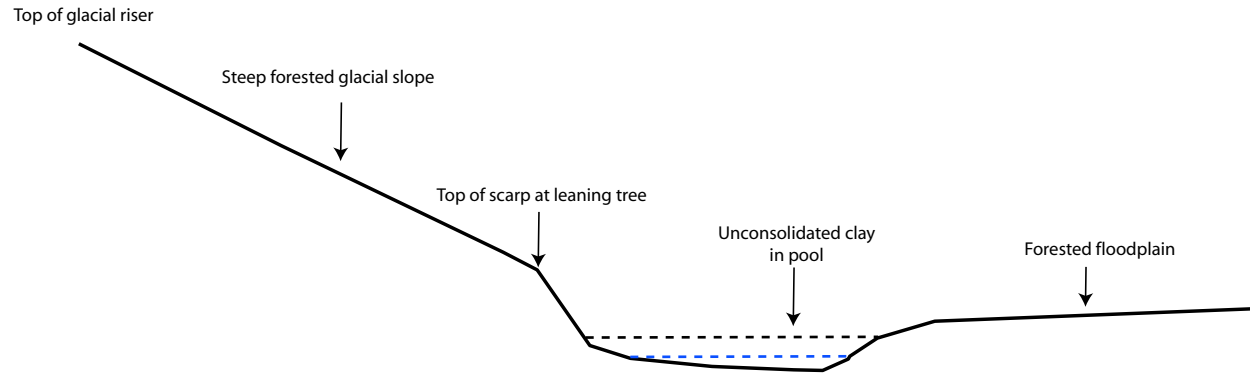
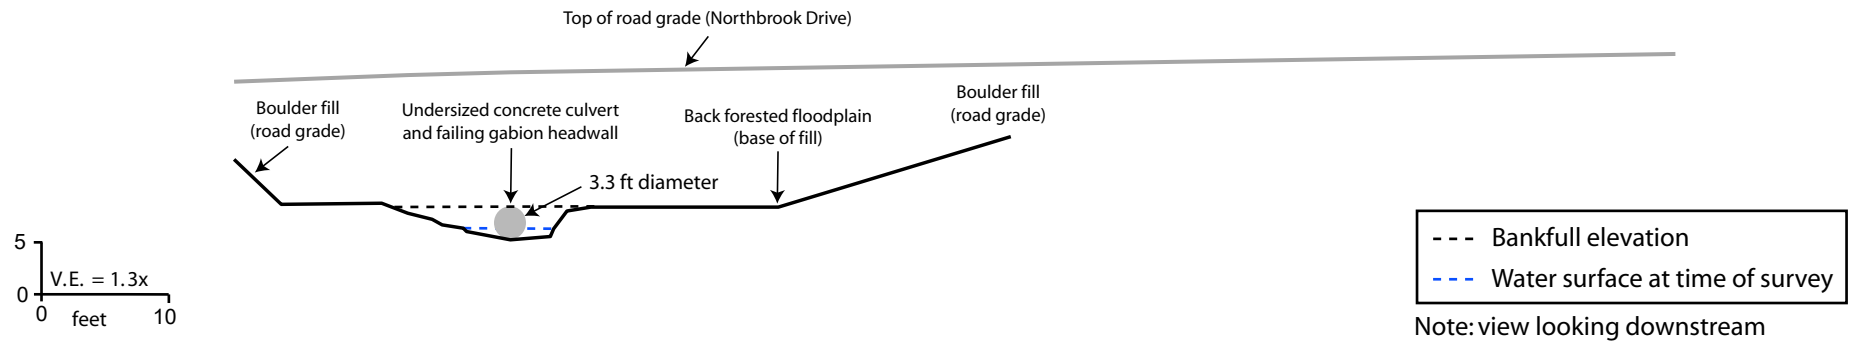
Norton Brook - Surveyed cross sections. Reach N3.

Cross Section 1 - Across tight meander and scour pool, just upstream of log jam

Cross Section 2 - Across straight cobble riffle

Cross Section 3 - Just upstream of Northbrook Drive culvert

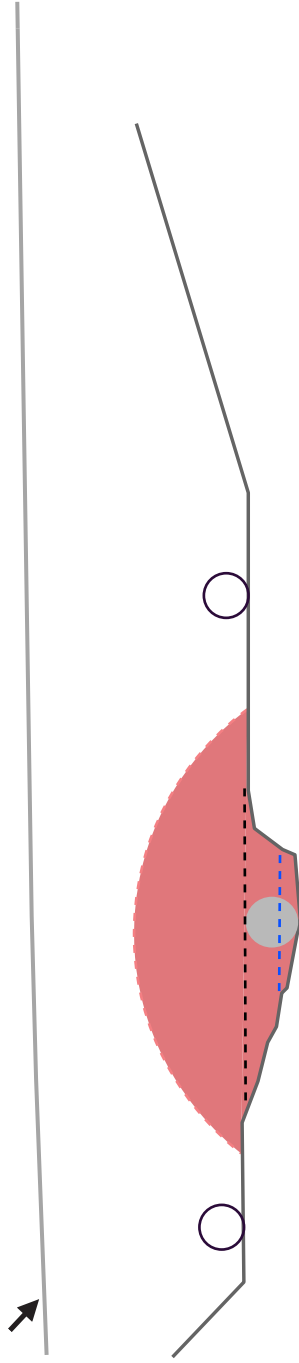
Norton Brook - Proposed condition for Cross Section 3. Reach N3.

Existing culvert diameter: 3.3 ft
Resized culvert diameter: 2.1ft
Bankful channel width: 17 ft
1.2x Bankful channel width: 20.4 ft

Cross Section 3
Culvert and Headwall Replacement
Floodplain Culverts

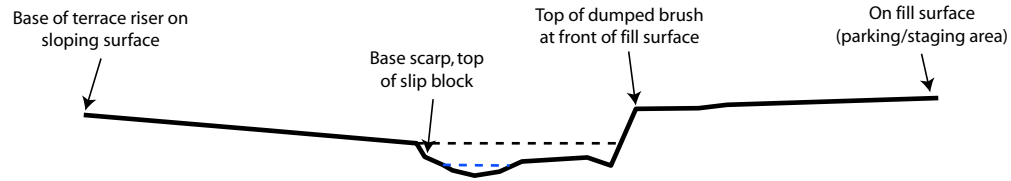
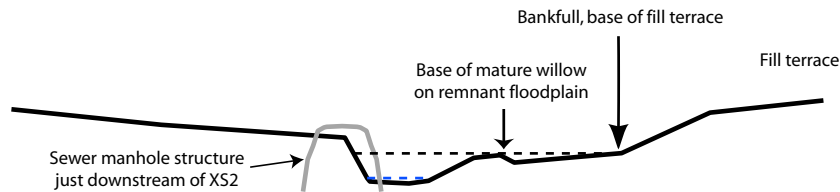
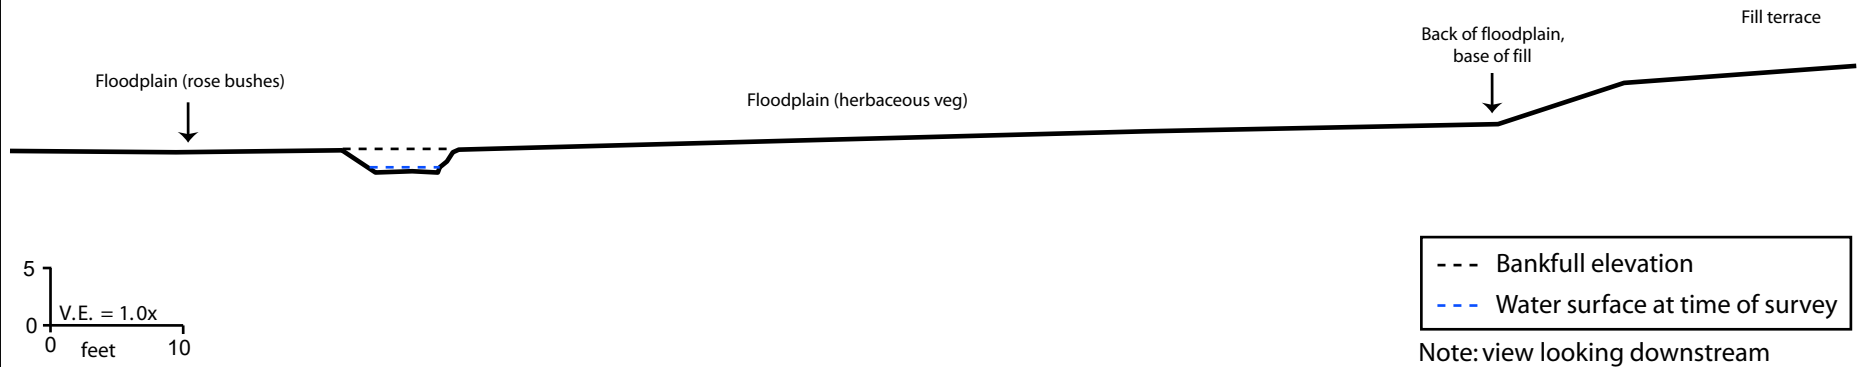
Webes Creek - Surveyed cross sections. Reach W1.

Cross Section 1 - Across straight channel with dumped brush encroaching into channel

Cross Section 2 - Just upstream of sewer manhole structure

Cross Section 3 - Across wide floodplain upstream of Depot Rd culverts
