# FALMOUTH ROUTE ONE INFRASTRUCTURE PROJECT

## Construction Update #27, October 28, 2014

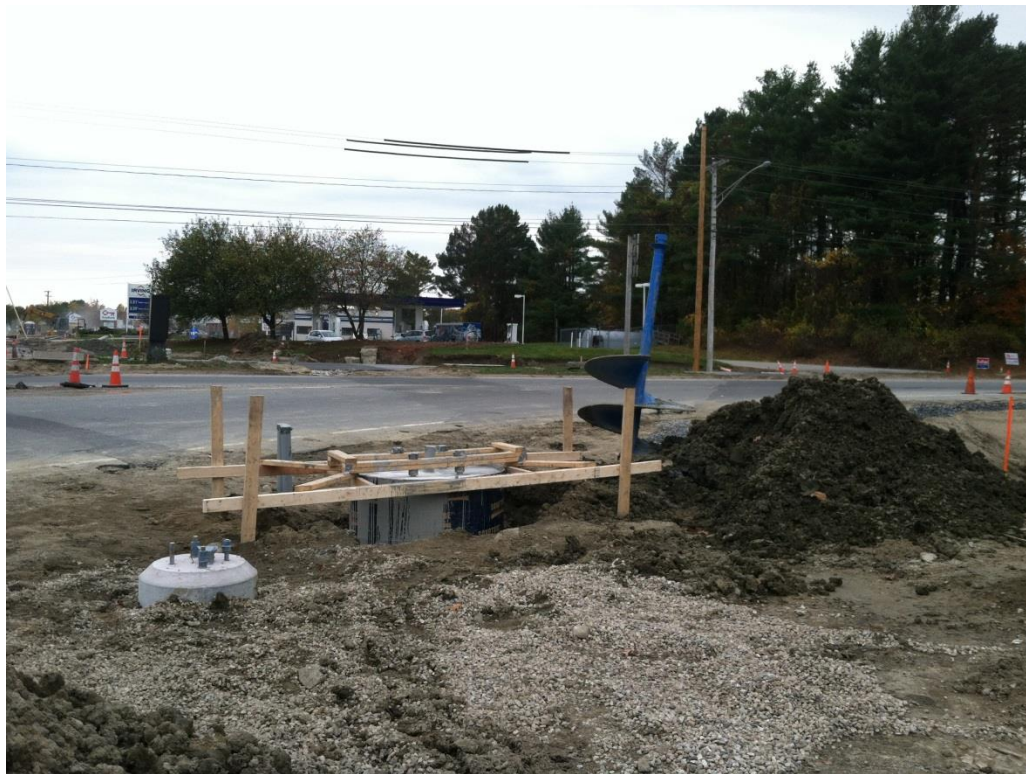
Looking south across Bucknam Road, we see (from left) a street lighting base; the base for a traffic signal pole, and the massive auger that dug the hole for it. This base was installed on 10/27; the concrete is still curing.

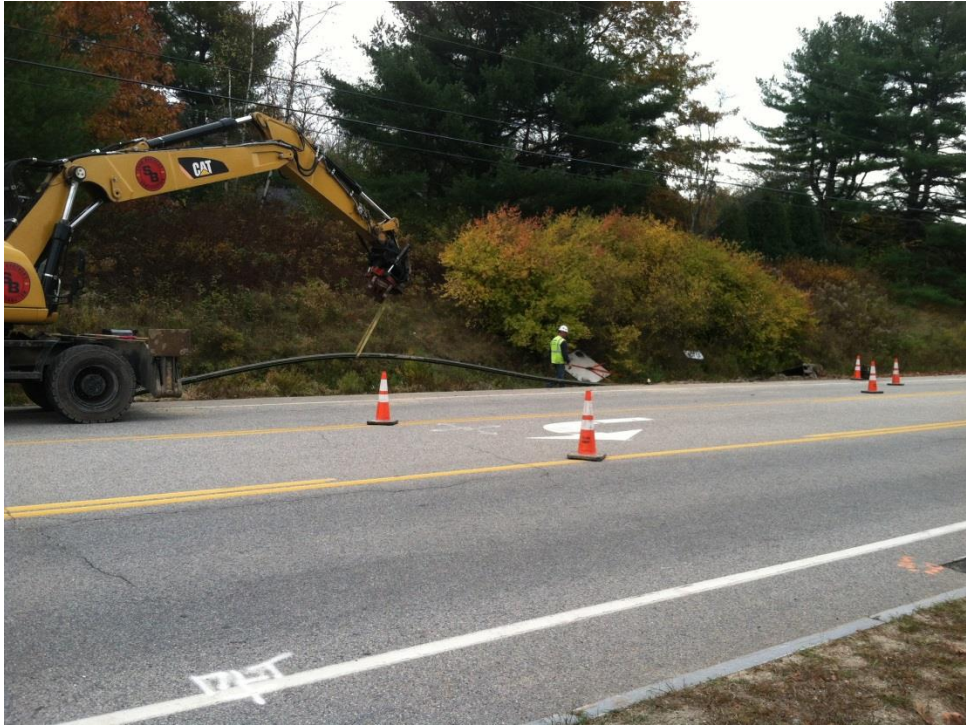
A work crew from Shaw Brothers Construction, contracted by Summit Natural Gas, is laying the gas main into a trench. This is near the southern end of the Route One Redevelopment Project work zone, just north of the intersection with Route 88.

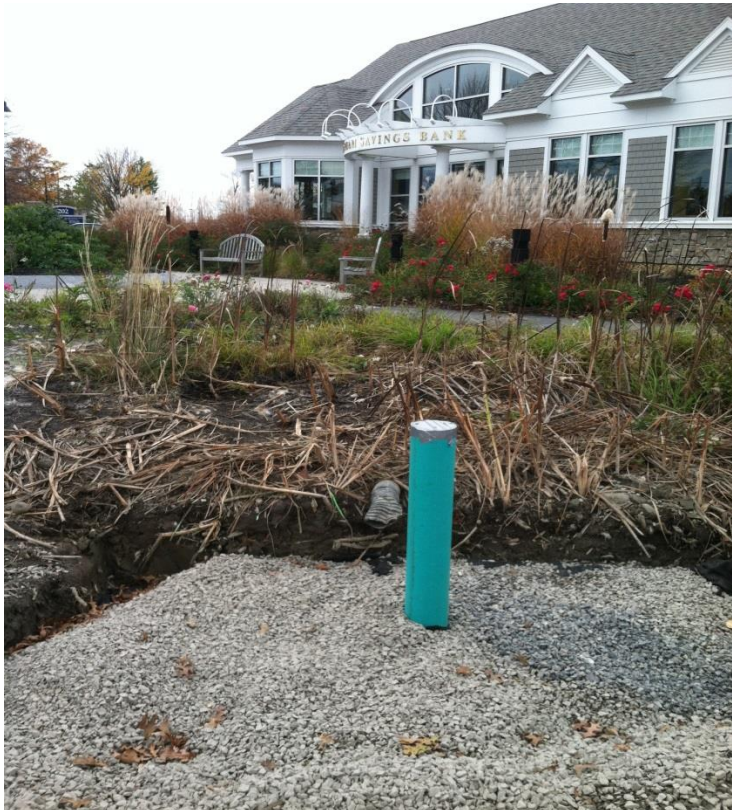
So what does a biofilter look like? Here's a nearly-completed one at the corner of Clearwater Drive, near the Gorham Savings Bank. Ultimately, the pipe will be cut down, the top will be mulched and vegetation will be installed. But there's much more than meets the eye. See below.

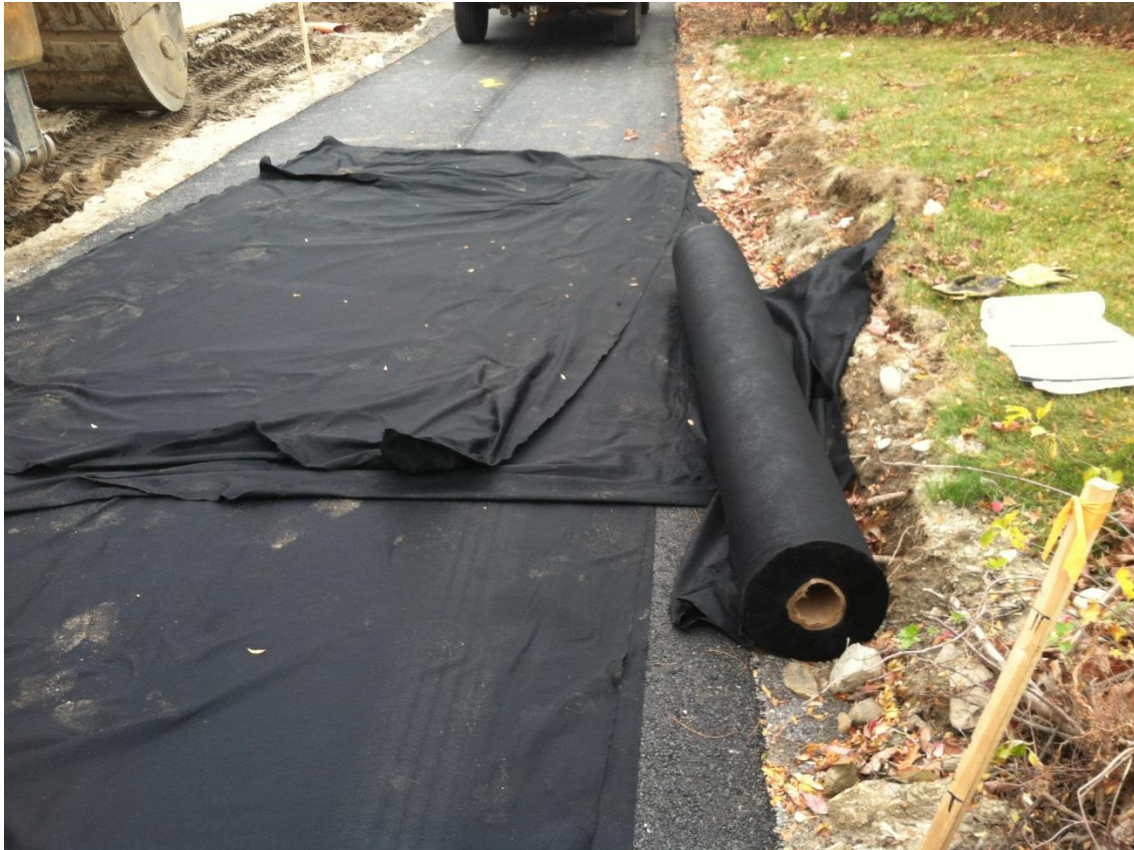
A biofilter starts with a rather deep hole, adjacent to a storm drain which collects street runoff. The hole is lined with several layers of geotextile, such as this...

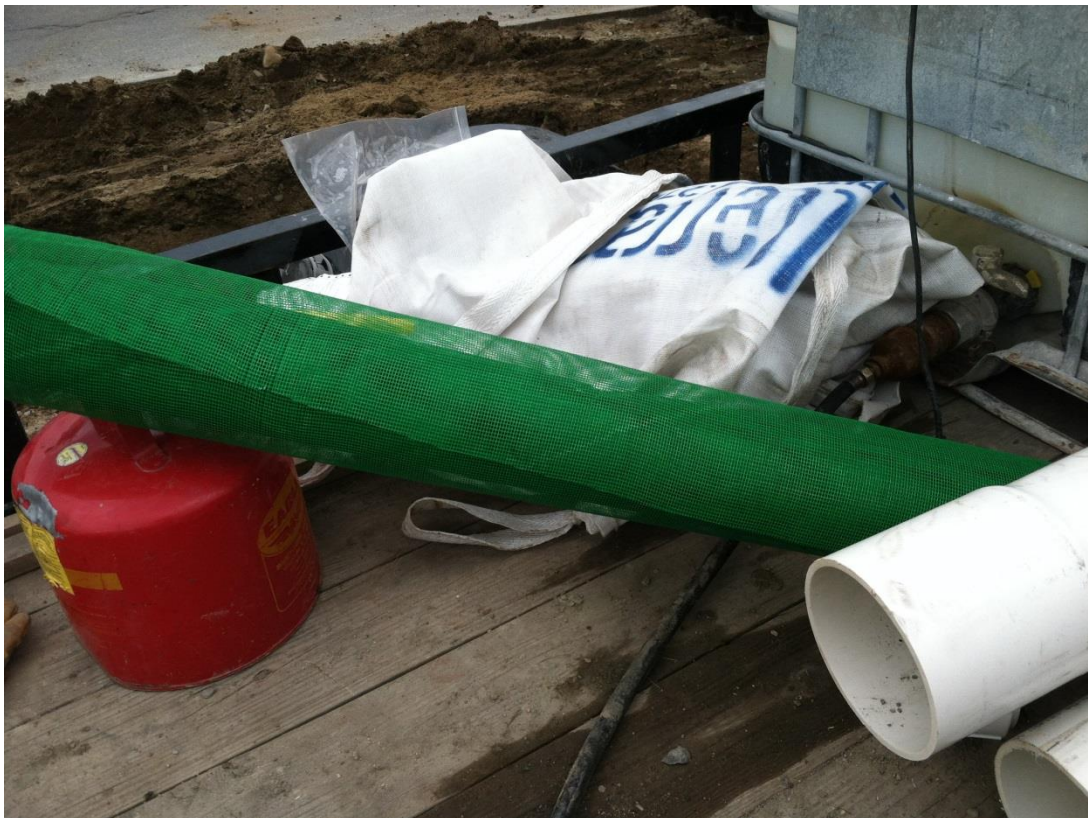
...and several other special fabrics, such as this.

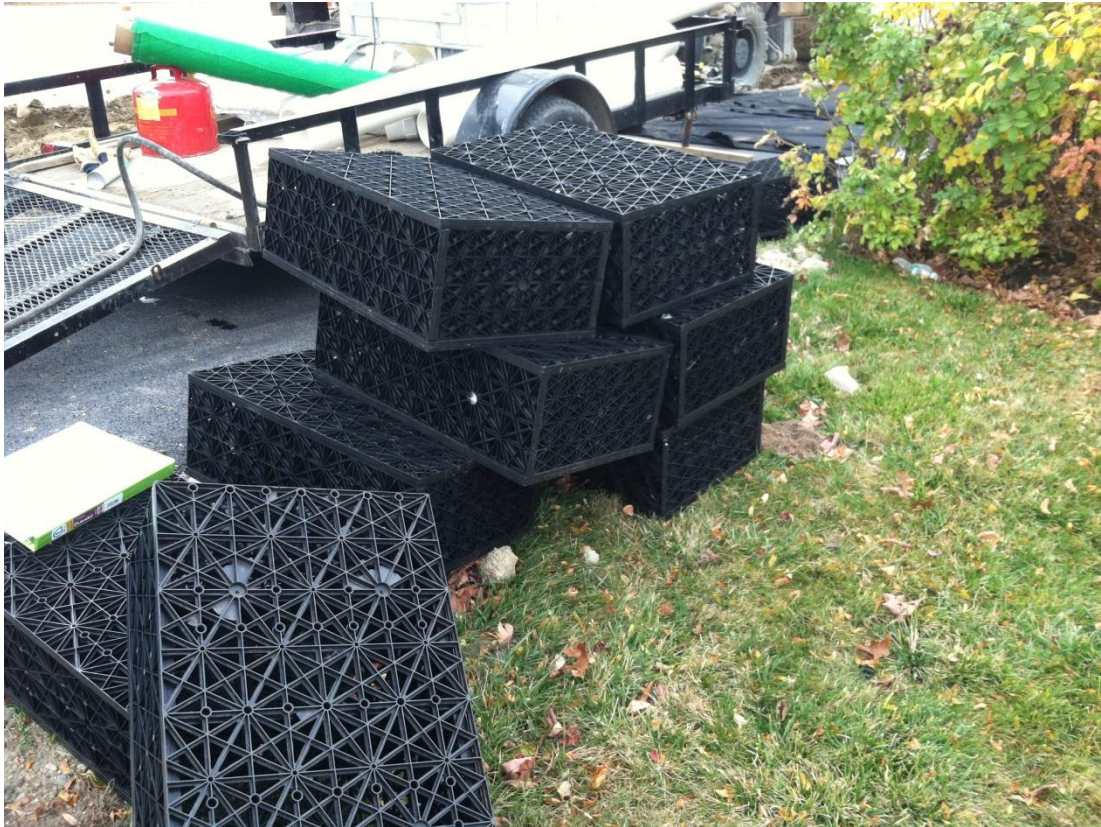
Next, these devices – called underdrains - are installed. They're basically plastic cages that facilitate collection of stormwater. More geotextiles are installed, then a layer of stone, and then a special biofiltration media is packed in. Crushed stone is placed atop this – followed, ultimately, by a layer of hardwood mulch and specially selected plantings. The result is cleaner stormwater runoff and an aesthetically appealing appearance.
