# FALMOUTH ROUTE ONE INFRASTRUCTURE PROJECT

## **Construction Update #18, August 26, 2014**

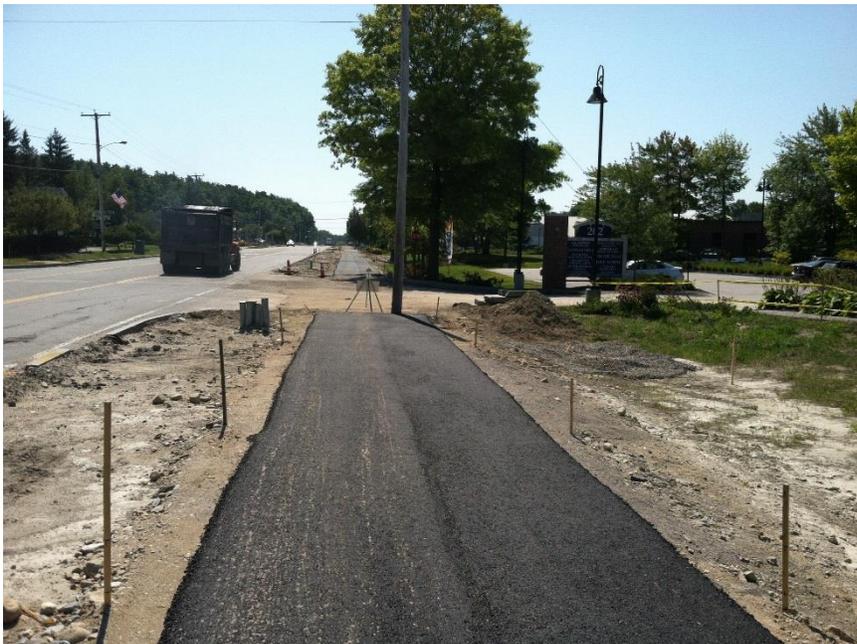
This view looks south from the front of Gorham Savings Bank, past the entrance to 202 Route One. We now have paved sidewalk from the south end of the project area almost to Clearwater Drive. Some openings remain to facilitate later utilities work.

With a few areas left open due to forthcoming utilities work, the west side sidewalks are now paved between Waldo's and Clearwater Drive.

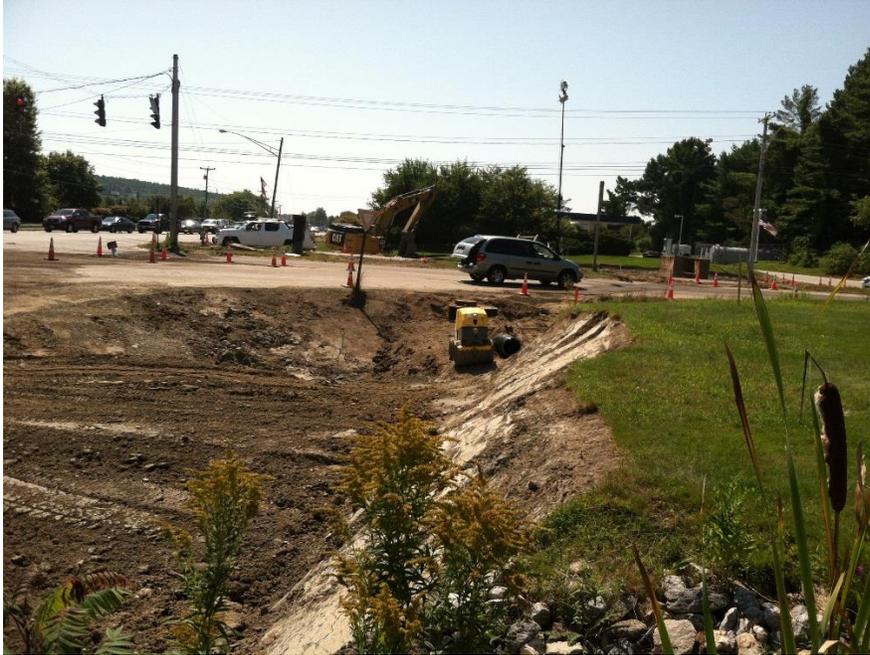
Looking south across Bucknam Road from the front of Norway Savings Bank, the Irving convenience store is in the background. Major drainage work is underway on both sides of Bucknam Road, as well as some Bucknam Road crossing work.

- Continued work involving drainage at the intersection of Route One and Bucknam Road.
- Duct bank crossings of Clearwater Drive. This work is likely to occur Tuesday and Wednesday nights this week.

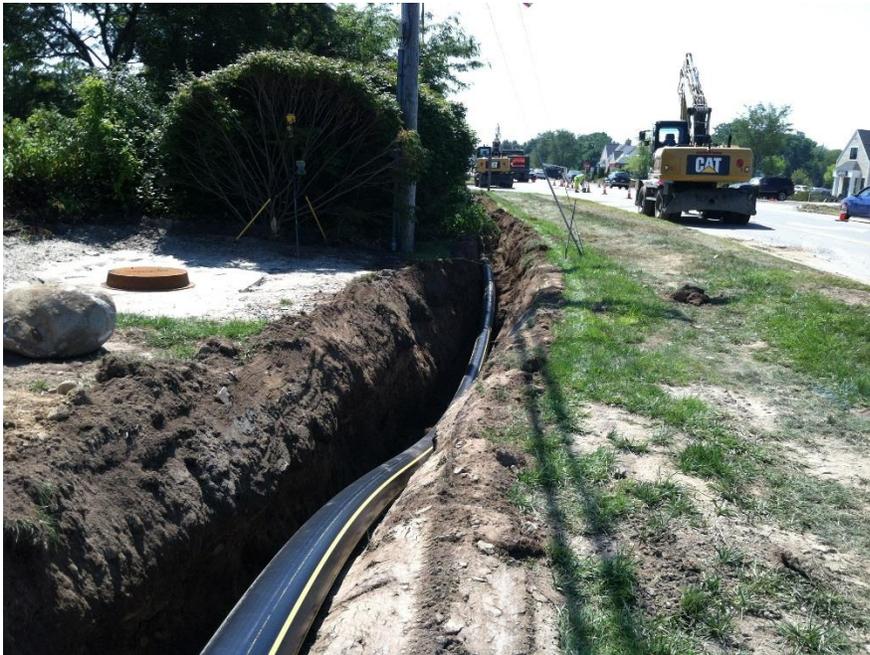
Businesses are always looking for ways to control energy costs, and many along Route One are eagerly anticipating the arrival of natural gas along the corridor. Installation has started! Here's the new natural gas main, in a trench near the north entrance to the Falmouth Shopping Plaza

Installation of the natural gas pipeline has begun, starting near the intersection of Route One and Bucknam Road and running south along the east side of Route One. The majority of this work is being done during daylight hours (several crossings of Route One are expected sometime next week). Two-way traffic is being maintained, although you may expect that the lane closest to the east side curb will often be reserved for construction equipment. Flaggers will direct traffic around this equipment.

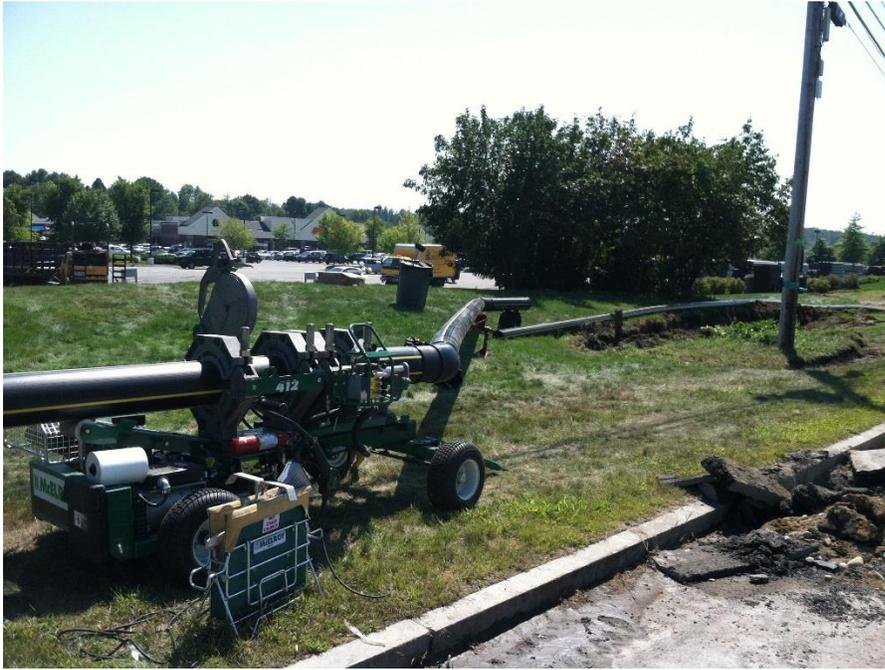
In the old days, gas mains were typically welded metal pipe – and subject to corrosion and failure. Today’s mains are highly engineered (and enormously strong) plastic. In this view, we see one of two machines on site that weld the plastic pipe. The green object in lower left is a heating element, and center left is a clamping mechanism. The pipe ends are trued with the circular saw (top left); the two pipe ends are heated for about 15 minutes, then the heating element is removed and hydraulically driven clamps push the pipe ends together. After a careful cool-down period, the weld is stronger than the pipe itself.
