West Branch Restoration Project

West Branch Erosion Damage

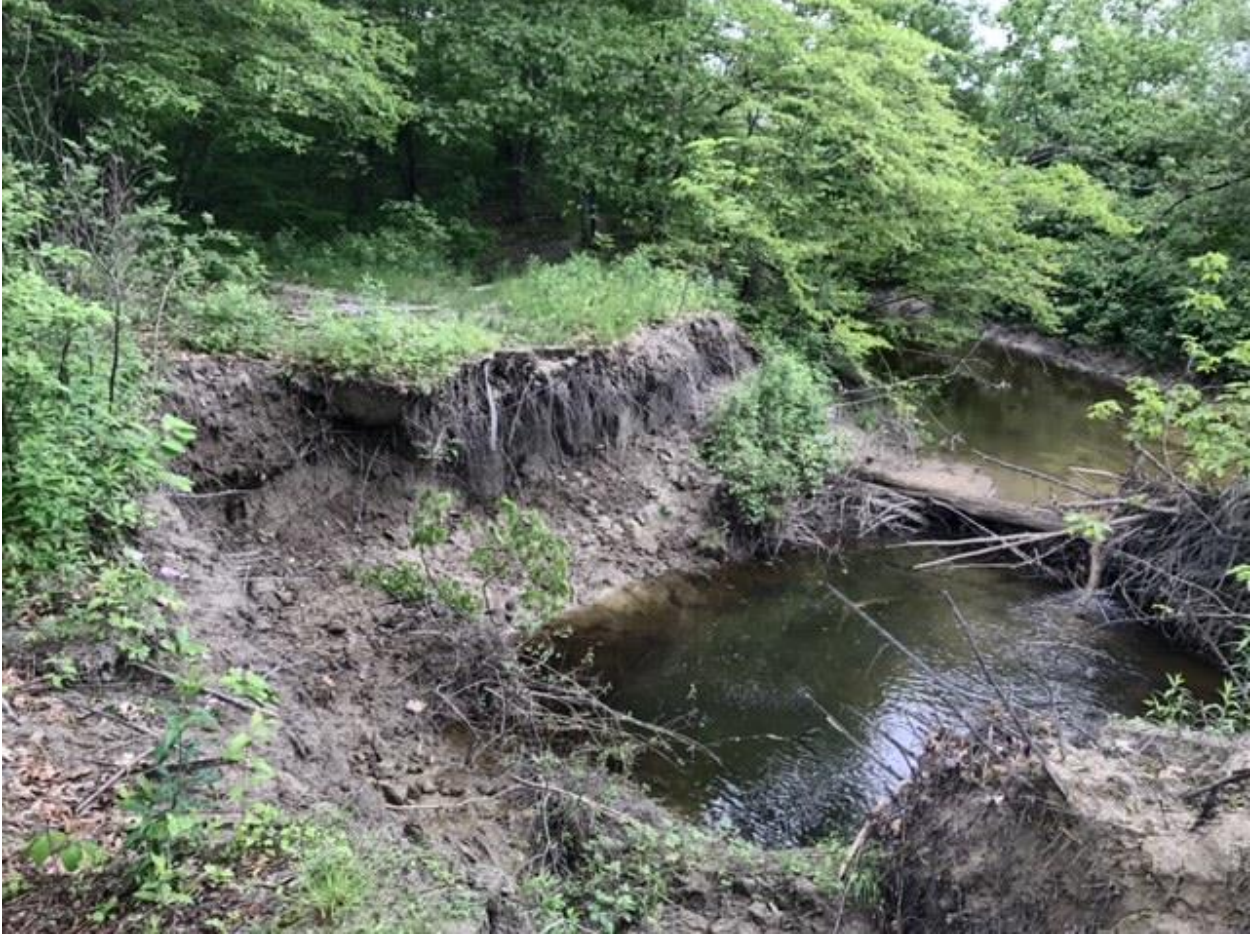
There is a serious bank erosion problem on a portion of the West Branch of the Piscataqua River at River Point Conservation Area (see attached photo). 300-400 feet of bank is already seriously eroded and another 600-700 feet are threatened. Tons of eroded soil has had a very harmful impact on the aquatic habitat in the West and East Branches of the Piscataqua and down to the Presumpscot River. We are also losing a great deal of land in that area, land that includes two very rare plant species and valuable early successional habitat.

Steps need to be taken now to prevent another 300-400 feet of stream bank damage this coming spring. An arborist needs to take down leaning trees that are likely to come down and tear out large chunks of the bank with their root balls attached. Felling and removing them now will keep the root balls intact and prevent additional erosion. The cost of doing that work is expected to be \$5-7,000.

A detailed restoration plan also needs to be developed to strengthen our grant proposal. That plan, essentially a detailed engineering document, can only be done by a fluvial geomorphologist and will cost \$2-\$3,000. These costs will not be reimbursable from future grant funds.
